**Executive Summary – September 2025**

JOB: Structural Integrity Reserve Study (SIRS)  
ADDRESS: 8290 LAKE DRIVE, CITY OF DORAL

FOLIO: 35-3022-028-0001

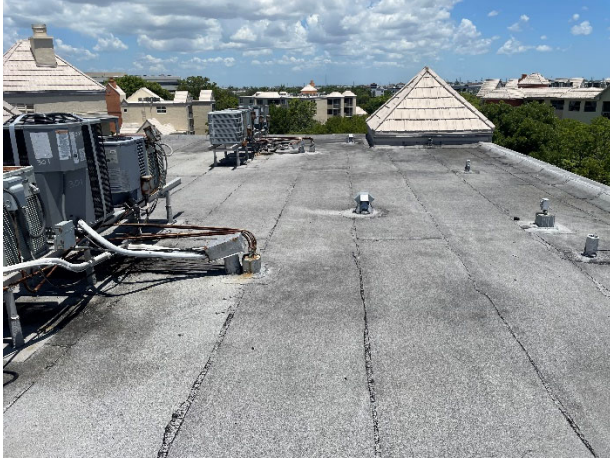
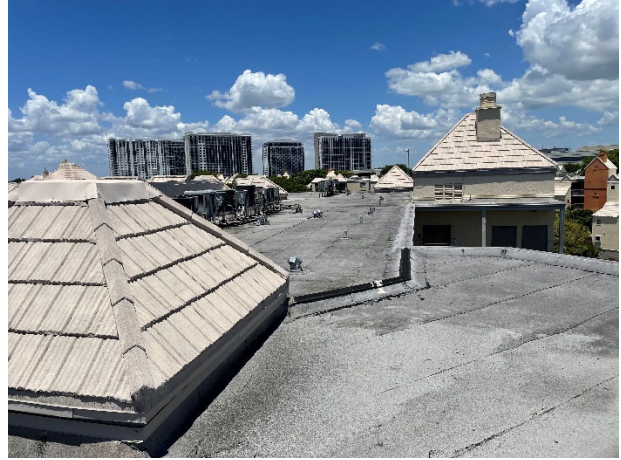
### Roof

The roof consists of reinforced concrete slabs in fair condition. The roof membrane is a built-up roof system with a granular surface modified bitumen cap sheet. The roofs are currently undergoing repair which are expected to be completed prior to December 21, 2025, reserve funds will be used to carry out the necessary maintenance and repair work during the ten-year period.

Roof drains, scuppers on all balconies, gutters, and leaders discharge into trench drains. The drainage system is in fair condition; some corrosion was found but no repairs are currently needed. There are no roof framing members with obvious overloading, overstress, deterioration, or excessive deflection observed. Surface conditions are overall fair to poor conditions. Previous repairs were observed, and hairline cracks were noted on the roof.

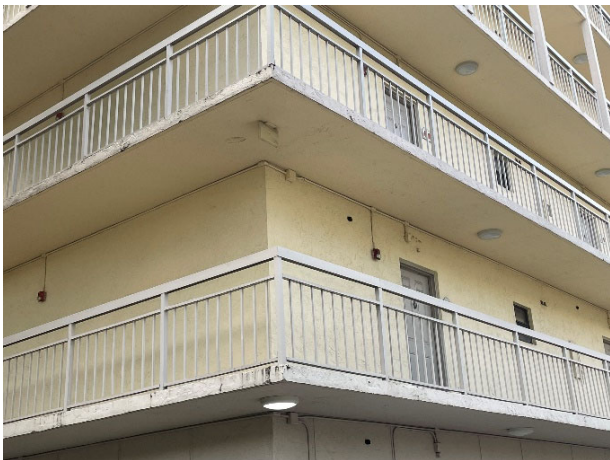
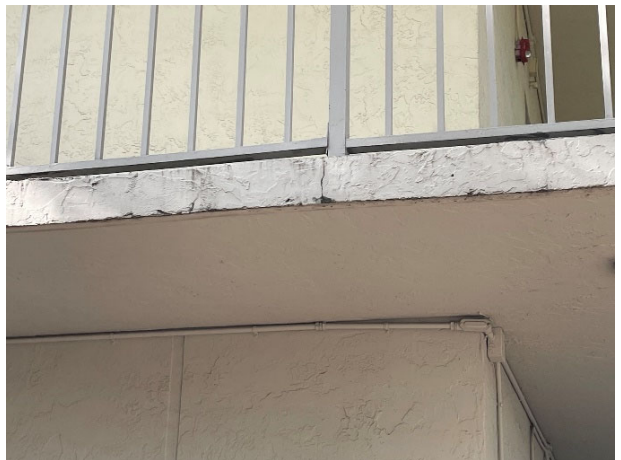
### Exterior Nonconcrete Walls

Nonbearing walls of exterior façade are in fair condition, showing signs of wear such as cracks and surface deterioration.

Minor wear such as small cracks were found at nonbearing walls. Maintenance is recommended over the next ten years, including localized repairs, repainting, sealing, and addressing any waterproofing issues to prevent further deterioration and maintain their functionality and appearance.

Maintenance is recommended over the next ten years, including localized crack repairs, repainting, resealing of joints and windows, and improvements to waterproofing where needed to prevent moisture intrusion.

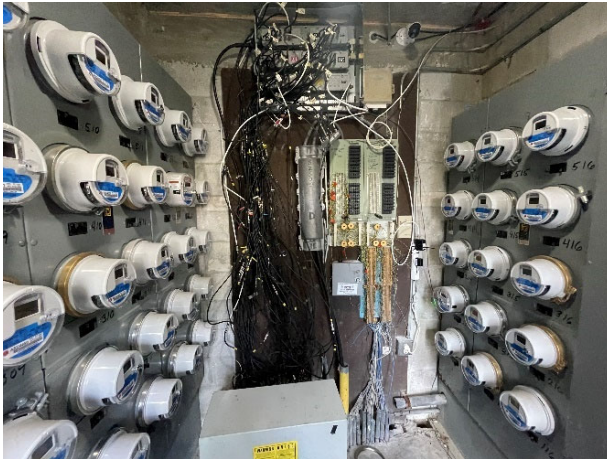
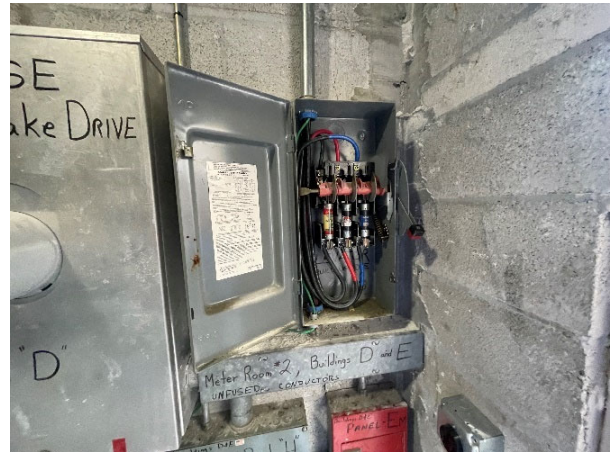
## A. Electrical Systems

The general conduits & raceways require repairs; There is rust and corrosion on some conduits. Moreover, there is loose BX conduit exiting concrete slab, the penetrations around these conduits must be patched, the wire and cables have rusted conduits and loose connections for BX exiting the concrete slab.

No defects were observed with swimming pool wiring or mechanical equipment or in wiring to mechanical equipment. There was no exposed wiring observed in open parking garage areas. Some breakers will need to be replaced during the ten-year period.

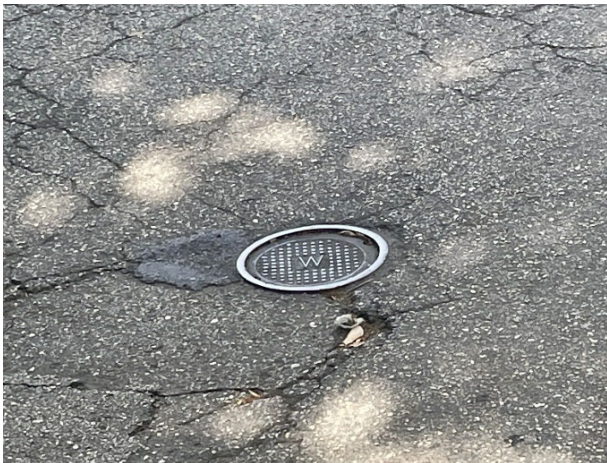
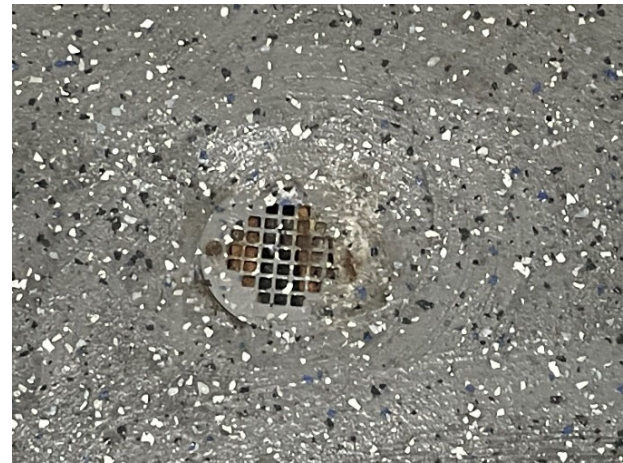
### Sanitary System:

They consist of sanitary risers (stacks) with full size ventilation through the roof. We project six incidents for this building in a ten years period.

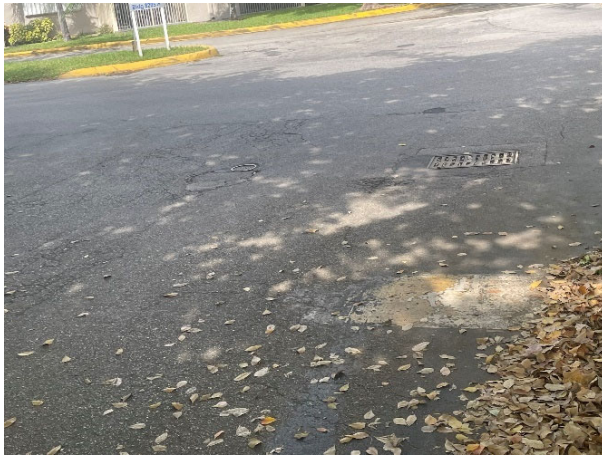
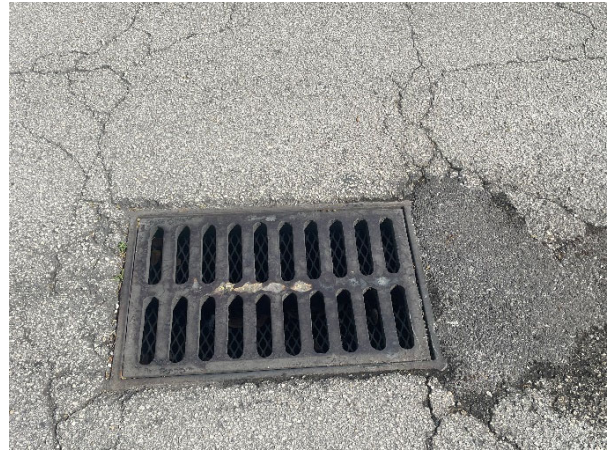
## Drainage System

A new drainage is needed to replace the existing ones, ensuring enhanced performance and durability. This section includes the replacement of the isolated catch basing and pipes.

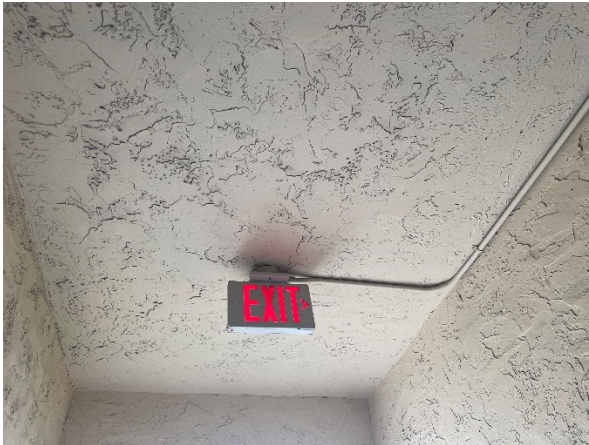
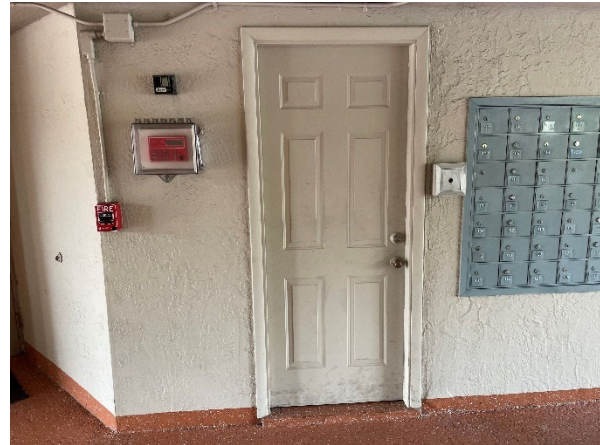
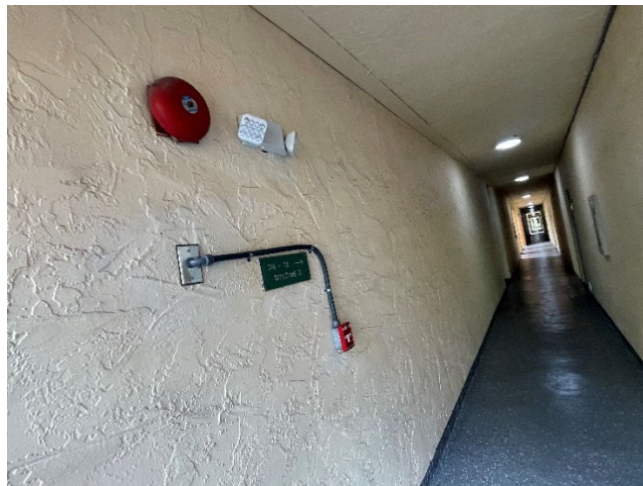
## C. Fireproofing and Fire Protection System

There is a fire alarm system in a dedicate fire command center; logbooks are up to date and provided in the electric panel room. The fire protection system utilizes a sprinklered system. There are fire alarm pull boxes, fire notification system and emergency lighting. Exit lights, emergency lights are building egress illumination is present and operable.

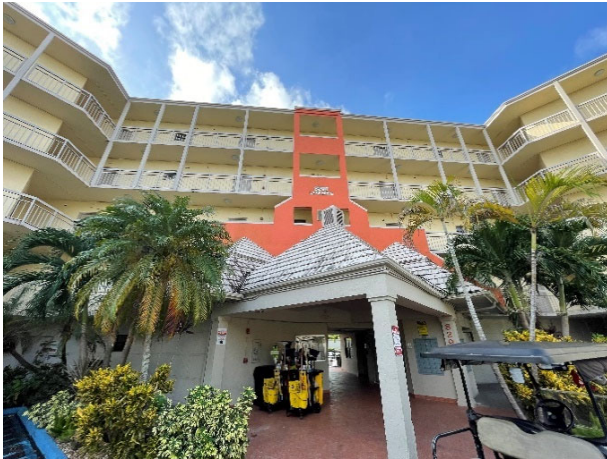
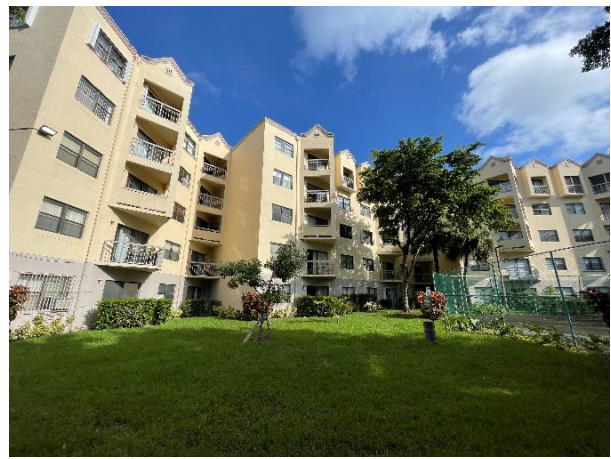
#### D. Painting

The paint is in overall fair condition; however, it is nearing the end of its service life and requires maintenance. Peeling paint was observed around windows on balconies, indicating the need for a new coating to preserve the building's exterior. Additionally, maintenance is required for some window caulking areas to prevent water infiltration. All services area of condominium are included.

The paint is in overall fair condition; however, it is nearing the end of its service life and requires maintenance. Peeling paint was observed around windows on balconies, indicating the need for a new coating to preserve the building's exterior. Additionally, maintenance is required for some window caulking areas to prevent water infiltration. Budgeting for repainting is necessary to maintain aesthetic and protective functions.

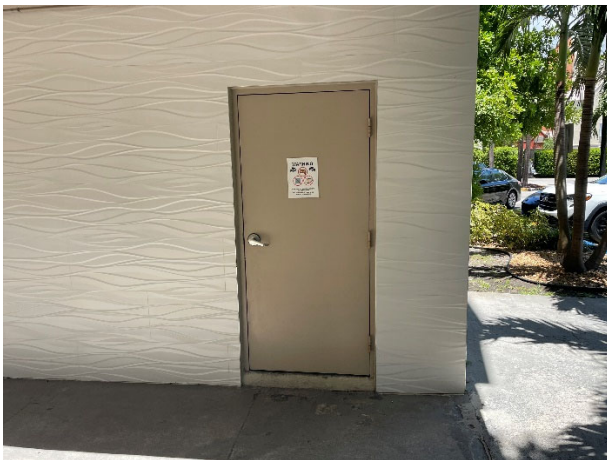
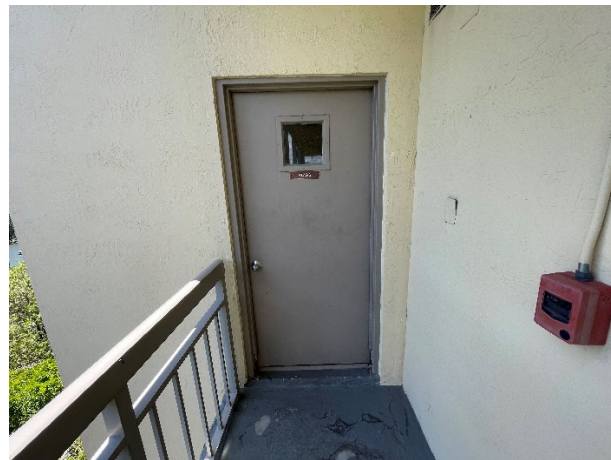
#### E. Exterior Doors

All doors are in fair condition, only regular maintenance.
