**Executive Summary – September 2025**

JOB: Structural Integrity Reserve Study (**SIRS**)  
ADDRESS: 8343 LAKE DRIVE, CITY OF DORAL

FOLIO: 35-3022-028-0001

This Structural Integrity Reserve Study is being prepared in compliance with F.S. § 718.112 (2) (g)

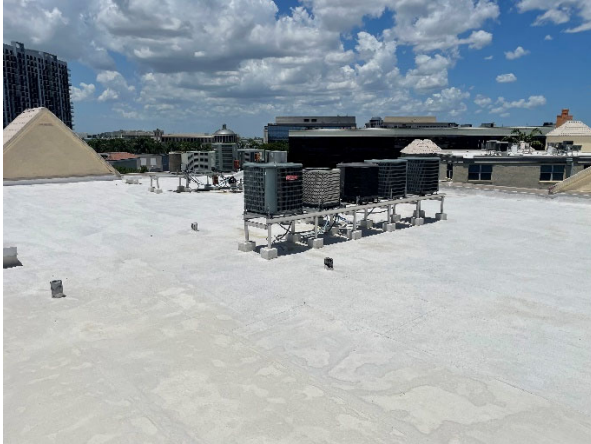
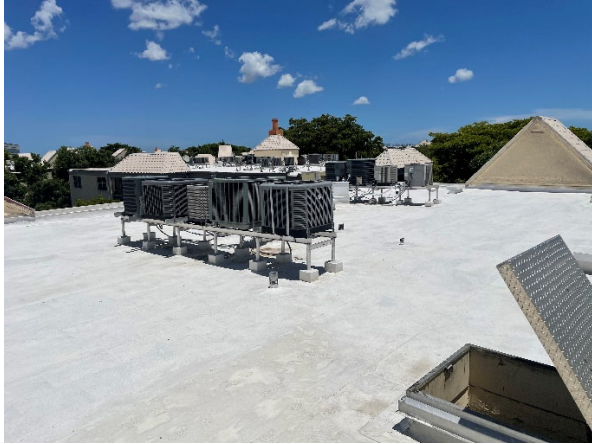
### Roof

Roof drains, scuppers on all balconies, gutters, and leaders discharge into trench drains. The drainage system is in fair condition; some corrosion was found but no repairs are currently needed. There are no roof framing members with obvious overloading, overstress, deterioration, or excessive deflection observed. Surface conditions are overall fair to poor conditions. Previous repairs were observed, and hairline cracks were noted on the roof.

The roof consists of reinforced concrete slabs in fair condition. The roof membrane is a built-up roof system with a granular surface modified bitumen cap sheet. The roofs are currently undergoing repair which are expected to be completed prior to December 21, 2025, reserve funds will be used to carry out the necessary maintenance and repair work during the ten-year period.

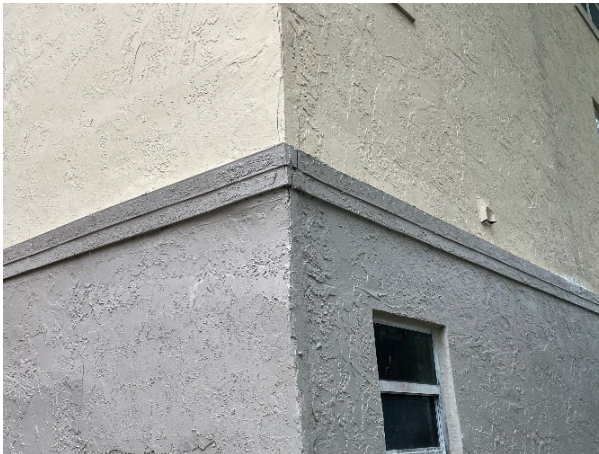
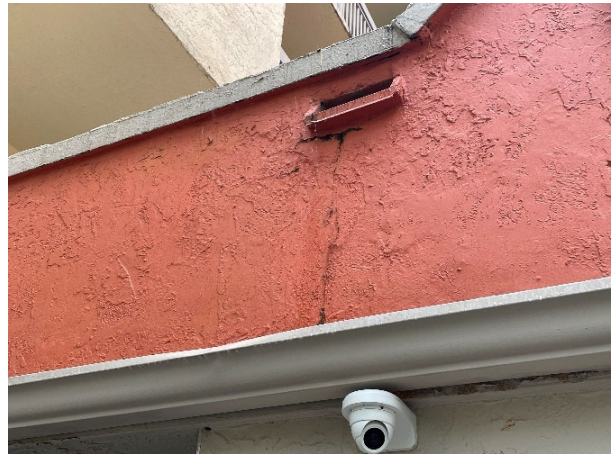
### Exterior Nonconcrete Walls

Minor wear such as small cracks were found at nonbearing walls. Maintenance is recommended over the next ten years, including localized repairs, repainting, sealing, and addressing any waterproofing issues to prevent further deterioration and maintain their functionality and appearance.

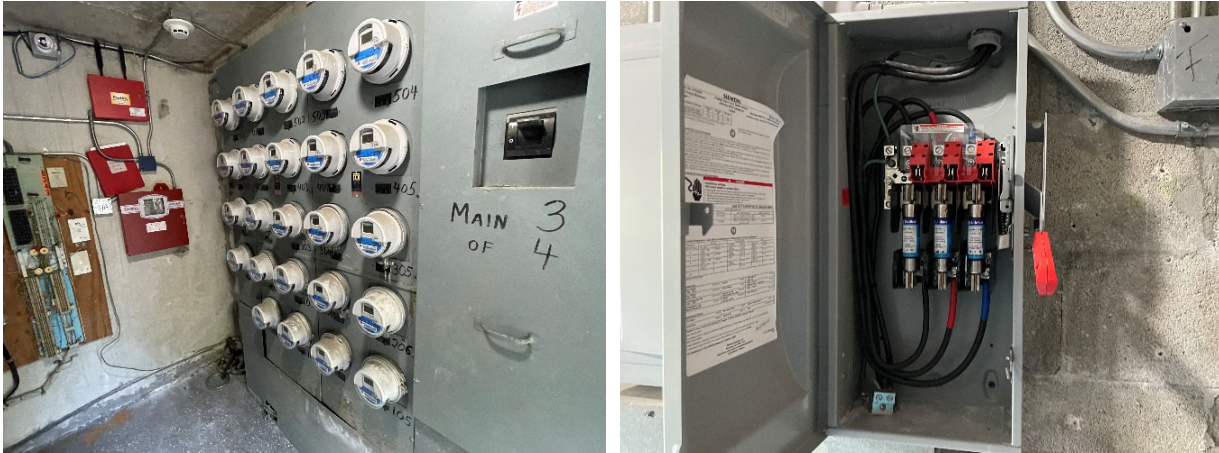
## A. Electrical Systems

The general conduits & raceways require repairs; There is rust and corrosion on some conduits. Moreover, there is loose BX conduit exiting concrete slab, the penetrations around these conduits must be patched, the wire and cables have rusted conduits and loose connections for BX exiting the concrete slab.

No defects were observed with swimming pool wiring or mechanical equipment or in wiring to mechanical equipment. There was no exposed wiring observed in open parking garage areas. Some breakers will need to be replaced during the ten-year period.

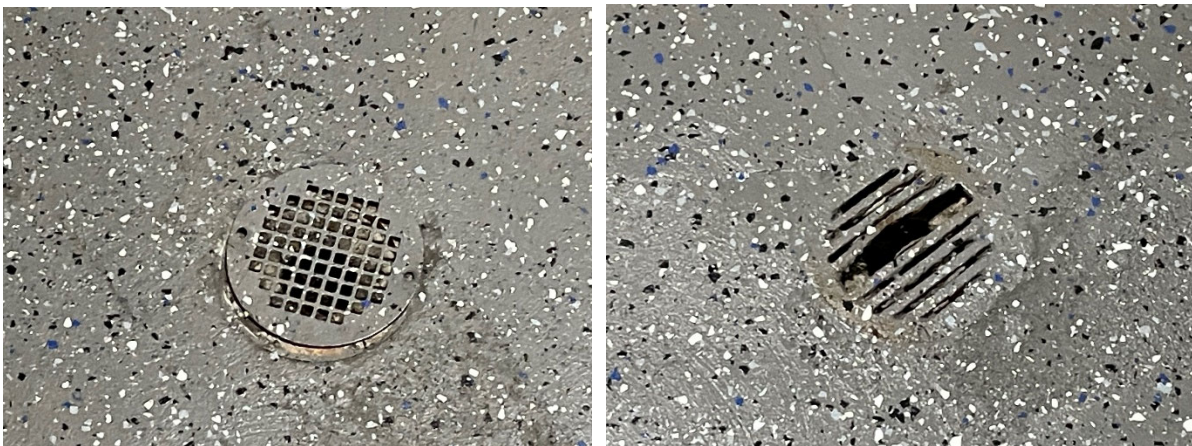
### Sanitary System:

They consist of sanitary risers (stacks) with full size ventilation through the roof. We project two incidents for this building in a ten years period.

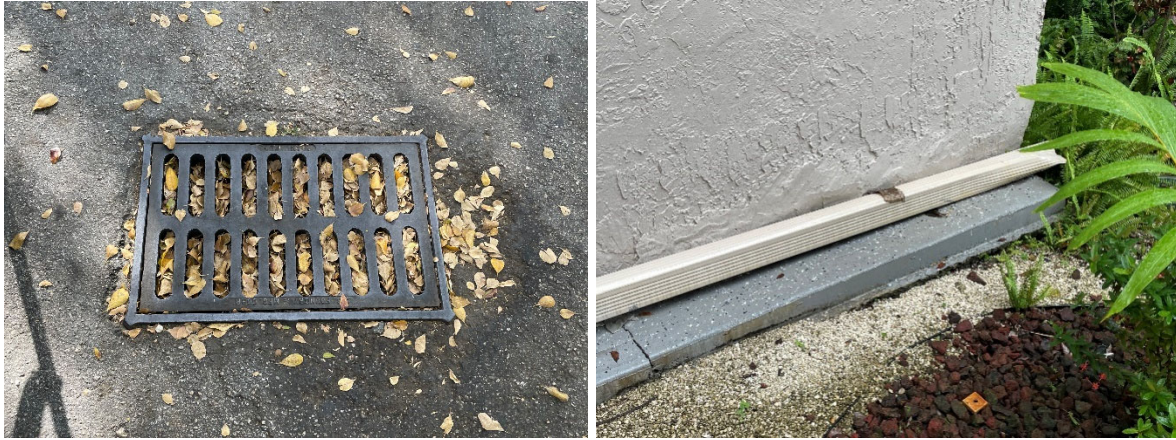
## Drainage System

A new drainage is needed to replace the existing ones, ensuring enhanced performance and durability. This section includes the replacement of the isolated catch basing and pipes.

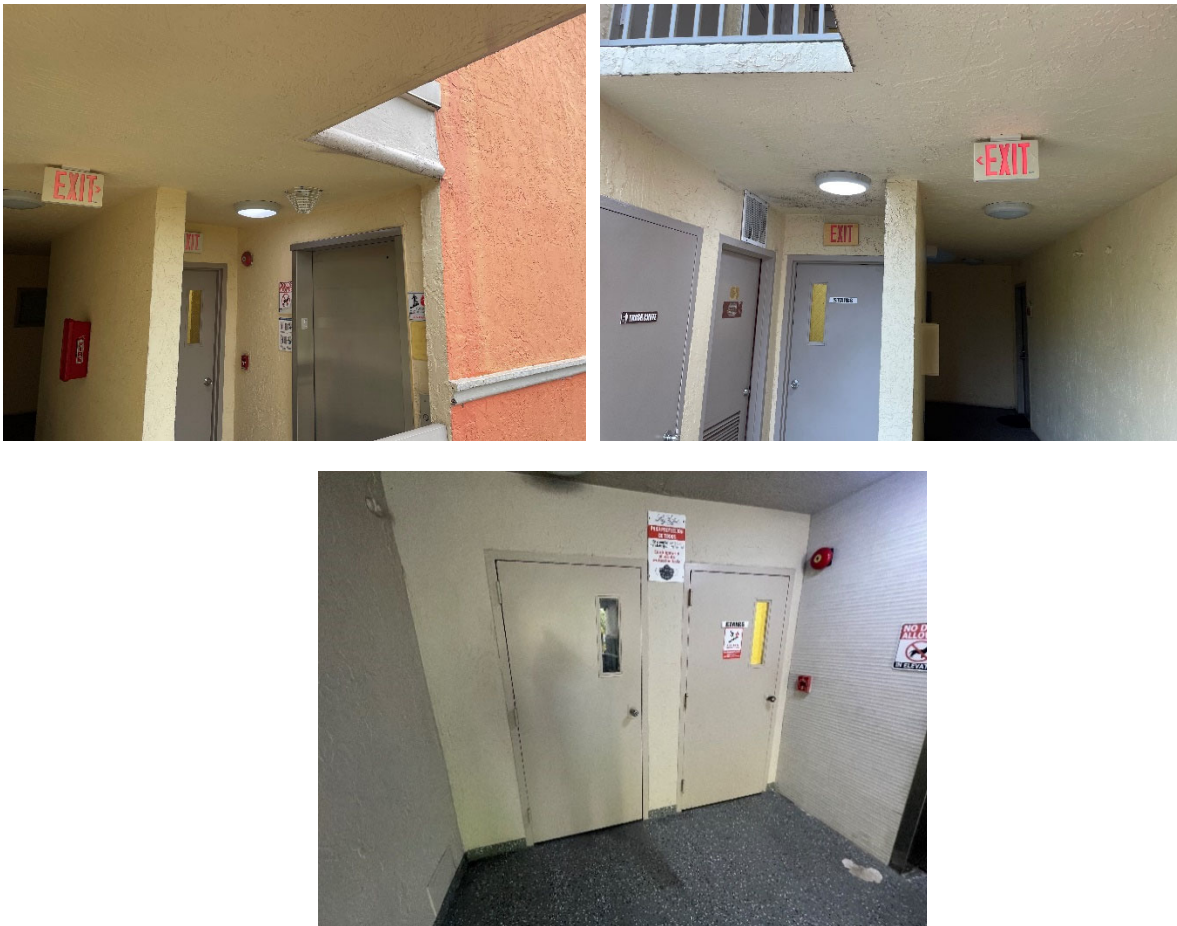
### C. Fireproofing and Fire Protection System

There is a fire alarm system in a dedicate fire command center; logbooks are up to date and provided in the electric panel room. The fire protection system utilizes a sprinklered system. There are fire alarm pull boxes, fire notification system and emergency lighting. Exit lights, emergency lights are building egress illumination is present and operable.

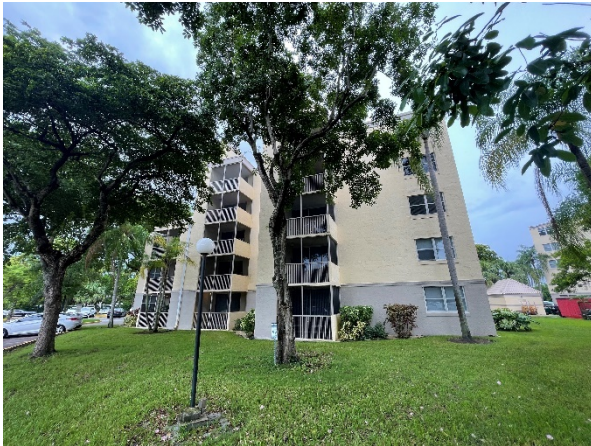
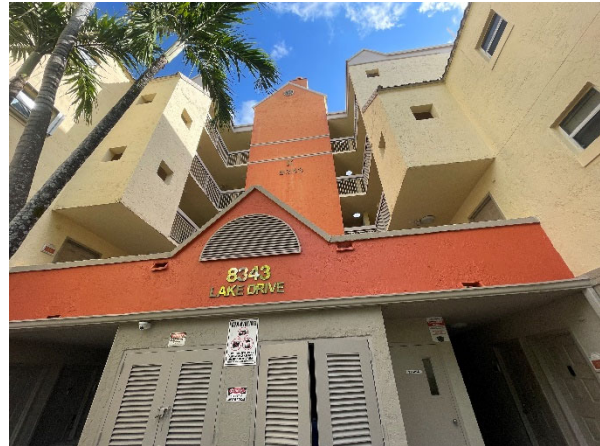
#### D. Painting

The paint is in overall fair condition; however, it is nearing the end of its service life and requires maintenance. Peeling paint was observed around windows on balconies, indicating the need for a new coating to preserve the building's exterior. Additionally, maintenance is required for some window caulking areas to prevent water infiltration. Budgeting for repainting is necessary to maintain aesthetic and protective functions.

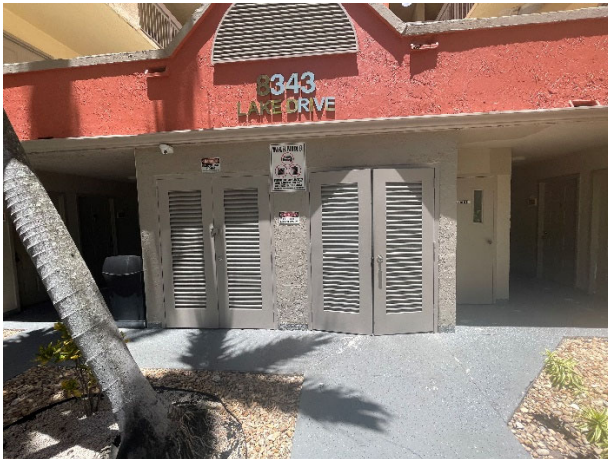
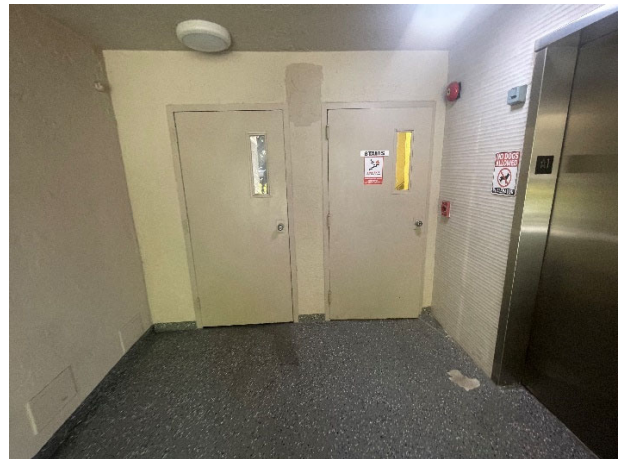
#### E. Exterior Doors

All doors are in fair condition, only regular maintenance.
