**Executive Summary – September 2025**

JOB: Structural Integrity Reserve Study (SIRS)  
ADDRESS: 8225 LAKE DRIVE, CITY OF DORAL

This Structural Integrity Reserve Study is being prepared in compliance with F.S. § 718.112 (2) (g)

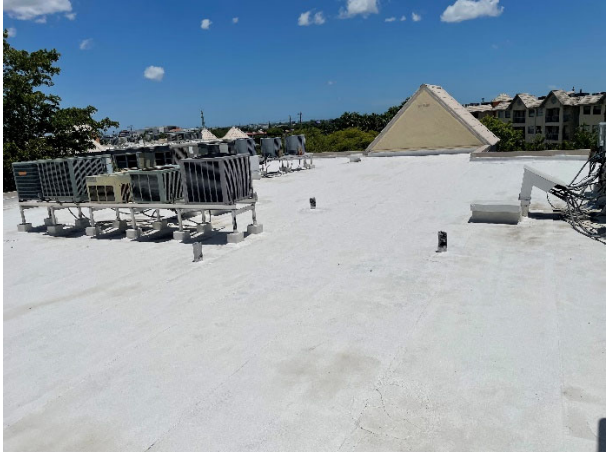
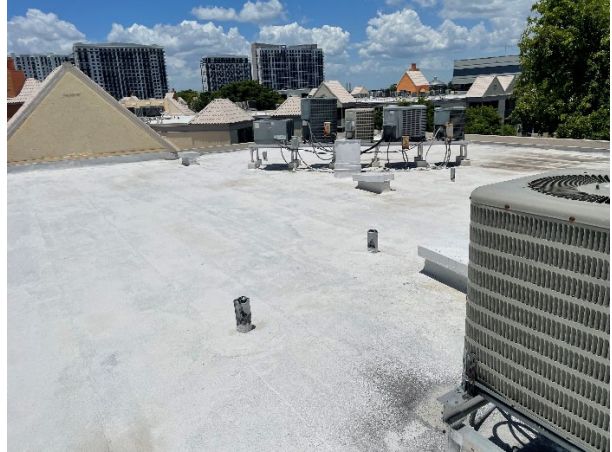
### Roof

Roof drains, scuppers on all balconies, gutters, and leaders discharge into trench drains. The drainage system is in fair condition; some corrosion was found but no repairs are currently needed. There are no roof framing members with obvious overloading, overstress, deterioration, or excessive deflection observed. Surface conditions are overall fair to poor conditions. Previous repairs were observed, and hairline cracks were noted on the roof.

The roof consists of reinforced concrete slabs in fair condition. The roof membrane is a built-up roof system with a granular surface modified bitumen cap sheet. The roofs are currently undergoing repair which are expected to be completed prior to December 21, 2025, reserve funds will be used to carry out the necessary maintenance and repair work during the ten-year period.

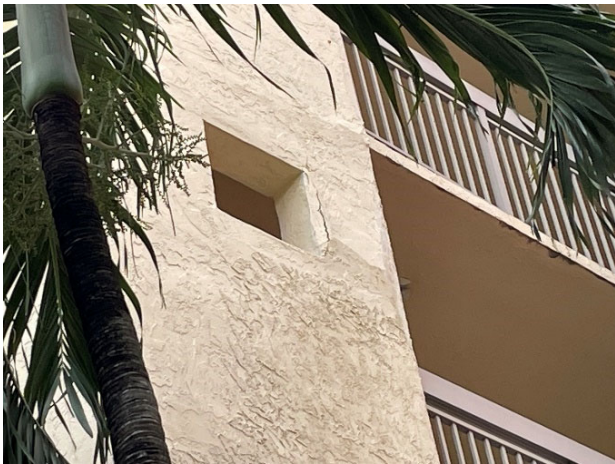
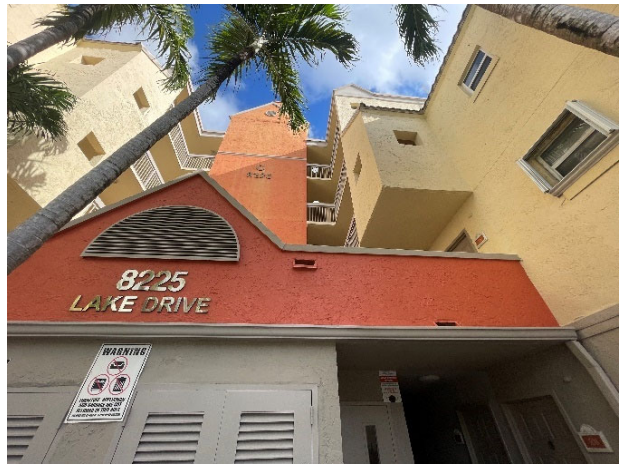
### Exterior Nonconcrete Walls

Nonbearing walls of exterior façade are in fair condition, showing signs of wear such as cracks and surface deterioration.

Minor wear such as small cracks were found at nonbearing walls. Maintenance is recommended over the next ten years, including localized repairs, repainting, sealing, and addressing any waterproofing issues to prevent further deterioration and maintain their functionality and appearance.

Maintenance is recommended over the next ten years, including localized crack repairs, repainting, resealing of joints and windows, and improvements to waterproofing where needed to prevent moisture intrusion.

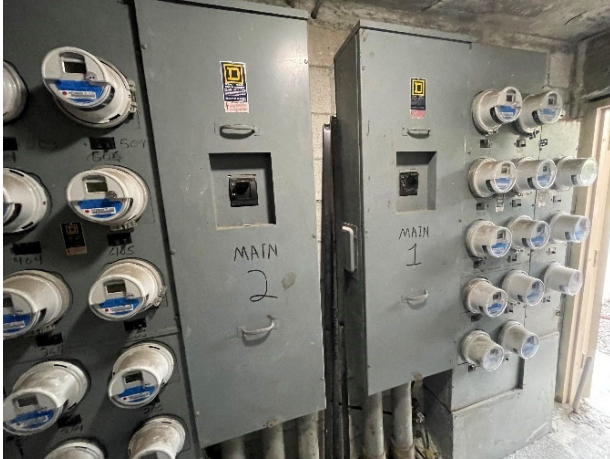
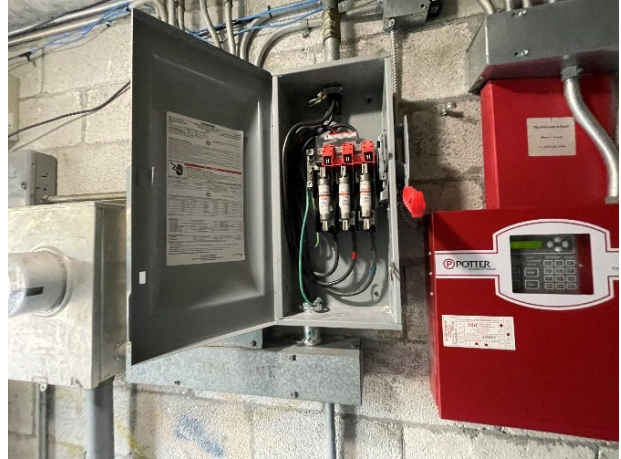
## A. Electrical Systems

The general conduits & raceways require repairs; There is rust and corrosion on some conduits. Moreover, there is loose BX conduit exiting concrete slab, the penetrations around these conduits must be patched, the wire and cables have rusted conduits and loose connections for BX exiting the concrete slab.

No defects were observed with swimming pool wiring or mechanical equipment or in wiring to mechanical equipment. There was no exposed wiring observed in open parking garage areas. Some breakers will need to be replaced during the ten-year period.

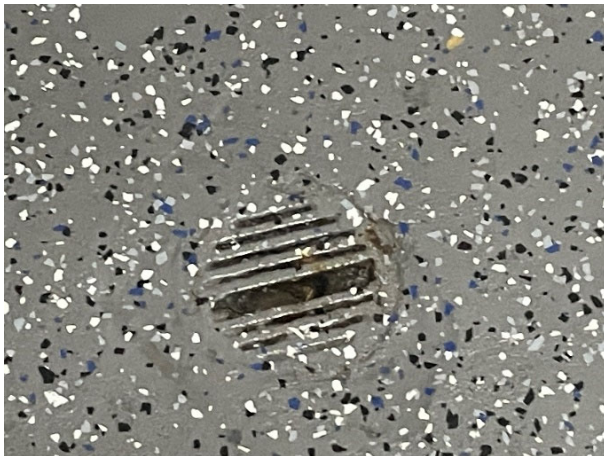
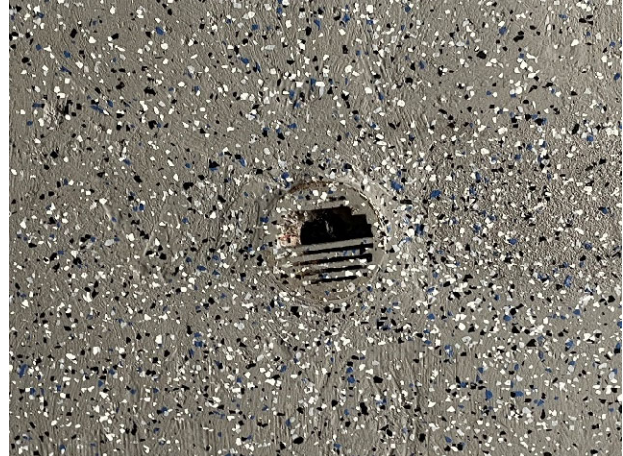
### Sanitary System:

They consist of sanitary risers (stacks) with full size ventilation through the roof. We project two incidents for this building in a ten years period.

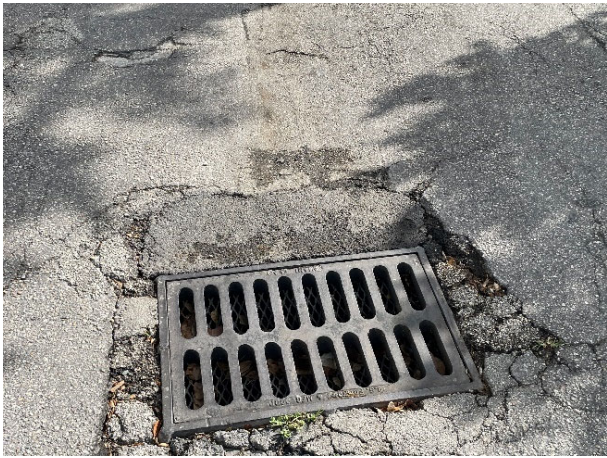
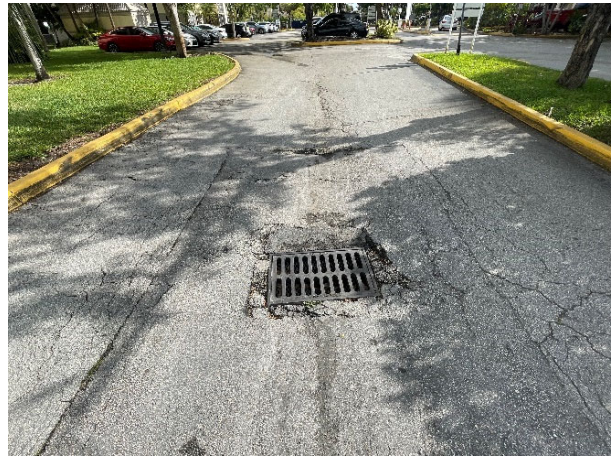
## Drainage System

A new drainage is needed to replace the existing ones, ensuring enhanced performance and durability. This section includes the replacement of the isolated catch basing and pipes.

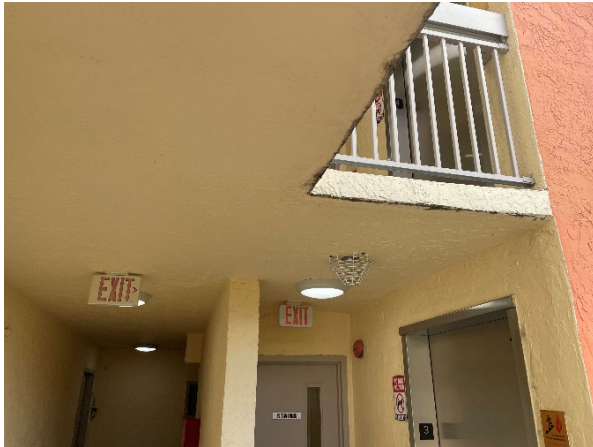
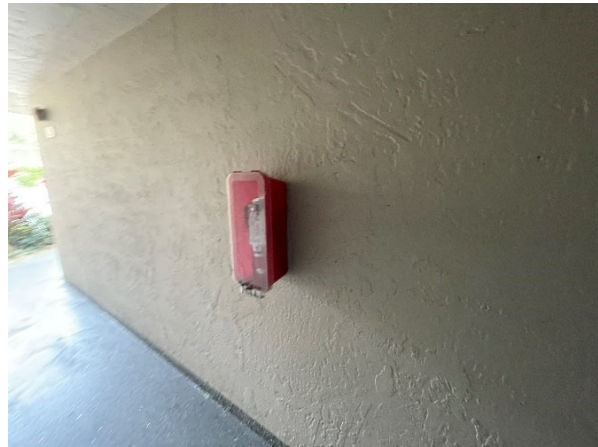
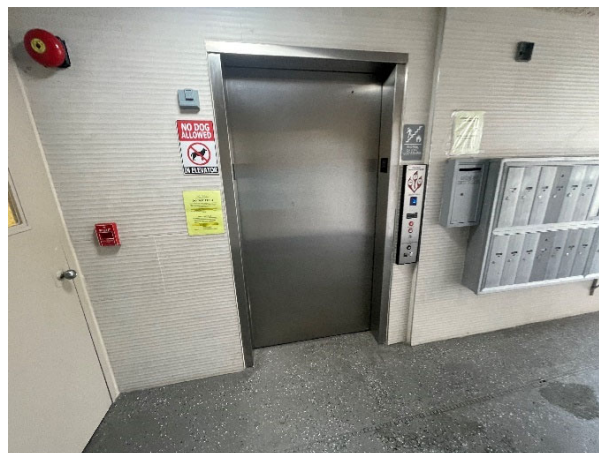
## C. Fireproofing and Fire Protection System

There is a fire alarm system in a dedicated fire command center; logbooks are up to date and provided in the electric panel room. The fire protection system utilizes a sprinklered system. There are fire alarm pull boxes, fire notification system and emergency lighting. Exit lights, emergency lights are building egress illumination is present and operable. Egress illumination is also present and operable in the parking garage. Some smoke detectors are covered due to ongoing masonry work causing dust to trigger alarms.

There is a fire alarm system in a dedicate fire command center; logbooks are up to date and provided in the electric panel room. The fire protection system utilizes a sprinklered system. There are fire alarm pull boxes, fire notification system and emergency lighting. Exit lights, emergency lights are building egress illumination is present and operable.

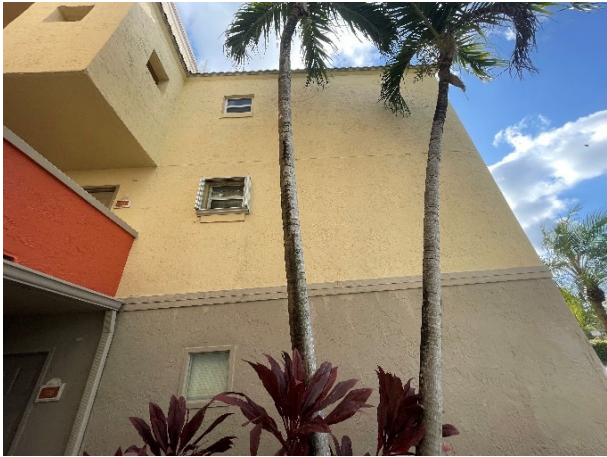
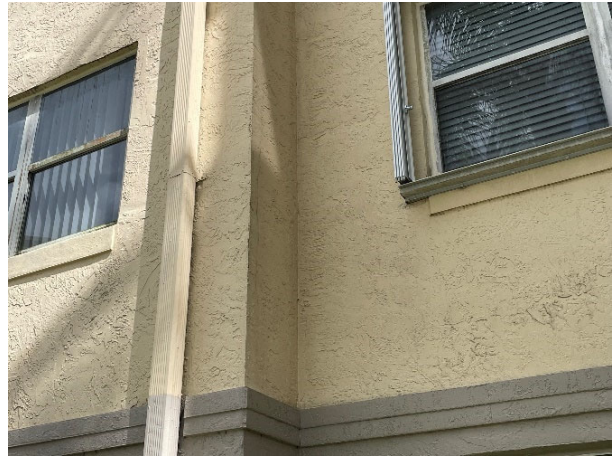
#### D. Painting

The paint is in overall fair condition; however, it is nearing the end of its service life and requires maintenance. Peeling paint was observed around windows on balconies, indicating the need for a new coating to preserve the building's exterior. Additionally, maintenance is required for some window caulking areas to prevent water infiltration. Budgeting for repainting is necessary to maintain aesthetic and protective functions.

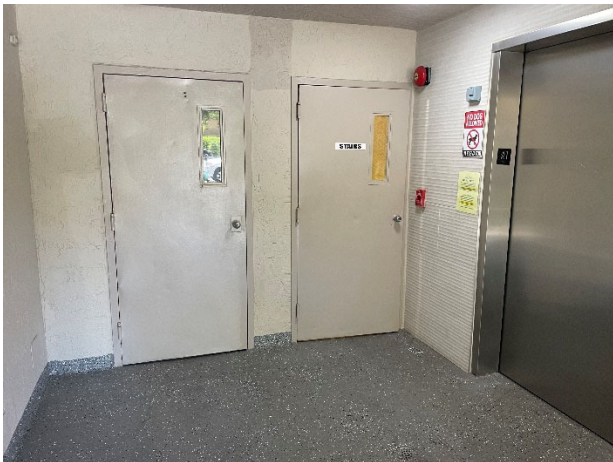
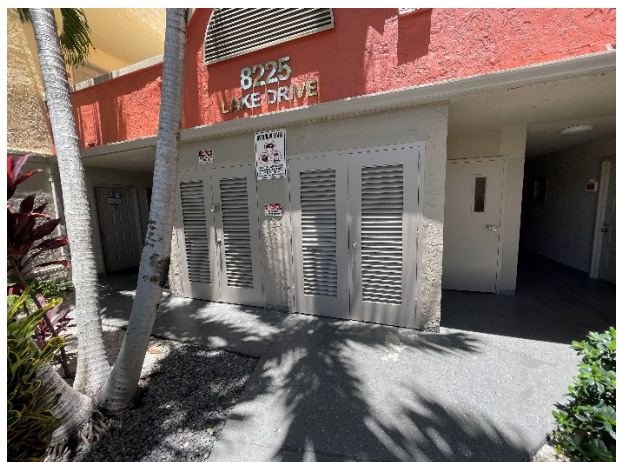
#### E. Exterior Doors

All doors are in fair condition, only regular maintenance.
