**Executive Summary – September 2025**

JOB: Structural Integrity Reserve Study (**SIRS**)  
ADDRESS: 8245 LAKE DRIVE, CITY OF DORAL

This Structural Integrity Reserve Study is being prepared in compliance with F.S. § 718.112 (2) (g)

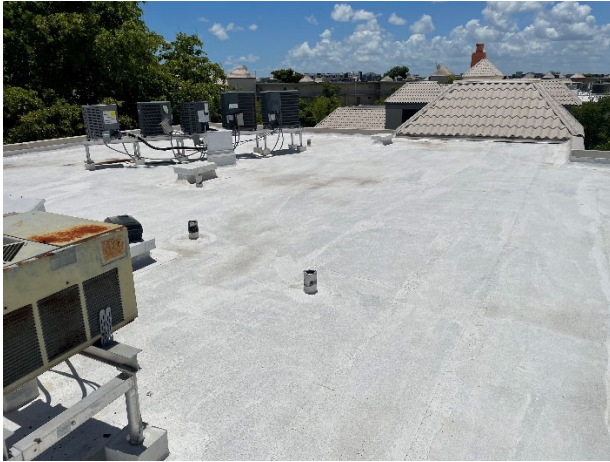
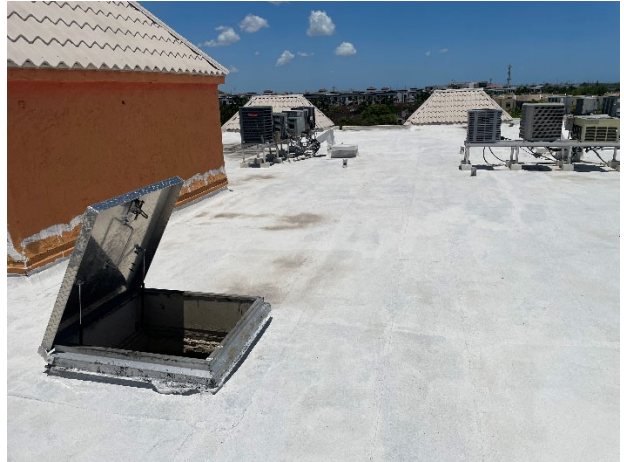
### Roof

Roof drains, scuppers on all balconies, gutters, and leaders discharge into trench drains. The drainage system is in fair condition; some corrosion was found but no repairs are currently needed. There are no roof framing members with obvious overloading, overstress, deterioration, or excessive deflection observed. Surface conditions are overall fair to poor conditions. Previous repairs were observed, and hairline cracks were noted on the roof.

The roof consists of reinforced concrete slabs in fair condition. The roof membrane is a built-up roof system with a granular surface modified bitumen cap sheet. The roofs are currently undergoing repair which are expected to be completed prior to December 21, 2025, reserve funds will be used to carry out the necessary maintenance and repair work during the ten-year period.

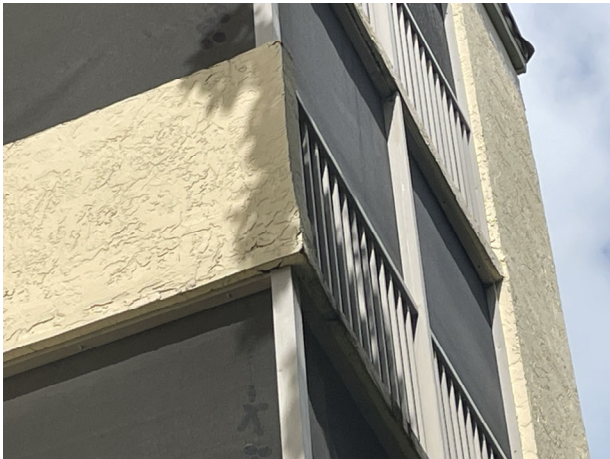
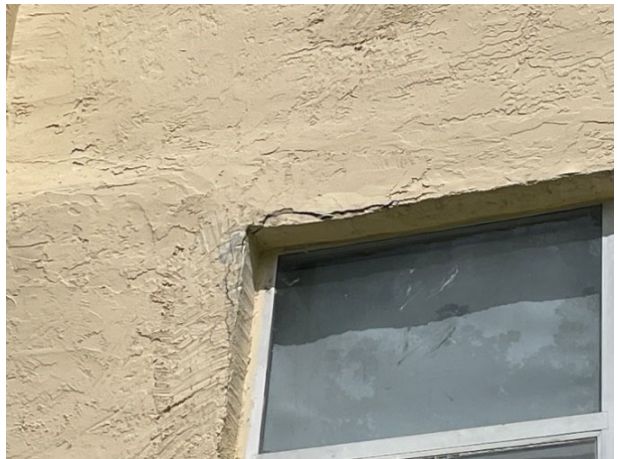
### Exterior Nonconcrete Walls

Nonbearing walls of exterior façade are in fair condition, showing signs of wear such as cracks and surface deterioration.

Minor wear such as small cracks were found at nonbearing walls. Maintenance is recommended over the next ten years, including localized repairs, repainting, sealing, and addressing any waterproofing issues to prevent further deterioration and maintain their functionality and appearance.

Maintenance is recommended over the next ten years, including localized crack repairs, repainting, resealing of joints and windows, and improvements to waterproofing where needed to prevent moisture intrusion.

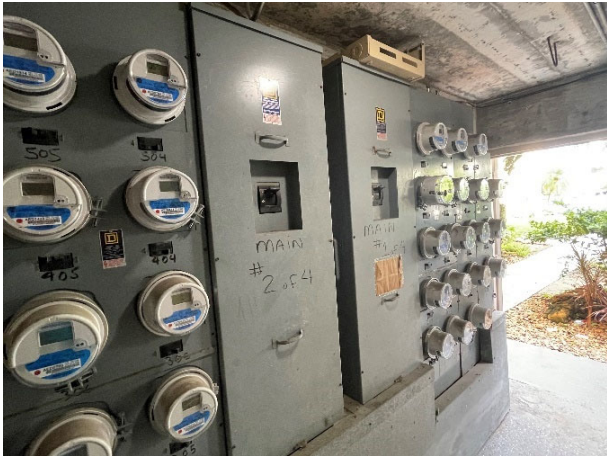
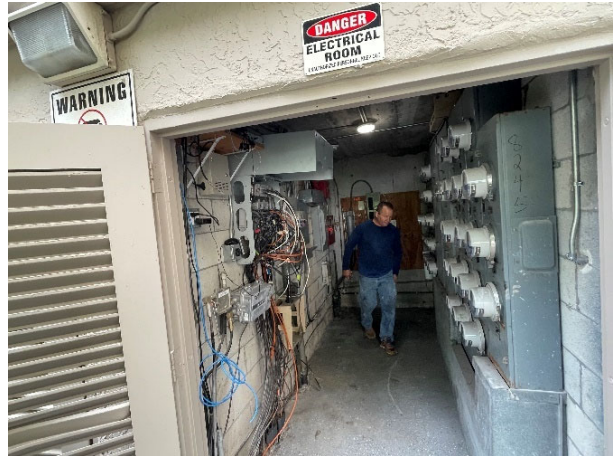
## A. Electrical Systems

The general conduits & raceways require repairs; There is rust and corrosion on some conduits. Moreover, there is loose BX conduit exiting concrete slab, the penetrations around these conduits must be patched, the wire and cables have rusted conduits and loose connections for BX exiting the concrete slab.

No defects were observed with swimming pool wiring or mechanical equipment or in wiring to mechanical equipment. There was no exposed wiring observed in open parking garage areas. Some breakers will need to be replaced during the ten-year period.

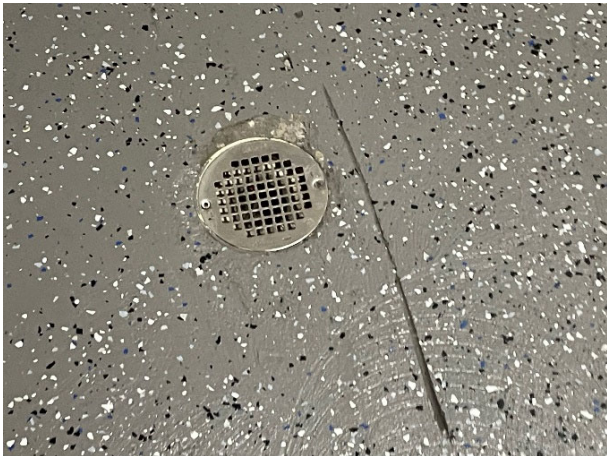
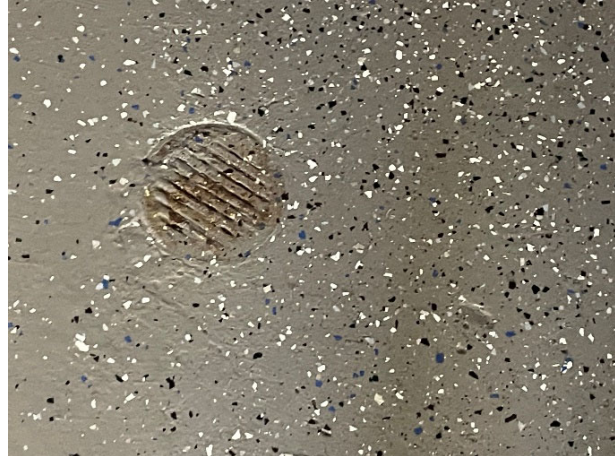
### Sanitary System:

They consist of sanitary risers (stacks) with full size ventilation through the roof. We project two incidents for this building in a ten years period.

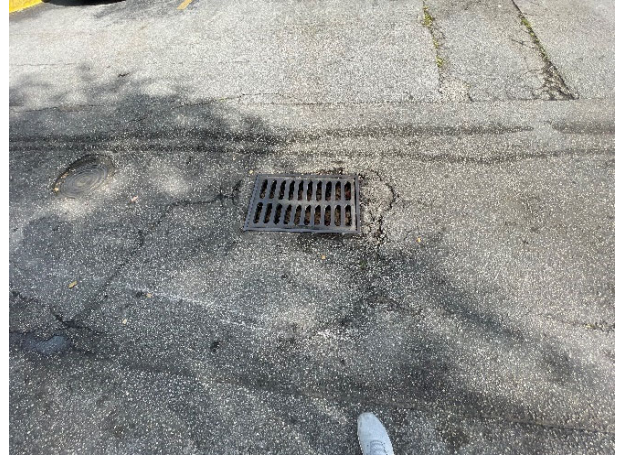
## Drainage System

A new drainage is needed to replace the existing ones, ensuring enhanced performance and durability. This section includes the replacement of the isolated catch basing and pipes.

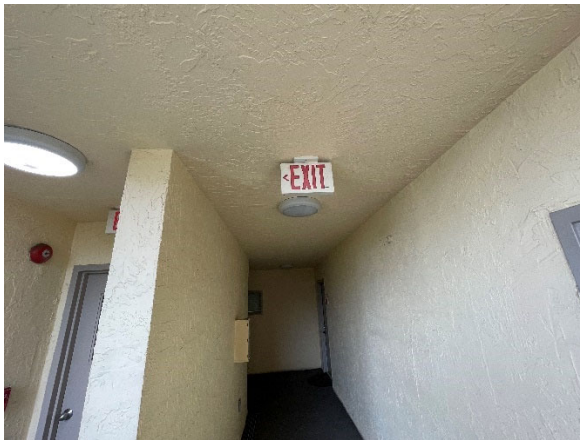
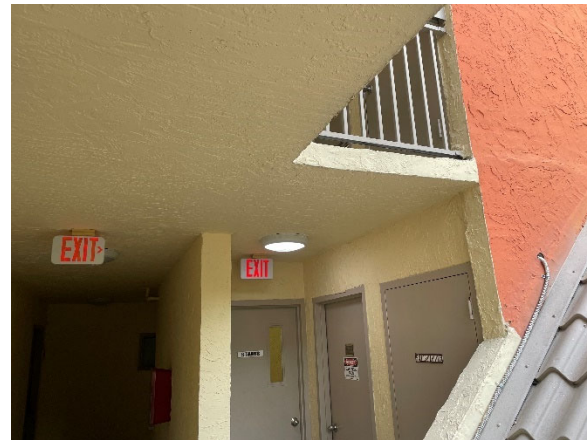
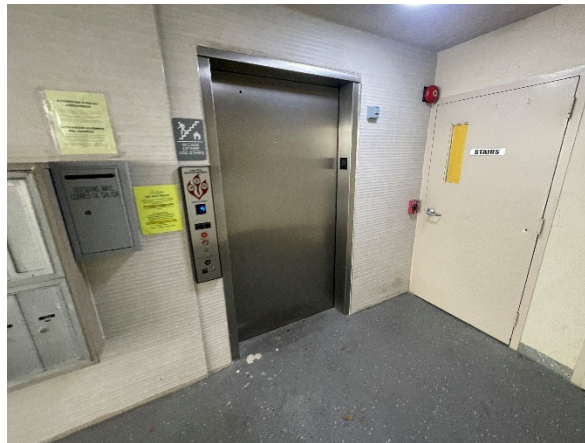
### C. Fireproofing and Fire Protection System

There is a fire alarm system in a dedicated fire command center; logbooks are up to date and provided in the electric panel room. The fire protection system utilizes a sprinklered system. There are fire alarm pull boxes, fire notification system and emergency lighting. Exit lights, emergency lights are building egress illumination is present and operable. Egress illumination is also present and operable in the parking garage. Some smoke detectors are covered due to ongoing masonry work causing dust to trigger alarms.

There is a fire alarm system in a dedicate fire command center; logbooks are up to date and provided in the electric panel room. The fire protection system utilizes a sprinklered system. There are fire alarm pull boxes, fire notification system and emergency lighting. Exit lights, emergency lights are building egress illumination is present and operable.

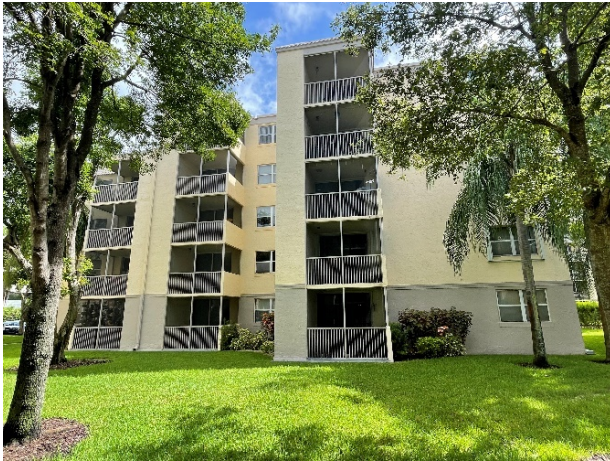
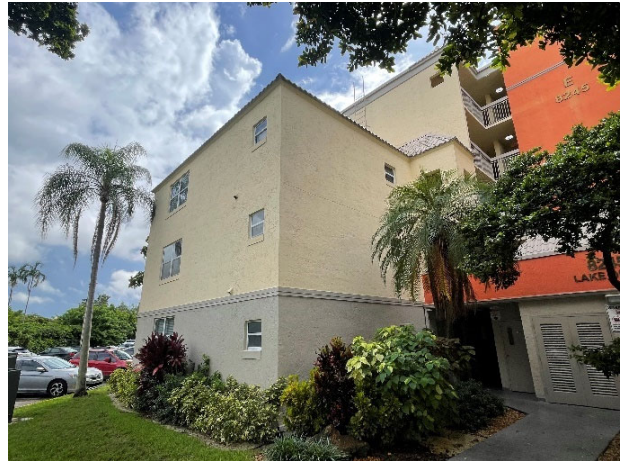
#### D. Painting

The paint is in overall fair condition; however, it is nearing the end of its service life and requires maintenance. Peeling paint was observed around windows on balconies, indicating the need for a new coating to preserve the building's exterior. Additionally, maintenance is required for some window caulking areas to prevent water infiltration. All services area of condominium are included.

The paint is in overall fair condition; however, it is nearing the end of its service life and requires maintenance. Peeling paint was observed around windows on balconies, indicating the need for a new coating to preserve the building's exterior. Additionally, maintenance is required for some window caulking areas to prevent water infiltration. Budgeting for repainting is necessary to maintain aesthetic and protective functions.

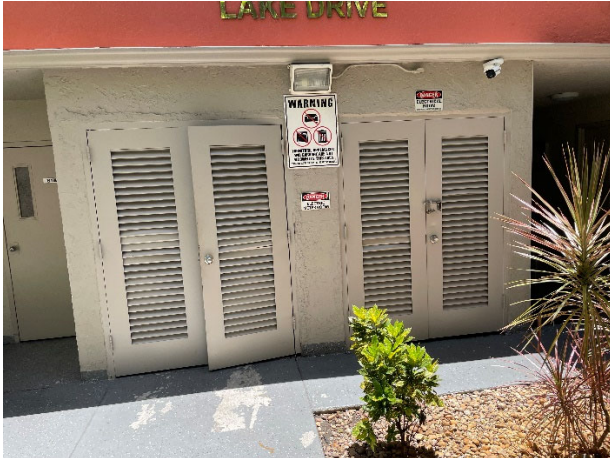
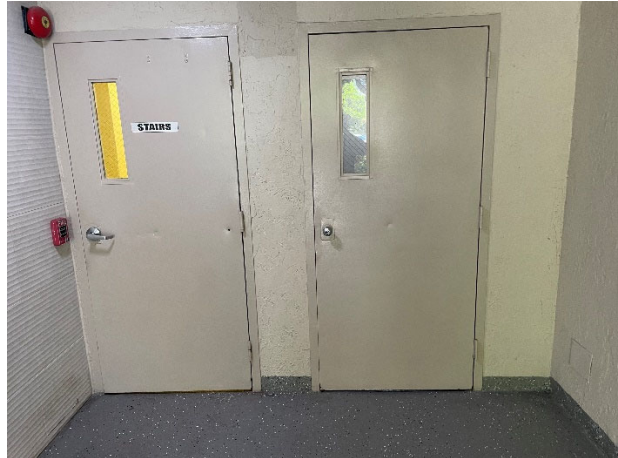
#### E. Exterior Doors

The installed doors are aluminum fixed and are in fair condition. Emergency metal doors are installed for stairs and mechanical rooms with metal frames. All doors are in fair condition.

All doors are in fair condition, only regular maintenance.
