STRUCTURAL INTEGRITY RESERVE STUDY (SIRS)

LAS VISTAS AT DORAL

Report date 09/09/2025

JOB: Structural Integrity Reserve Study (**SIRS**) ADDRESS: 8205 LAKE DRIVE, CITY OF DORAL

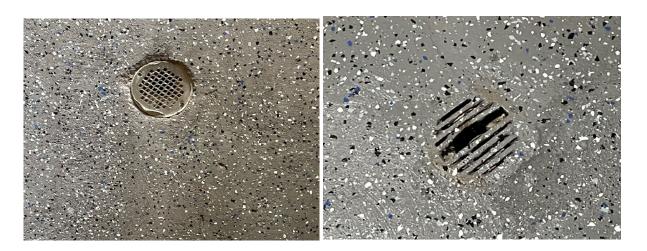
Sanitary System:

They consist of sanitary risers (stacks) with full size ventilation through the roof. We project two incidents for this building in a ten years period.

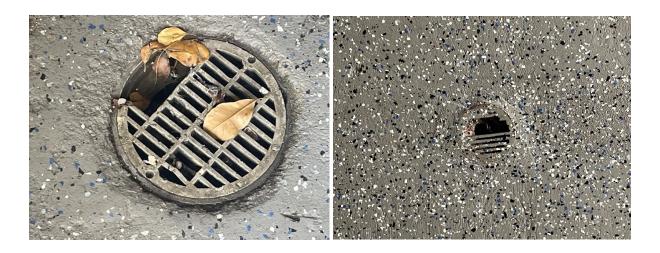
Sanitary System:

They consist of sanitary risers (stacks) with full size ventilation through the roof. We project two incidents for this building in a ten years period.

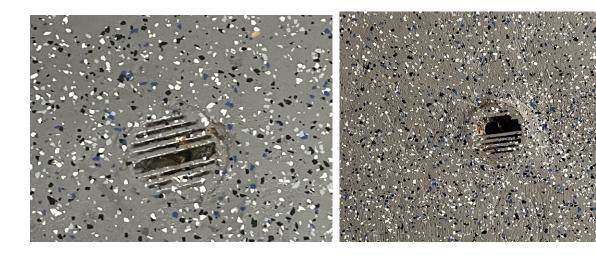
Sanitary System:

They consist of sanitary risers (stacks) with full size ventilation through the roof. We project two incidents for this building in a ten years period.

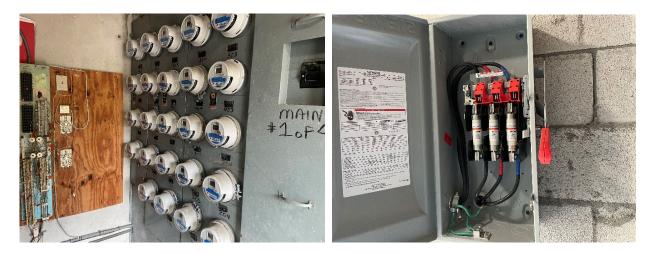
A. Electrical Systems

No defects were observed with swimming pool wiring or mechanical equipment or in wiring to mechanical equipment. There was no exposed wiring observed in open parking garage areas. Some breakers will need to be replaced during the ten-year period.

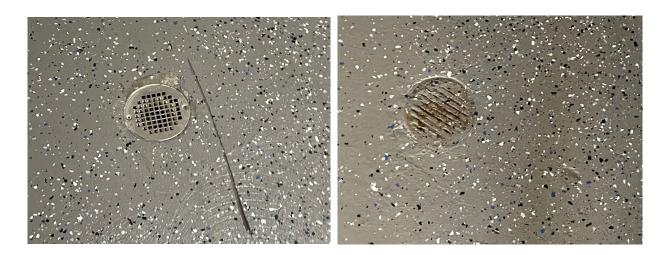
Sanitary System:

They consist of sanitary risers (stacks) with full size ventilation through the roof. We project two incidents for this building in a ten years period.

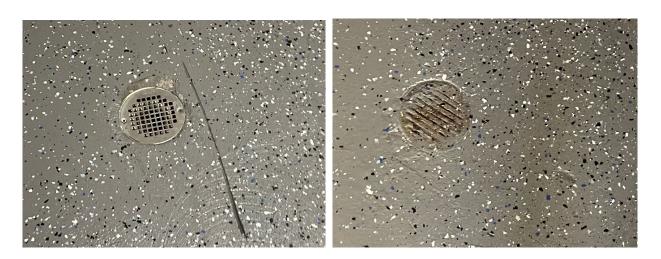
Sanitary System:

They consist of sanitary risers (stacks) with full size ventilation through the roof. We project two incidents for this building in a ten years period.

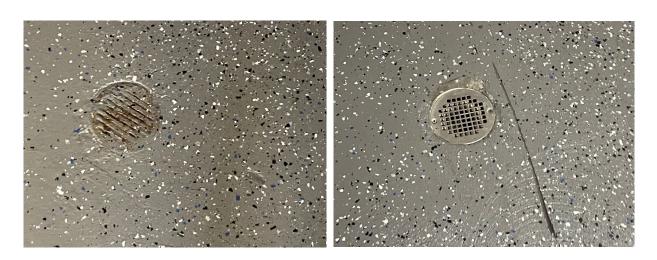
Sanitary System:

They consist of sanitary risers (stacks) with full size ventilation through the roof. We project two incidents for this building in a ten years period.

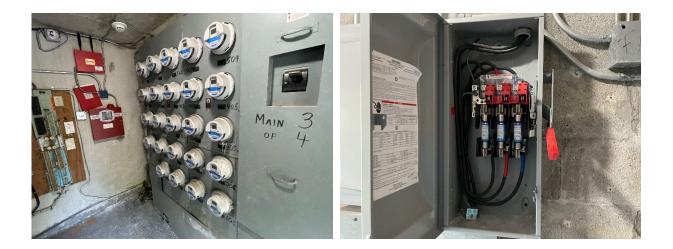
A. Electrical Systems

No defects were observed with swimming pool wiring or mechanical equipment or in wiring to mechanical equipment. There was no exposed wiring observed in open parking garage areas. Some breakers will need to be replaced during the ten-year period.

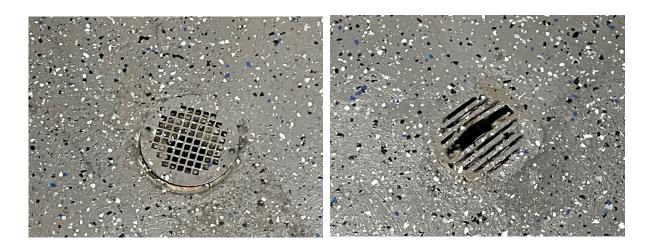
Sanitary System:

They consist of sanitary risers (stacks) with full size ventilation through the roof. We project two incidents for this building in a ten years period.

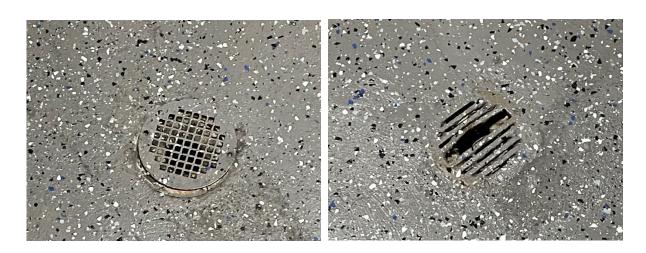
Sanitary System:

They consist of sanitary risers (stacks) with full size ventilation through the roof. We project two incidents for this building in a ten years period.

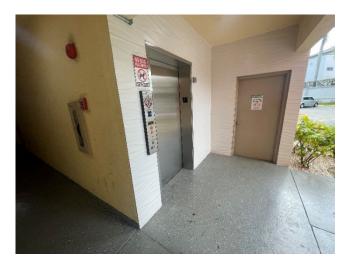
There is a fire alarm system in a dedicate fire command center; logbooks are up to date and provided in the electric panel room. The fire protection system utilizes a sprinklered system. There are fire alarm pull boxes, fire notification system and emergency lighting. Exit lights, emergency lights are builting egress illumination is present and operable.

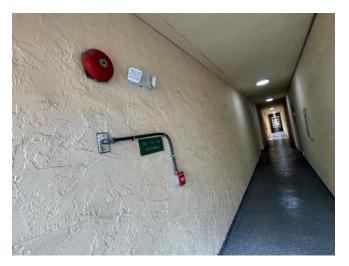
There is a fire alarm system in a dedicate fire command center; logbooks are up to date and provided in the electric panel room. The fire protection system utilizes a sprinklered system. There are fire alarm pull boxes, fire notification system and emergency lighting. Exit lights, emergency lights are are lightly egress illumination is present and operable.
