**Executive Summary – September 2025**

JOB: Structural Integrity Reserve Study (**SIRS**)

ADDRESS: 8180 GENEVA, CITY OF DORAL

FOLIO: 35-3022-028-0001

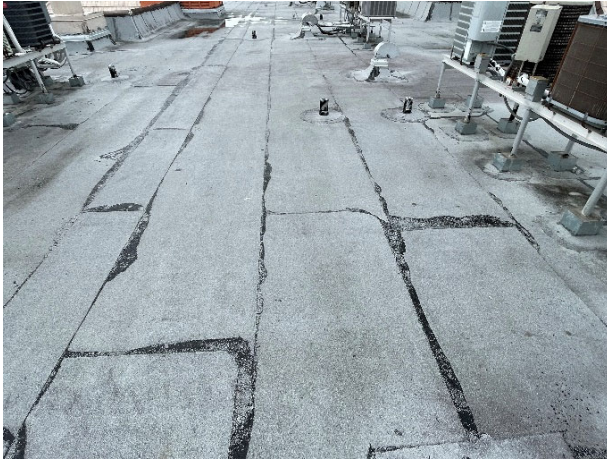
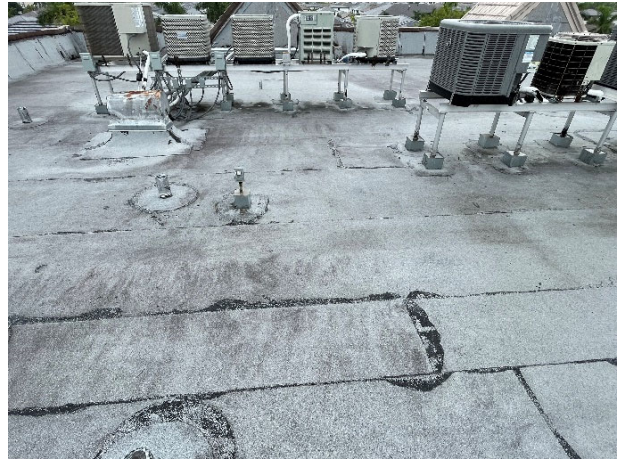
### Roof

Roof drains, scuppers on all balconies, gutters, and leaders discharge into trench drains. The drainage system is in fair condition; some corrosion was found but no repairs are currently needed. There are no roof framing members with obvious overloading, overstress, deterioration, or excessive deflection observed. Surface conditions are overall fair to poor conditions. Previous repairs were observed, and hairline cracks were noted on the roof.

The roof consists of reinforced concrete slabs in fair condition. The roof membrane is a built-up roof system with a granular surface modified bitumen cap sheet. The roofs are currently undergoing repair which are expected to be completed prior to December 21, 2025, reserve funds will be used to carry out the necessary maintenance and repair work during the ten-year period.

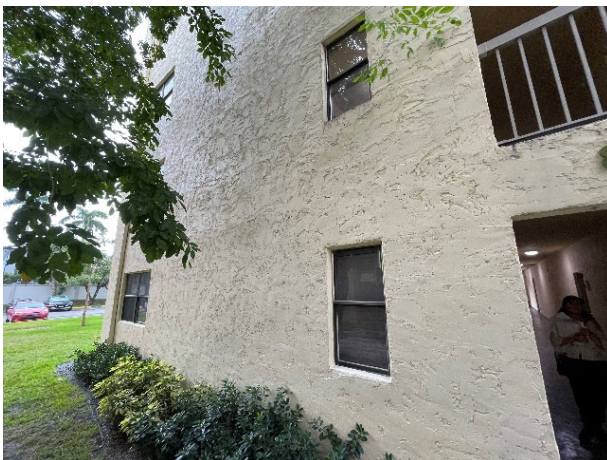
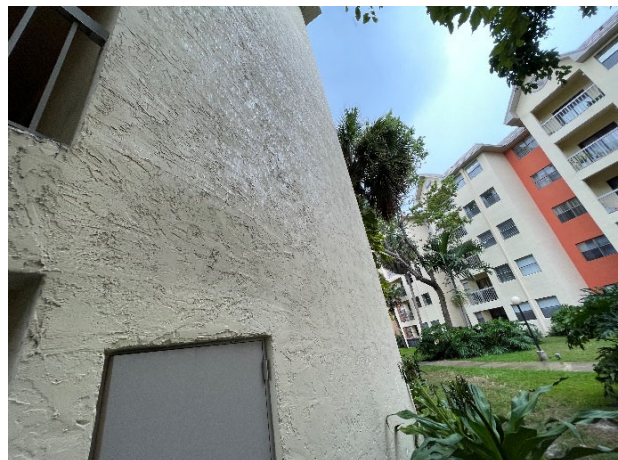
### Exterior Nonconcrete Walls

Nonbearing walls of exterior façade are in fair condition, showing signs of wear such as cracks and surface deterioration.

Minor wear such as small cracks were found at nonbearing walls. Maintenance is recommended over the next ten years, including localized repairs, repainting, sealing, and addressing any waterproofing issues to prevent further deterioration and maintain their functionality and appearance.

Maintenance is recommended over the next ten years, including localized crack repairs, repainting, resealing of joints and windows, and improvements to waterproofing where needed to prevent moisture intrusion.

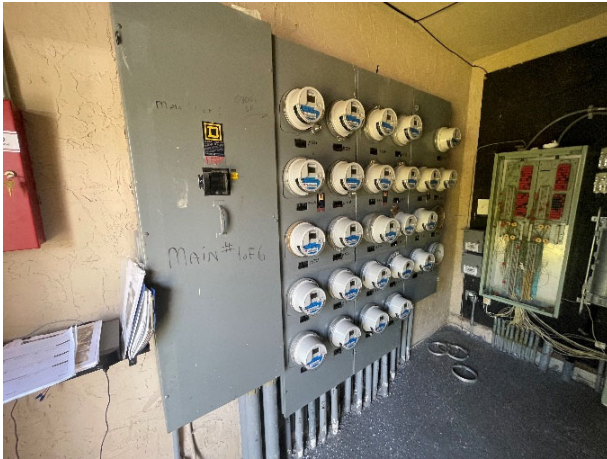
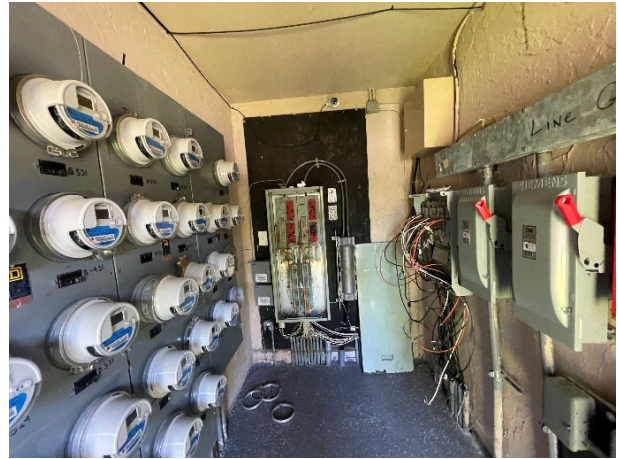
## A. Electrical Systems

The general conduits & raceways require repairs; There is rust and corrosion on some conduits. Moreover, there is loose BX conduit exiting concrete slab, the penetrations around these conduits must be patched, the wire and cables have rusted conduits and loose connections for BX exiting the concrete slab.

No defects were observed with swimming pool wiring or mechanical equipment or in wiring to mechanical equipment. There was no exposed wiring observed in open parking garage areas. Some breakers will need to be replaced during the ten-year period.

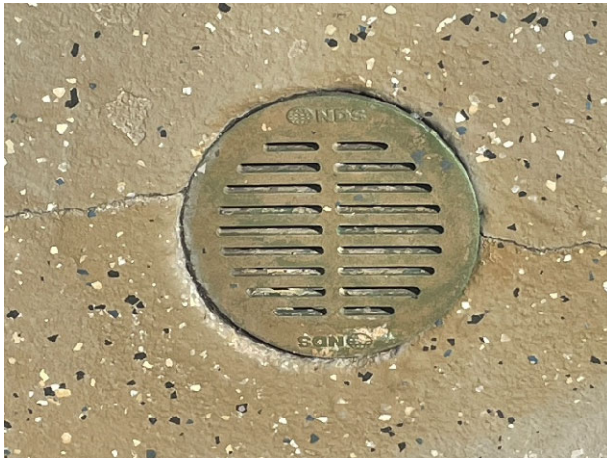
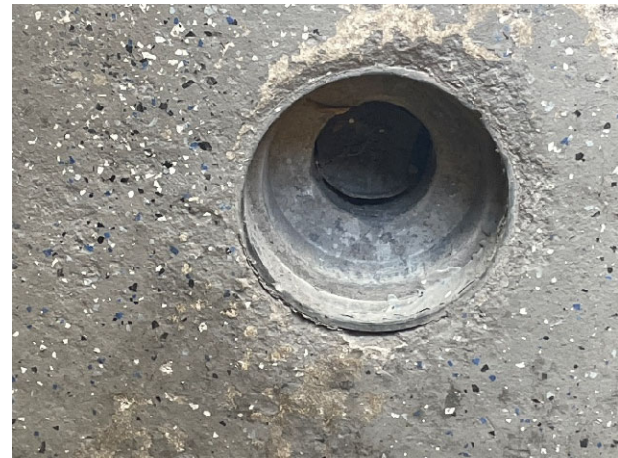
### Sanitary System:

They consist of sanitary risers (stacks) with full size ventilation through the roof. We project four incidents for this building in a ten years period.

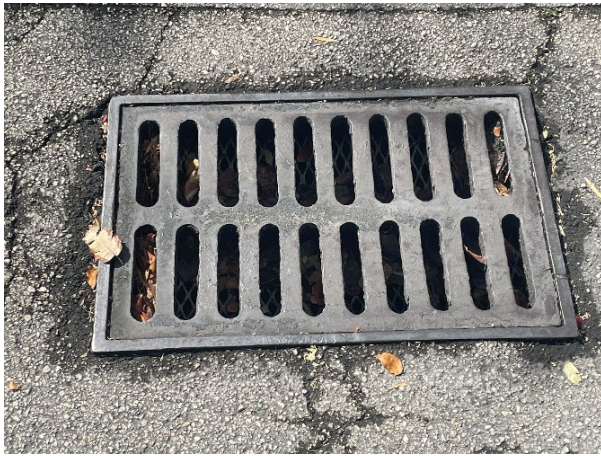
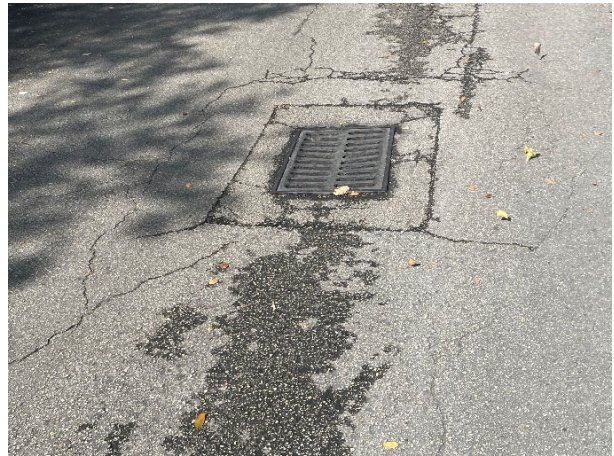
## Drainage System

A new drainage is needed to replace the existing ones, ensuring enhanced performance and durability. This section includes the replacement of the isolated catch basing and pipes.

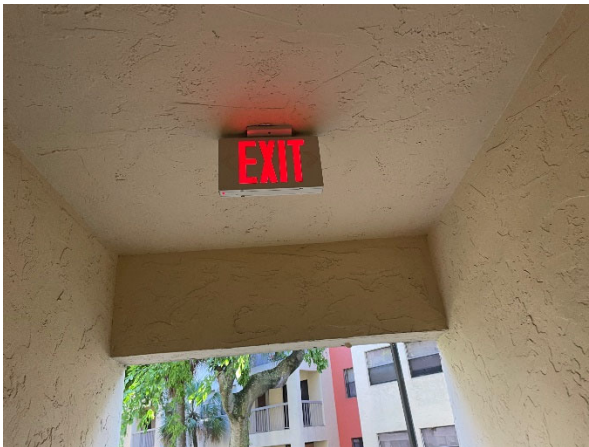
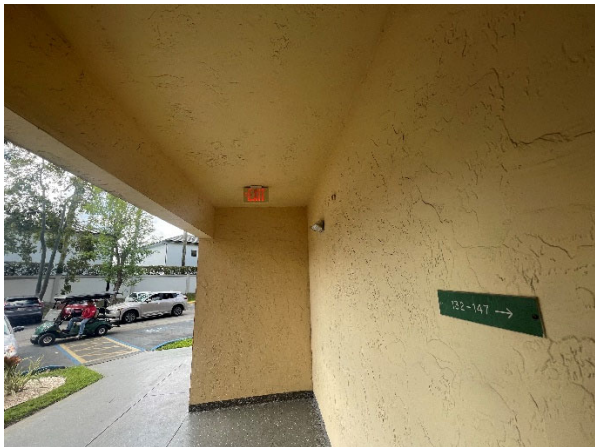
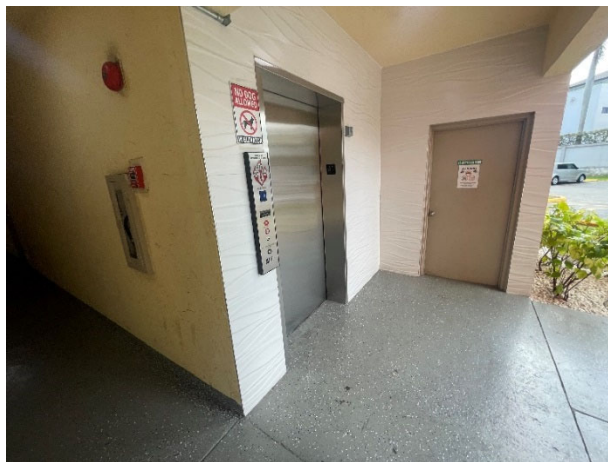
### C. Fireproofing and Fire Protection System

There is a fire alarm system in a dedicated fire command center; logbooks are up to date and provided in the electric panel room. The fire protection system utilizes a sprinklered system. There are fire alarm pull boxes, fire notification system and emergency lighting. Exit lights, emergency lights are building egress illumination is present and operable. Egress illumination is also present and operable in the parking garage. Some smoke detectors are covered due to ongoing masonry work causing dust to trigger alarms.

There is a fire alarm system in a dedicate fire command center; logbooks are up to date and provided in the electric panel room. The fire protection system utilizes a sprinklered system. There are fire alarm pull boxes, fire notification system and emergency lighting. Exit lights, emergency lights are building egress illumination is present and operable.

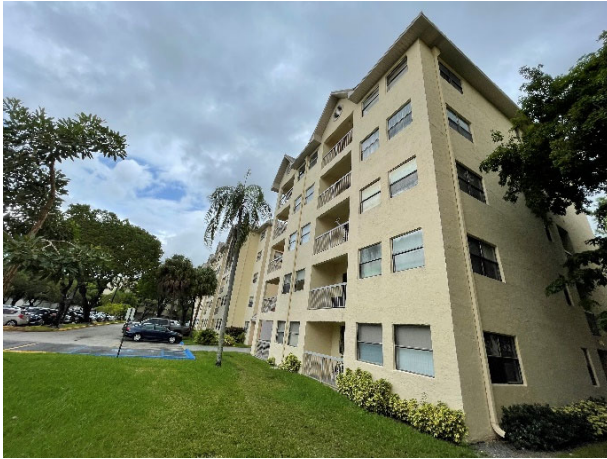
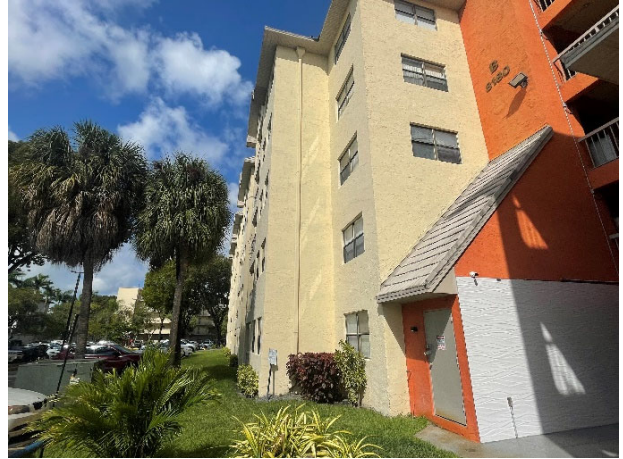
#### D. Painting

The paint is in overall fair condition; however, it is nearing the end of its service life and requires maintenance. Peeling paint was observed around windows on balconies, indicating the need for a new coating to preserve the building's exterior. Additionally, maintenance is required for some window caulking areas to prevent water infiltration. All services area of condominium are included.

The paint is in overall fair condition; however, it is nearing the end of its service life and requires maintenance. Peeling paint was observed around windows on balconies, indicating the need for a new coating to preserve the building's exterior. Additionally, maintenance is required for some window caulking areas to prevent water infiltration. Budgeting for repainting is necessary to maintain aesthetic and protective functions.

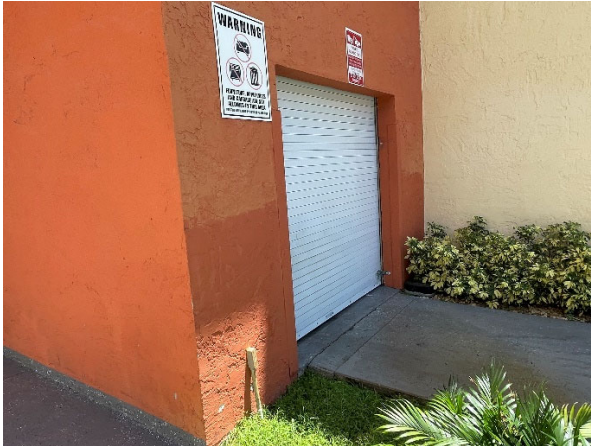
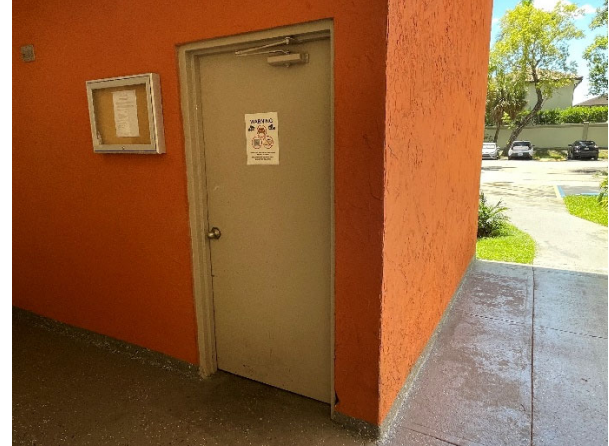
#### E. Exterior Doors

The installed doors are aluminum fixed and are in fair condition. Emergency metal doors are installed for stairs and mechanical rooms with metal frames. All doors are in fair condition.

All doors are in fair condition, only regular maintenance.
