**Executive Summary – September 2025**

JOB: Structural Integrity Reserve Study (**SIRS**)  
ADDRESS: 8353 LAKE DRIVE, CITY OF DORAL

This Structural Integrity Reserve Study is being prepared in compliance with F.S. § 718.112 (2) (g)

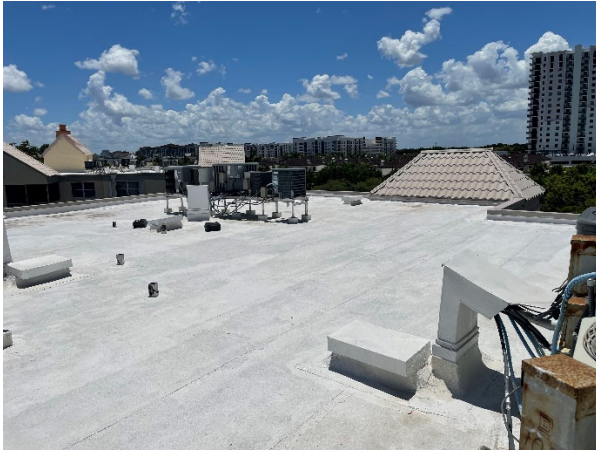
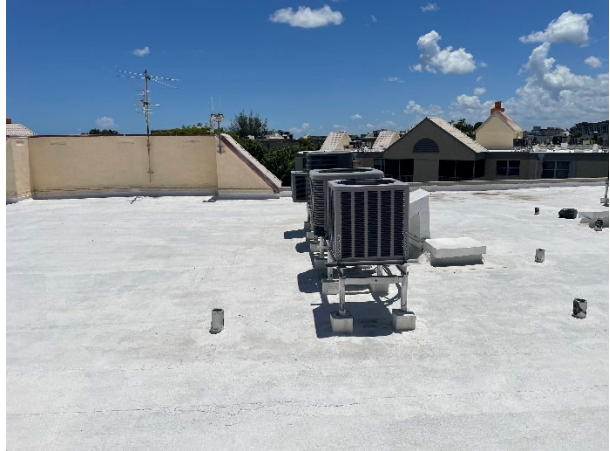
### Roof

Roof drains, scuppers on all balconies, gutters, and leaders discharge into trench drains. The drainage system is in fair condition; some corrosion was found but no repairs are currently needed. There are no roof framing members with obvious overloading, overstress, deterioration, or excessive deflection observed. Surface conditions are overall fair to poor conditions. Previous repairs were observed, and hairline cracks were noted on the roof.

The roof consists of reinforced concrete slabs in fair condition. The roof membrane is a built-up roof system with a granular surface modified bitumen cap sheet. The roofs are currently undergoing repair which are expected to be completed prior to December 21, 2025, reserve funds will be used to carry out the necessary maintenance and repair work during the ten-year period.

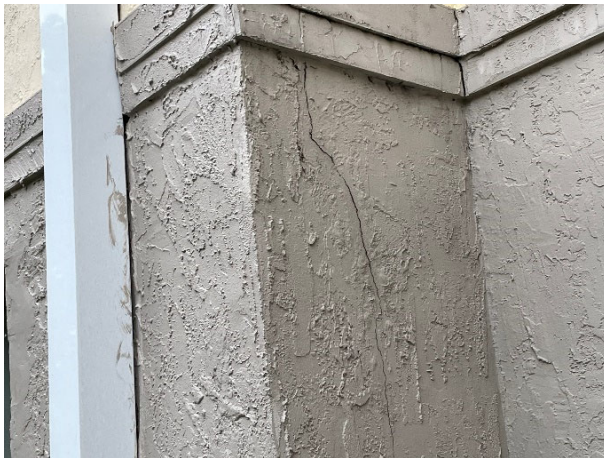
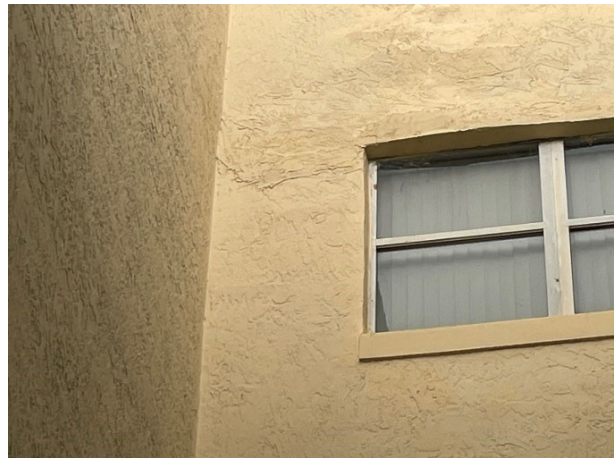
### Exterior Nonconcrete Walls

Nonbearing walls of exterior façade are in fair condition, showing signs of wear such as cracks and surface deterioration.

Minor wear such as small cracks were found at nonbearing walls. Maintenance is recommended over the next ten years, including localized repairs, repainting, sealing, and addressing any waterproofing issues to prevent further deterioration and maintain their functionality and appearance.

Maintenance is recommended over the next ten years, including localized crack repairs, repainting, resealing of joints and windows, and improvements to waterproofing where needed to prevent moisture intrusion.

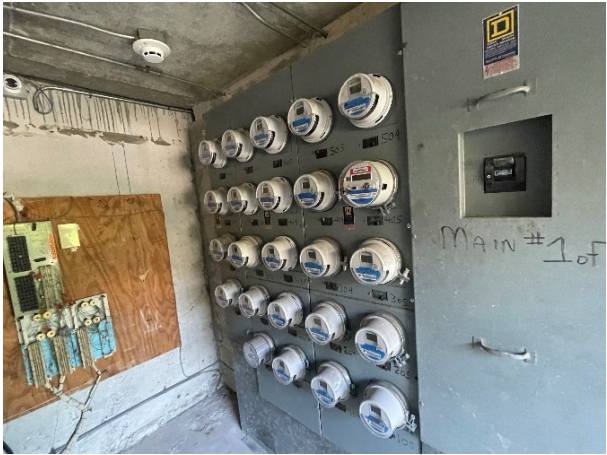
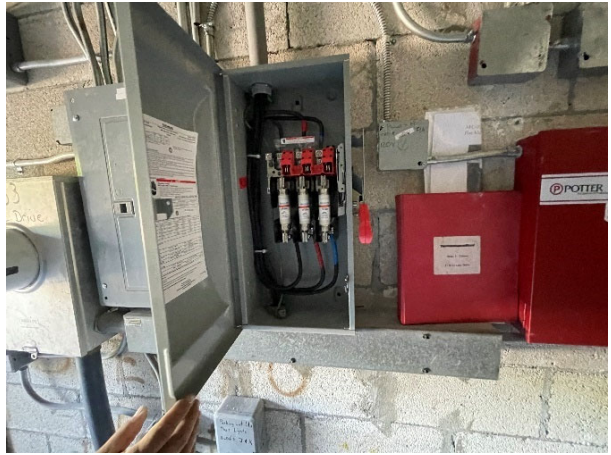
## A. Electrical Systems

The general conduits & raceways require repairs; There is rust and corrosion on some conduits. Moreover, there is loose BX conduit exiting concrete slab, the penetrations around these conduits must be patched, the wire and cables have rusted conduits and loose connections for BX exiting the concrete slab.

No defects were observed with swimming pool wiring or mechanical equipment or in wiring to mechanical equipment. There was no exposed wiring observed in open parking garage areas. Some breakers will need to be replaced during the ten-year period.

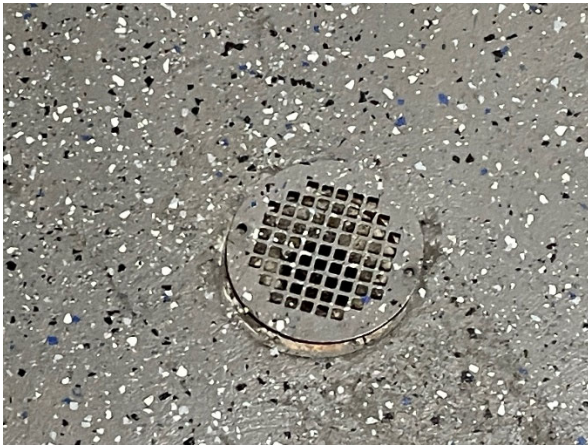
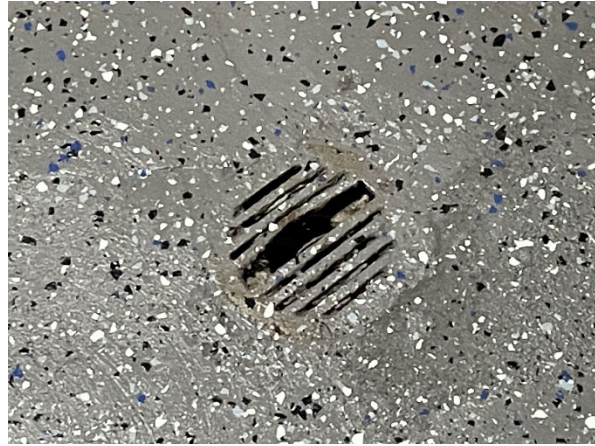
### Sanitary System:

They consist of sanitary risers (stacks) with full size ventilation through the roof. We project two incidents for this building in a ten years period.

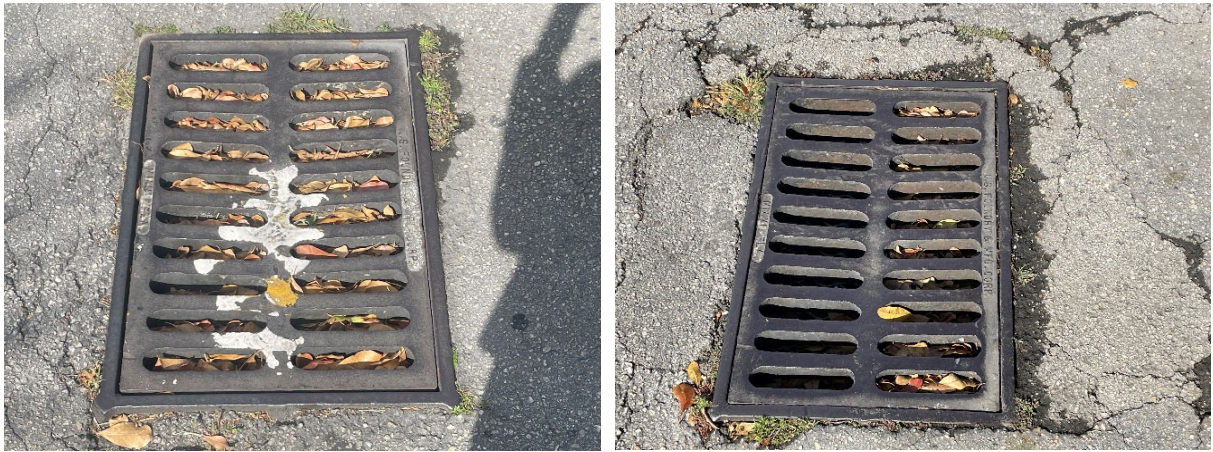
## Drainage System

A new drainage is needed to replace the existing ones, ensuring enhanced performance and durability. This section includes the replacement of the isolated catch basing and pipes.

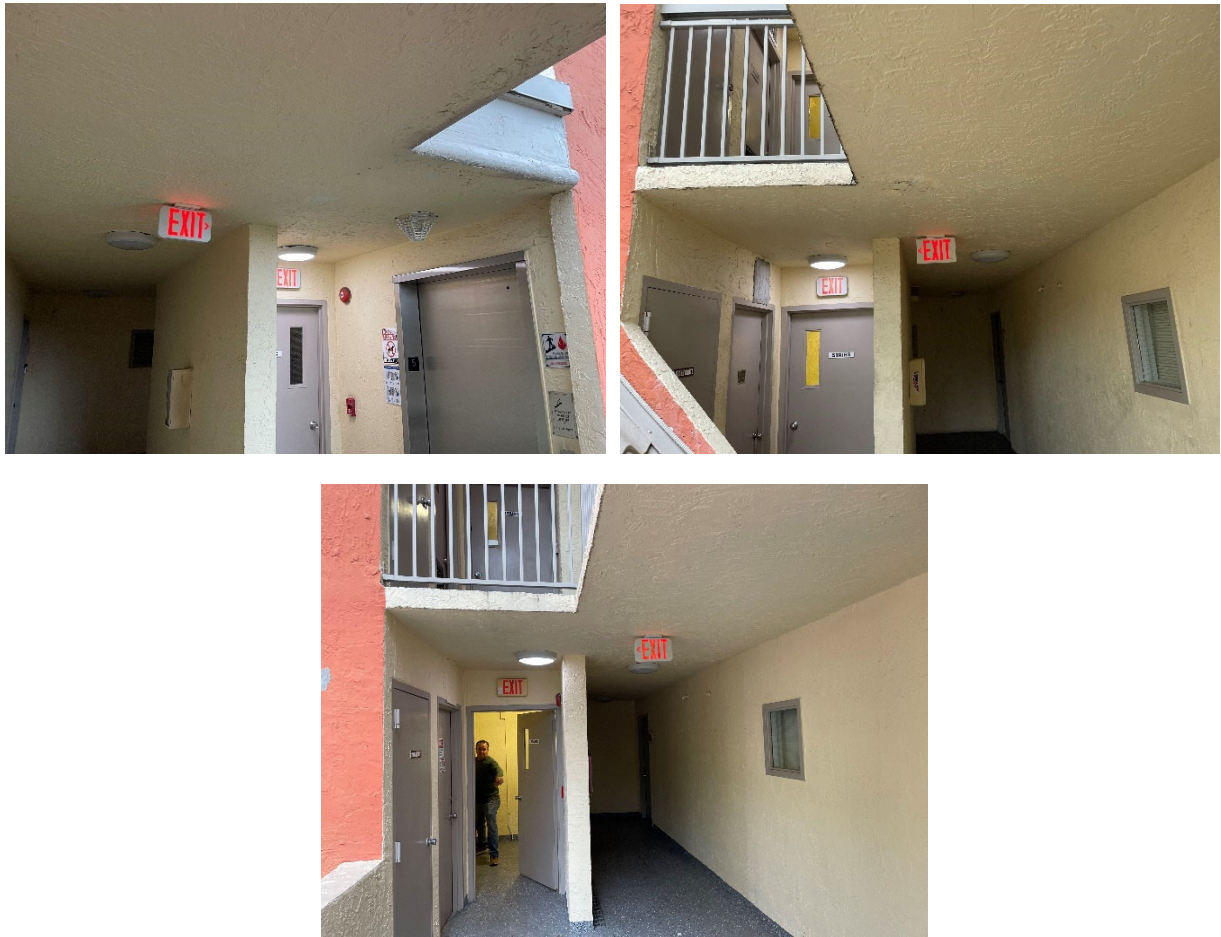
### C. Fireproofing and Fire Protection System

There is a fire alarm system in a dedicated fire command center; logbooks are up to date and provided in the electric panel room. The fire protection system utilizes a sprinklered system. There are fire alarm pull boxes, fire notification system and emergency lighting. Exit lights, emergency lights are building egress illumination is present and operable. Egress illumination is also present and operable in the parking garage. Some smoke detectors are covered due to ongoing masonry work causing dust to trigger alarms.

There is a fire alarm system in a dedicated fire command center; logbooks are up to date and provided in the electric panel room. The fire protection system utilizes a sprinklered system. There are fire alarm pull boxes, fire notification system and emergency lighting. Exit lights, emergency lights are building egress illumination is present and operable.

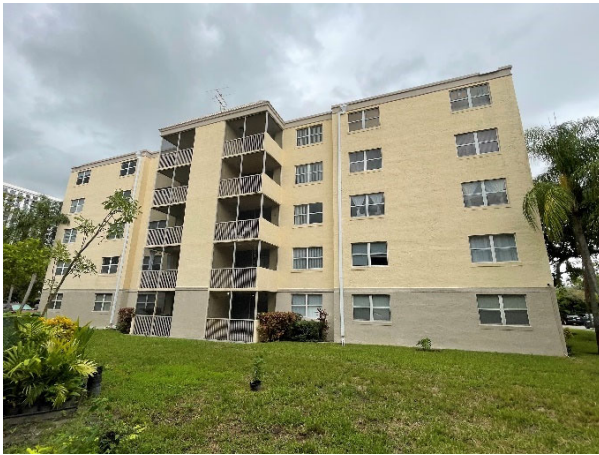
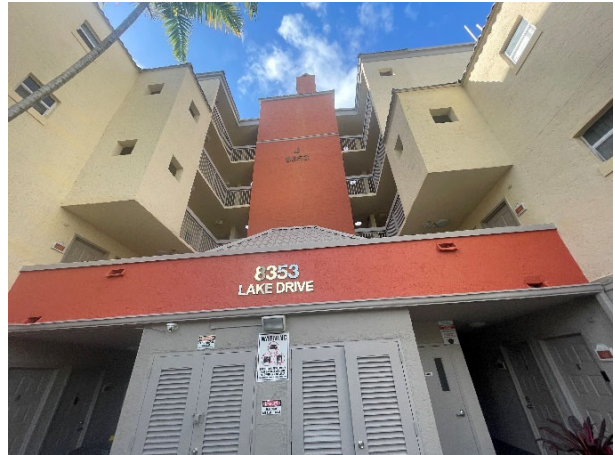
#### D. Painting

The paint is in overall fair condition; however, it is nearing the end of its service life and requires maintenance. Peeling paint was observed around windows on balconies, indicating the need for a new coating to preserve the building's exterior. Additionally, maintenance is required for some window caulking areas to prevent water infiltration. All services area of condominium are included.

The paint is in overall fair condition; however, it is nearing the end of its service life and requires maintenance. Peeling paint was observed around windows on balconies, indicating the need for a new coating to preserve the building's exterior. Additionally, maintenance is required for some window caulking areas to prevent water infiltration. Budgeting for repainting is necessary to maintain aesthetic and protective functions.

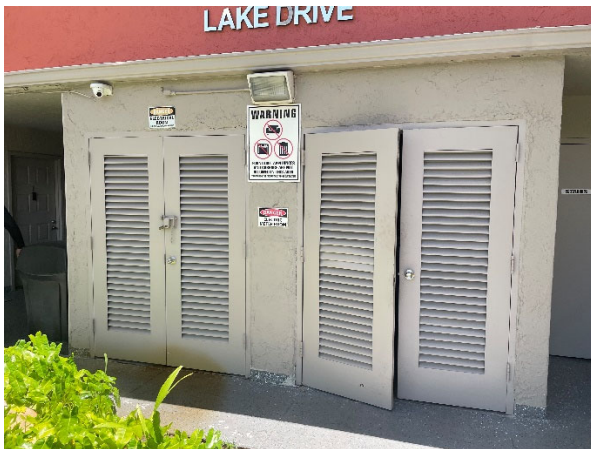
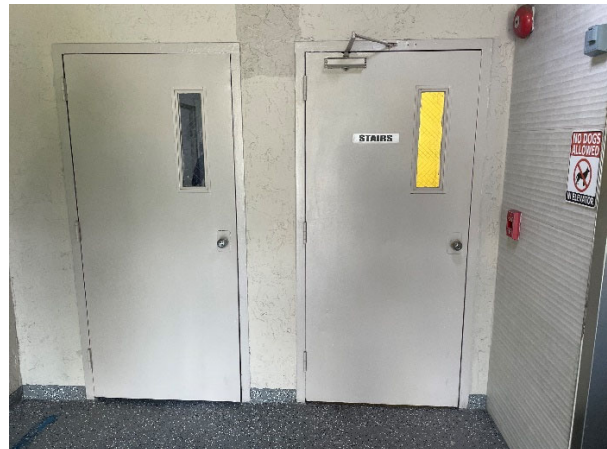
#### E. Exterior Doors

The installed doors are aluminum fixed and are in fair condition. Emergency metal doors are installed for stairs and mechanical rooms with metal frames. All doors are in fair condition.

All doors are in fair condition, only regular maintenance.
