**Executive Summary – September 2025**

JOB: Structural Integrity Reserve Study (SIRS)  
ADDRESS: 8205 LAKE DRIVE, CITY OF DORAL

This Structural Integrity Reserve Study is being prepared in compliance with F.S. § 718.112 (2) (g)

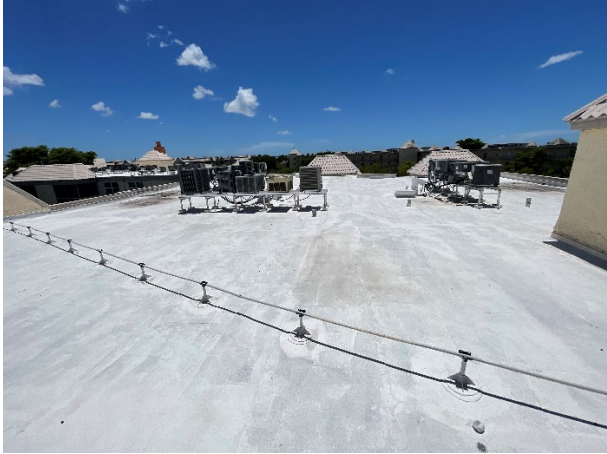
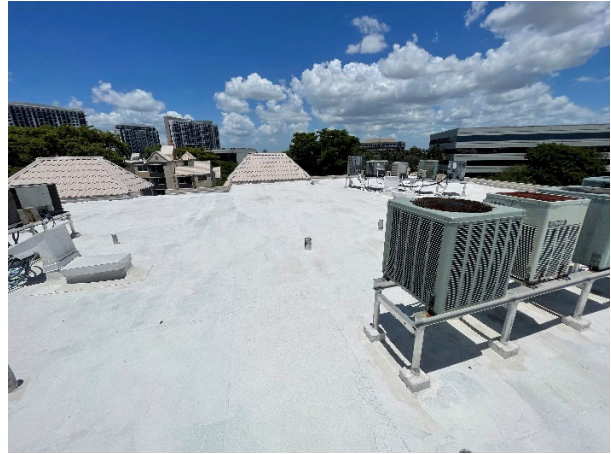
### Roof

Roof drains, scuppers on all balconies, gutters, and leaders discharge into trench drains. The drainage system is in fair condition; some corrosion was found but no repairs are currently needed. There are no roof framing members with obvious overloading, overstress, deterioration, or excessive deflection observed. Surface conditions are overall fair to poor conditions. Previous repairs were observed, and hairline cracks were noted on the roof.

The roof consists of reinforced concrete slabs in fair condition. The roof membrane is a built-up roof system with a granular surface modified bitumen cap sheet. The roofs are currently undergoing repair which are expected to be completed prior to December 21, 2025, reserve funds will be used to carry out the necessary maintenance and repair work during the ten-year period.

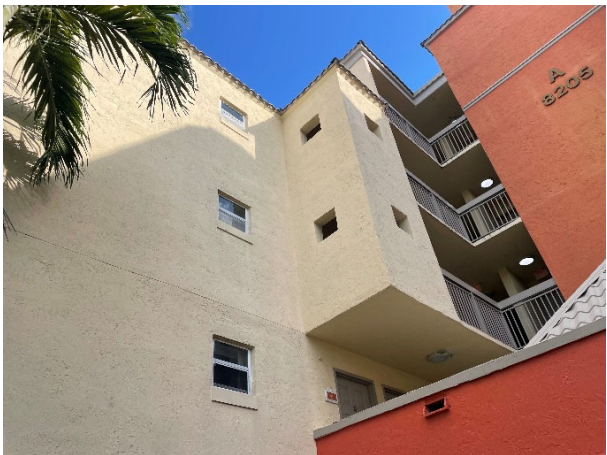
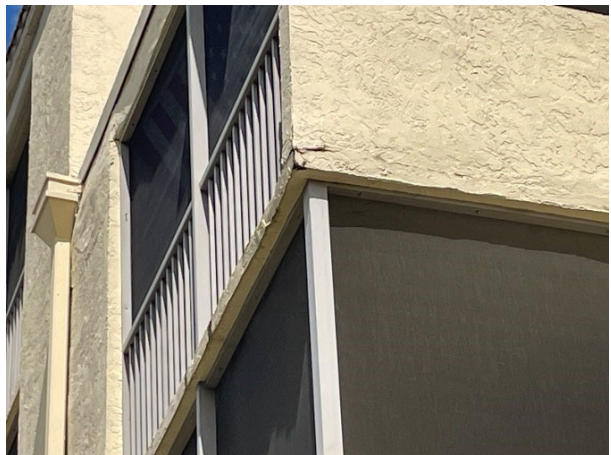
### Exterior Nonconcrete Walls

Nonbearing walls of exterior façade are in fair condition, showing signs of wear such as cracks and surface deterioration.

Minor wear such as small cracks were found at nonbearing walls. Maintenance is recommended over the next ten years, including localized repairs, repainting, sealing, and addressing any waterproofing issues to prevent further deterioration and maintain their functionality and appearance.

Maintenance is recommended over the next ten years, including localized crack repairs, repainting, resealing of joints and windows, and improvements to waterproofing where needed to prevent moisture intrusion.

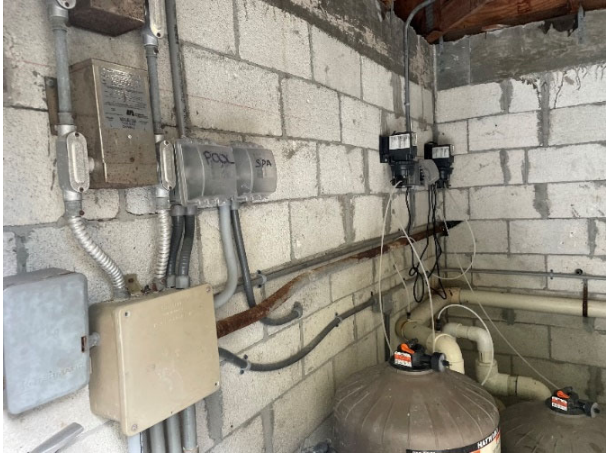
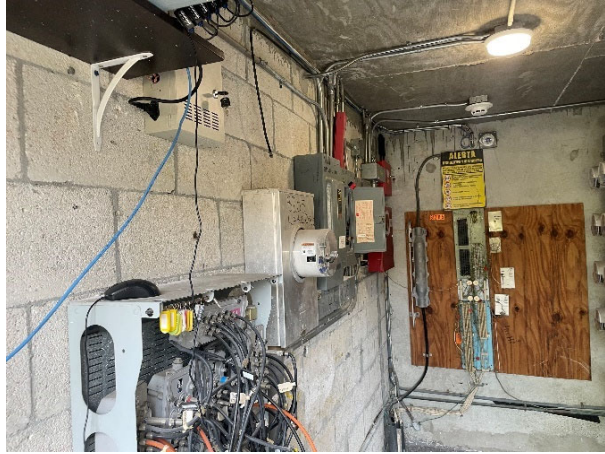
## A. Electrical Systems

The general conduits & raceways require repairs; There is rust and corrosion on some conduits. Moreover, there is loose BX conduit exiting concrete slab, the penetrations around these conduits must be patched, the wire and cables have rusted conduits and loose connections for BX exiting the concrete slab.

No defects were observed with swimming pool wiring or mechanical equipment or in wiring to mechanical equipment. There was no exposed wiring observed in open parking garage areas. Some breakers will need to be replaced during the ten-year period.

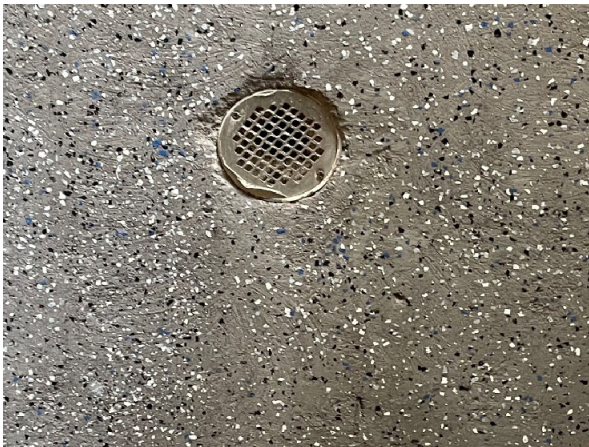
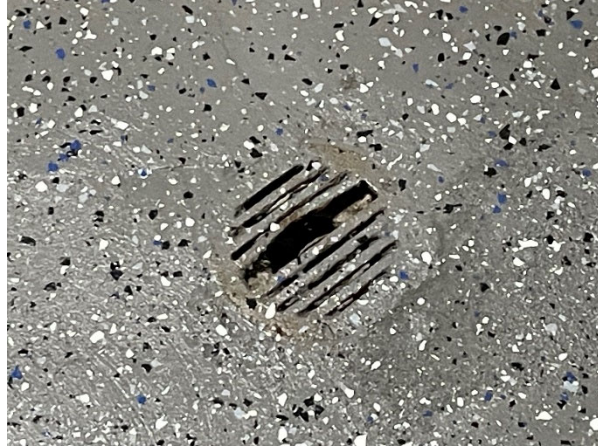
### Sanitary System:

They consist of sanitary risers (stacks) with full size ventilation through the roof. We project two incidents for this building in a ten years period.

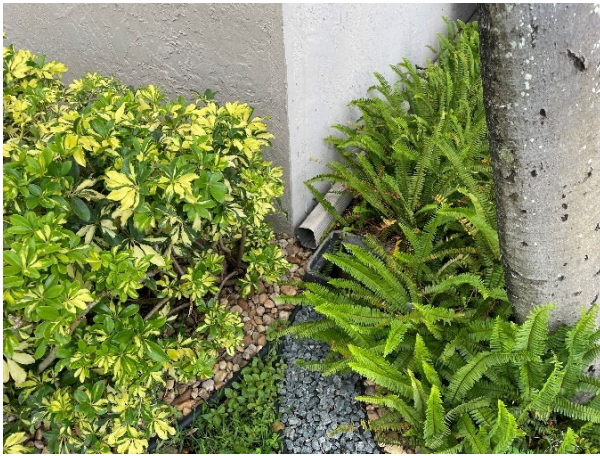
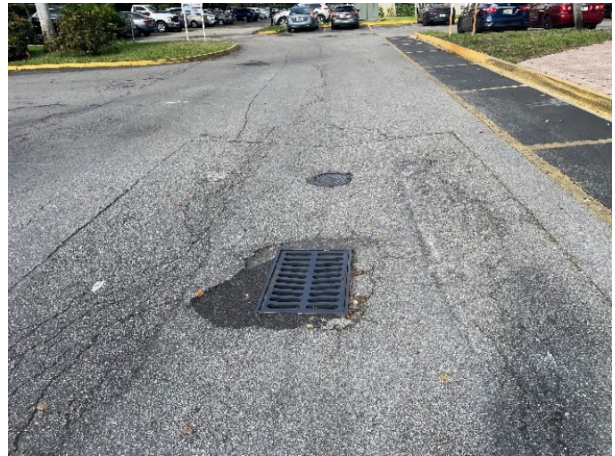
## Drainage System

A new drainage is needed to replace the existing ones, ensuring enhanced performance and durability. This section includes the replacement of the isolated catch basing and pipes.

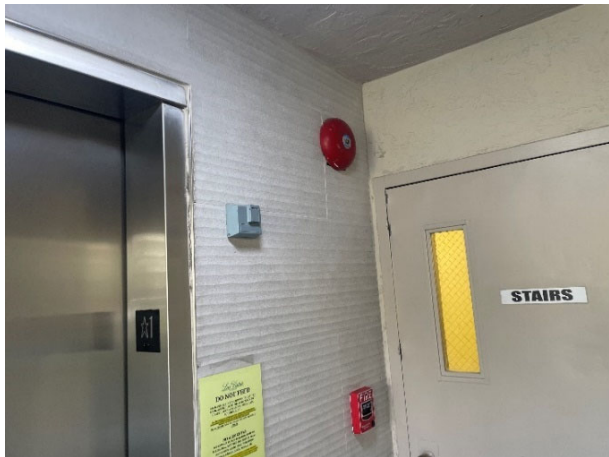
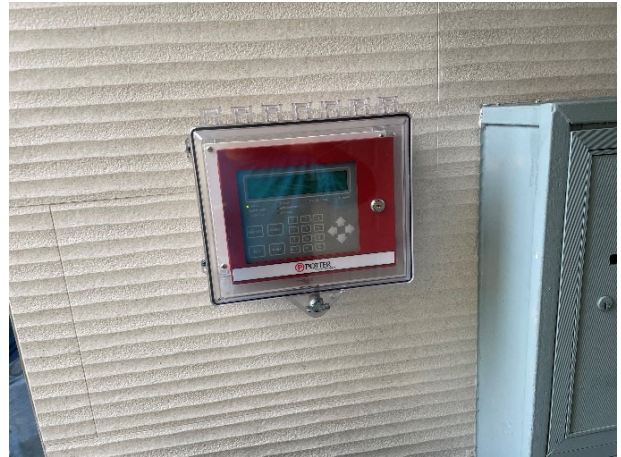
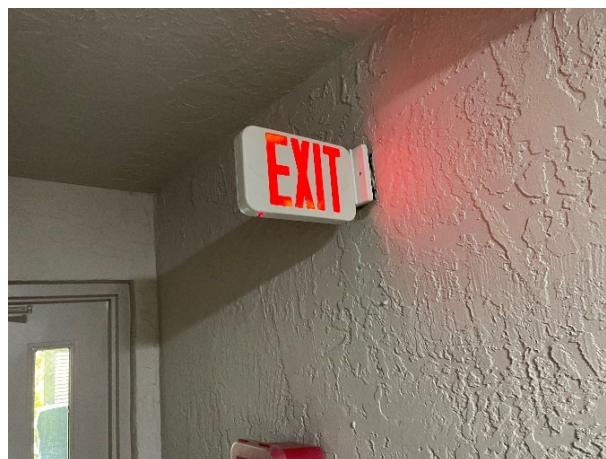
### C. Fireproofing and Fire Protection System

There is a fire alarm system in a dedicated fire command center; logbooks are up to date and provided in the electric panel room. The fire protection system utilizes a sprinklered system. There are fire alarm pull boxes, fire notification system and emergency lighting. Exit lights, emergency lights are building egress illumination is present and operable. Egress illumination is also present and operable in the parking garage. Some smoke detectors are covered due to ongoing masonry work causing dust to trigger alarms.

There is a fire alarm system in a dedicate fire command center; logbooks are up to date and provided in the electric panel room. The fire protection system utilizes a sprinklered system. There are fire alarm pull boxes, fire notification system and emergency lighting. Exit lights, emergency lights are building egress illumination is present and operable.

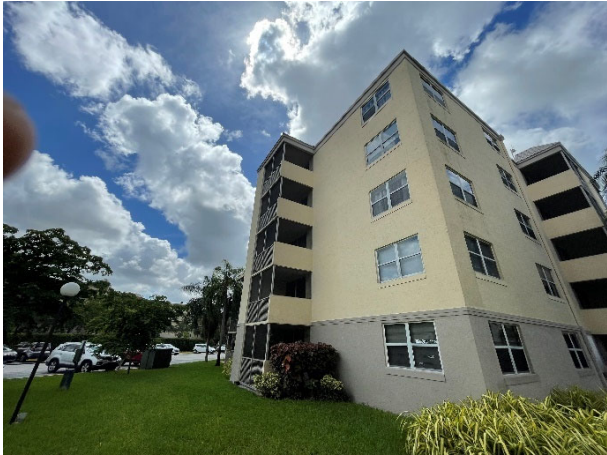
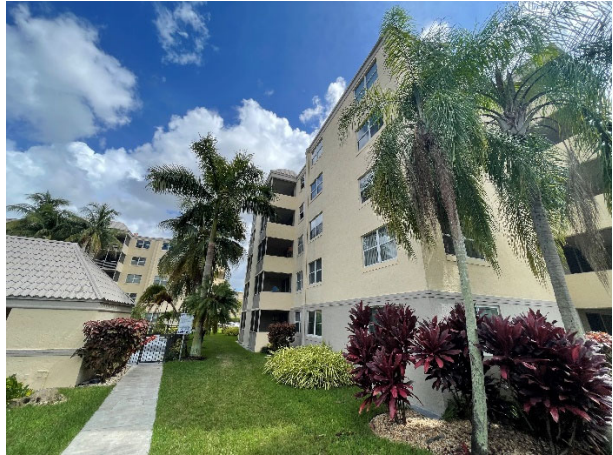
#### D. Painting

The paint is in overall fair condition; however, it is nearing the end of its service life and requires maintenance. Peeling paint was observed around windows on balconies, indicating the need for a new coating to preserve the building's exterior. Additionally, maintenance is required for some window caulking areas to prevent water infiltration. All services area of condominium are included.

The paint is in overall fair condition; however, it is nearing the end of its service life and requires maintenance. Peeling paint was observed around windows on balconies, indicating the need for a new coating to preserve the building's exterior. Additionally, maintenance is required for some window caulking areas to prevent water infiltration. Budgeting for repainting is necessary to maintain aesthetic and protective functions.

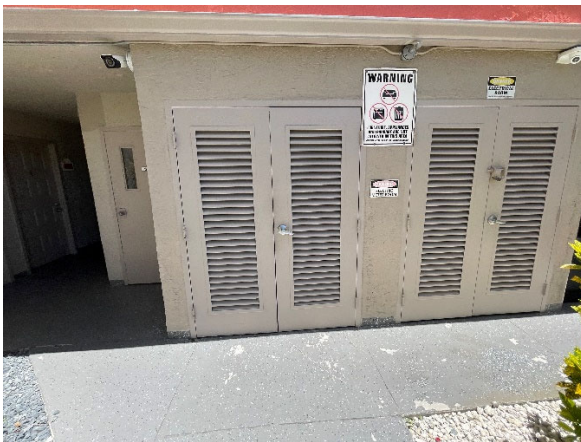
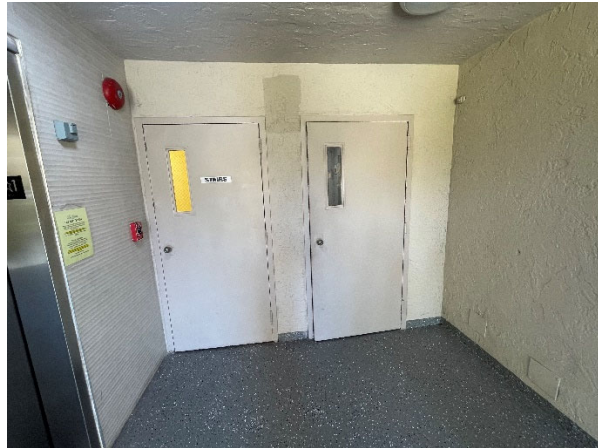
#### E. Exterior Doors

The installed doors are aluminum fixed and are in fair condition. Emergency metal doors are installed for stairs and mechanical rooms with metal frames. All doors are in fair condition.

All doors are in fair condition, only regular maintenance.
