**Executive Summary – September 2025**

JOB: Structural Integrity Reserve Study (SIRS)  
ADDRESS: 8363 LAKE DRIVE, CITY OF DORAL

This Structural Integrity Reserve Study is being prepared in compliance with F.S. § 718.112 (2) (g)

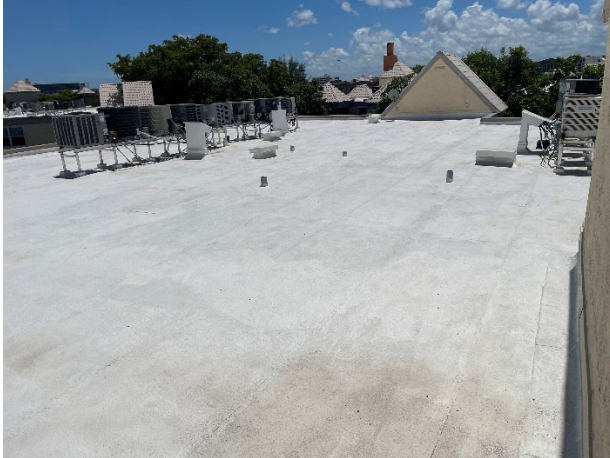
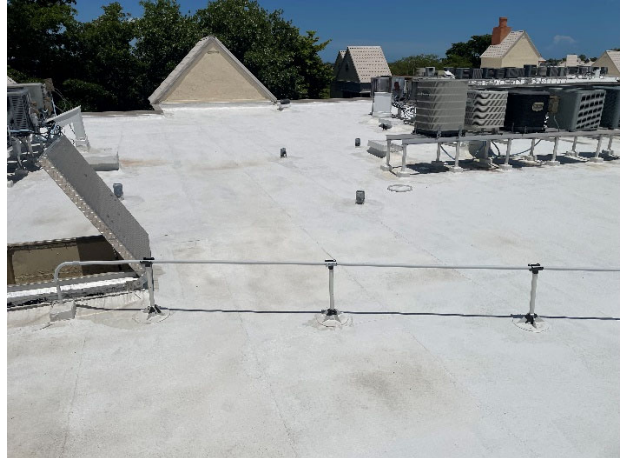
### Roof

Roof drains, scuppers on all balconies, gutters, and leaders discharge into trench drains. The drainage system is in fair condition; some corrosion was found but no repairs are currently needed. There are no roof framing members with obvious overloading, overstress, deterioration, or excessive deflection observed. Surface conditions are overall fair to poor conditions. Previous repairs were observed, and hairline cracks were noted on the roof.

The roof consists of reinforced concrete slabs in fair condition. The roof membrane is a built-up roof system with a granular surface modified bitumen cap sheet. The roofs are currently undergoing repair which are expected to be completed prior to December 21, 2025, reserve funds will be used to carry out the necessary maintenance and repair work during the ten-year period.

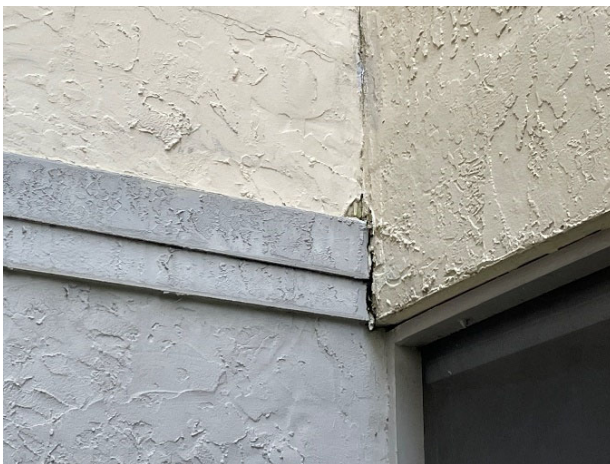
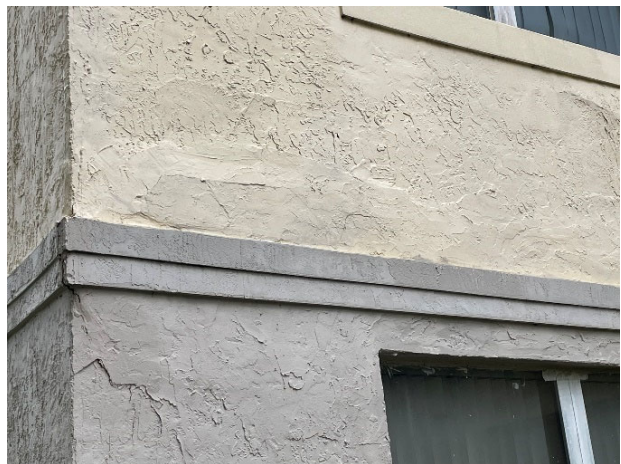
### Exterior Nonconcrete Walls

Nonbearing walls of exterior façade are in fair condition, showing signs of wear such as cracks and surface deterioration.

Minor wear such as small cracks were found at nonbearing walls. Maintenance is recommended over the next ten years, including localized repairs, repainting, sealing, and addressing any waterproofing issues to prevent further deterioration and maintain their functionality and appearance.

Maintenance is recommended over the next ten years, including localized crack repairs, repainting, resealing of joints and windows, and improvements to waterproofing where needed to prevent moisture intrusion.

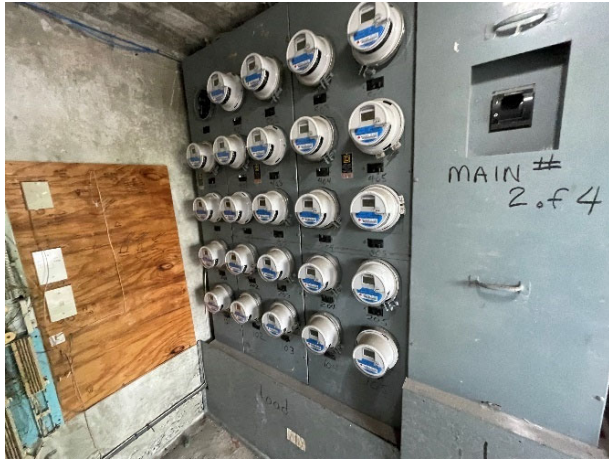
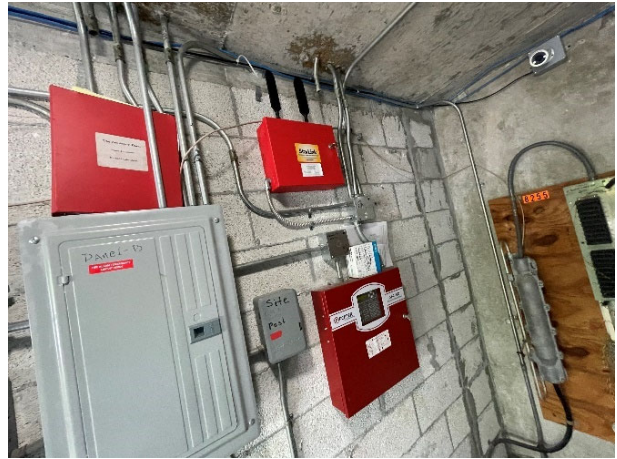
## A. Electrical Systems

The general conduits & raceways require repairs; There is rust and corrosion on some conduits. Moreover, there is loose BX conduit exiting concrete slab, the penetrations around these conduits must be patched, the wire and cables have rusted conduits and loose connections for BX exiting the concrete slab.

No defects were observed with swimming pool wiring or mechanical equipment or in wiring to mechanical equipment. There was no exposed wiring observed in open parking garage areas. Some breakers will need to be replaced during the ten-year period.

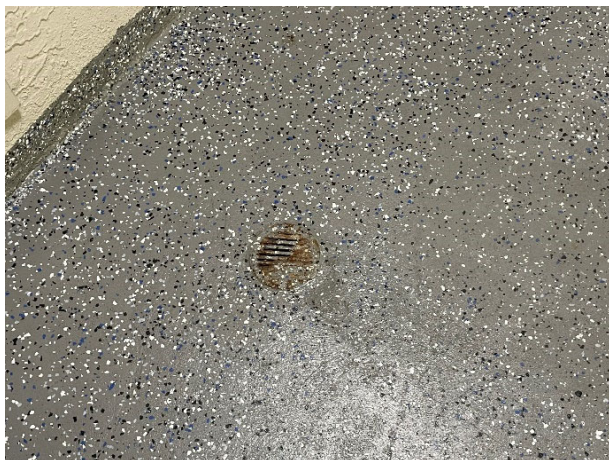
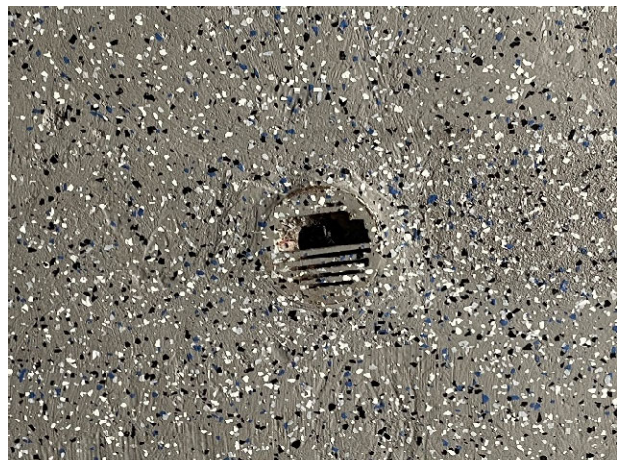
### Sanitary System:

They consist of sanitary risers (stacks) with full size ventilation through the roof. We project two incidents for this building in a ten years period.

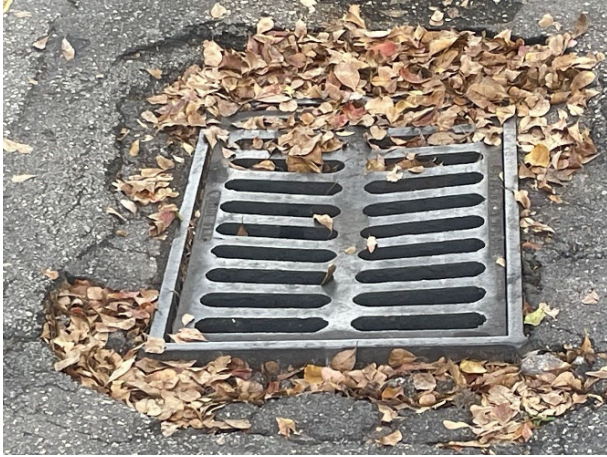
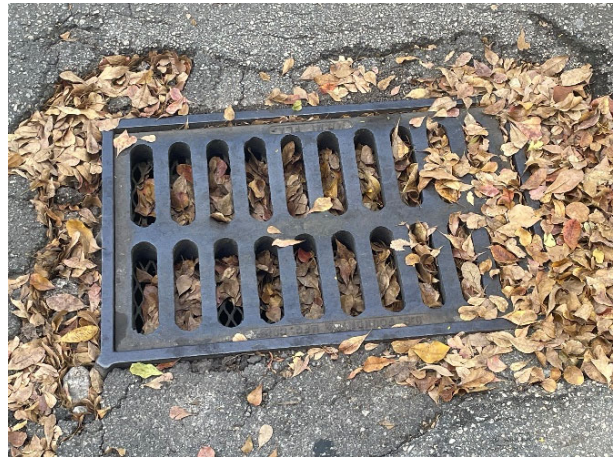
## Drainage System

A new drainage is needed to replace the existing ones, ensuring enhanced performance and durability. This section includes the replacement of the isolated catch basing and pipes.

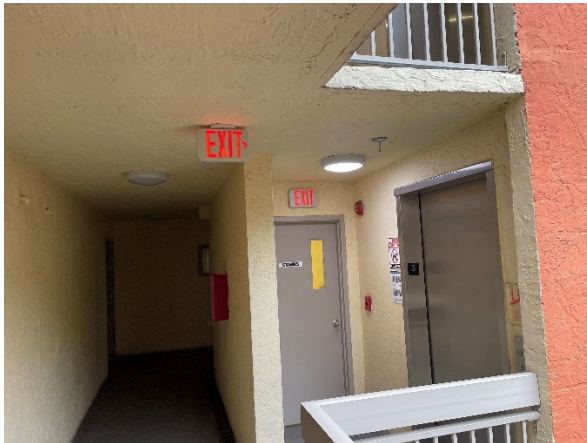
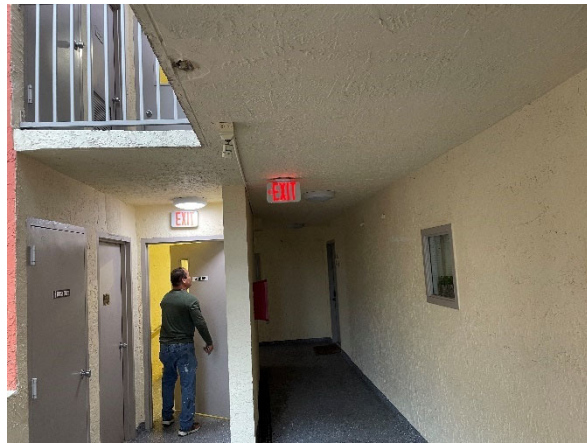
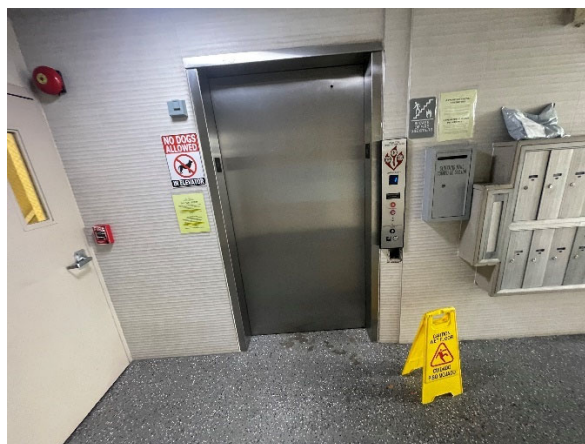
## C. Fireproofing and Fire Protection System

There is a fire alarm system in a dedicated fire command center; logbooks are up to date and provided in the electric panel room. The fire protection system utilizes a sprinklered system. There are fire alarm pull boxes, fire notification system and emergency lighting. Exit lights, emergency lights are building egress illumination is present and operable. Egress illumination is also present and operable in the parking garage. Some smoke detectors are covered due to ongoing masonry work causing dust to trigger alarms.

There is a fire alarm system in a dedicated fire command center; logbooks are up to date and provided in the electric panel room. The fire protection system utilizes a sprinklered system. There are fire alarm pull boxes, fire notification system and emergency lighting. Exit lights, emergency lights are building egress illumination is present and operable.

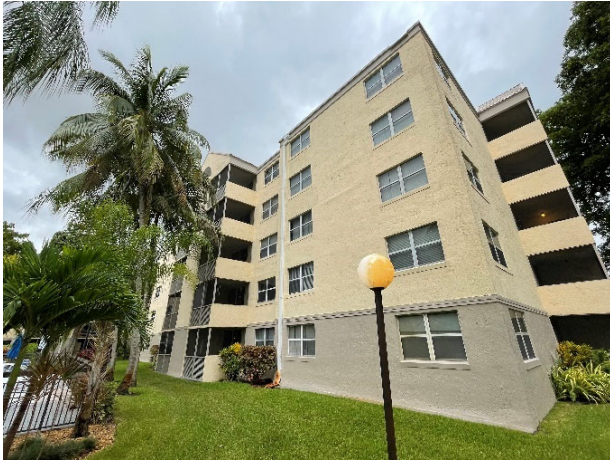
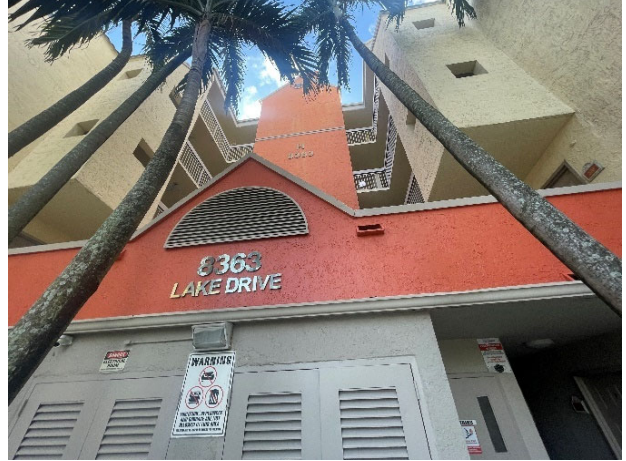
#### D. Painting

The paint is in overall fair condition; however, it is nearing the end of its service life and requires maintenance. Peeling paint was observed around windows on balconies, indicating the need for a new coating to preserve the building's exterior. Additionally, maintenance is required for some window caulking areas to prevent water infiltration. Budgeting for repainting is necessary to maintain aesthetic and protective functions.

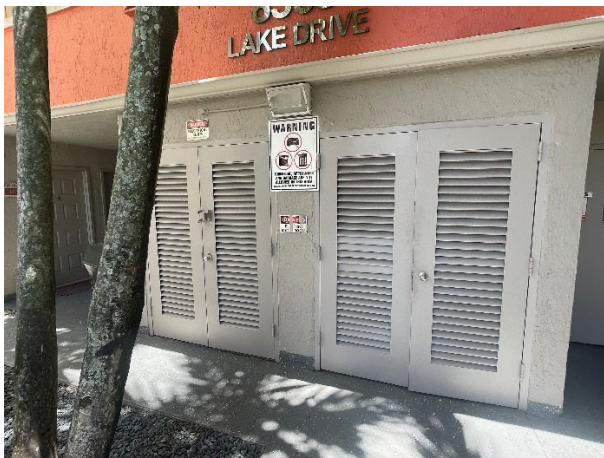
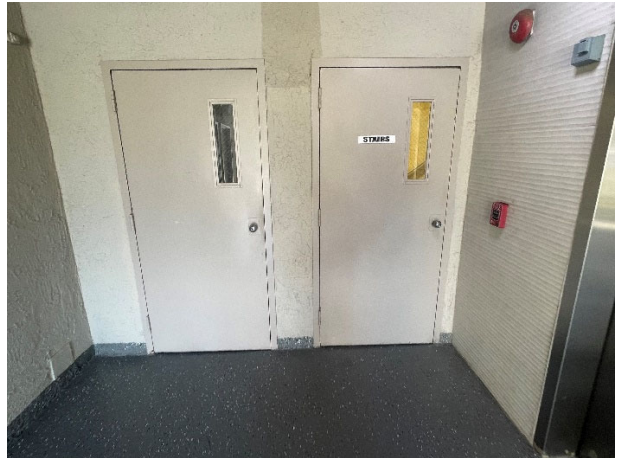
#### E. Exterior Doors

All doors are in fair condition, only regular maintenance.
