**Executive Summary – September 2025**

JOB: Structural Integrity Reserve Study (SIRS)  
ADDRESS: 8160 GENEVA, CITY OF DORAL

FOLIO: 35-3022-028-0001

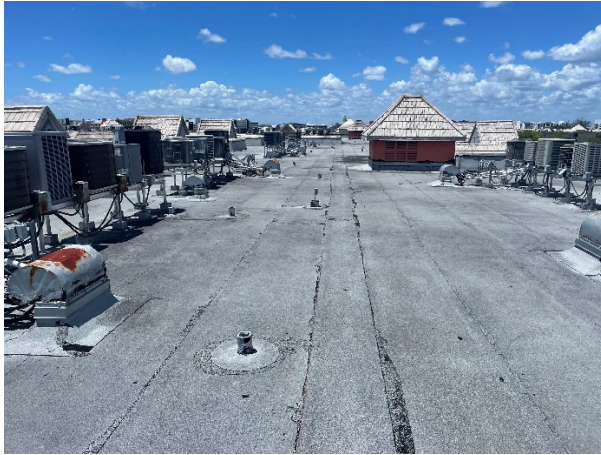
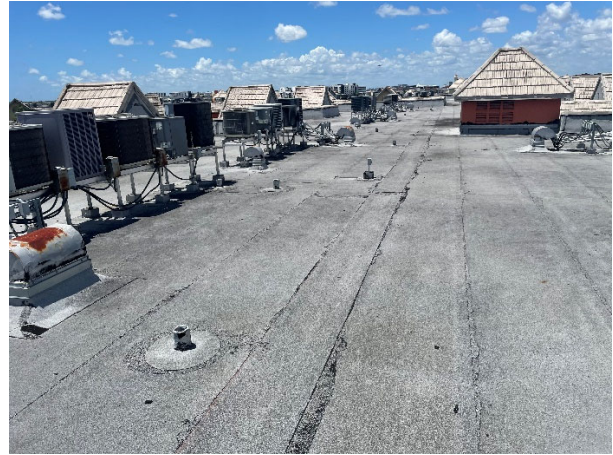
### Roof

Roof drains, scuppers on all balconies, gutters, and leaders discharge into trench drains. The drainage system is in fair condition; some corrosion was found but no repairs are currently needed. There are no roof framing members with obvious overloading, overstress, deterioration, or excessive deflection observed. Surface conditions are overall fair to poor conditions. Previous repairs were observed, and hairline cracks were noted on the roof.

The roof consists of reinforced concrete slabs in fair condition. The roof membrane is a built-up roof system with a granular surface modified bitumen cap sheet. The roofs are currently undergoing repair which are expected to be completed prior to December 21, 2025, reserve funds will be used to carry out the necessary maintenance and repair work during the ten-year period.

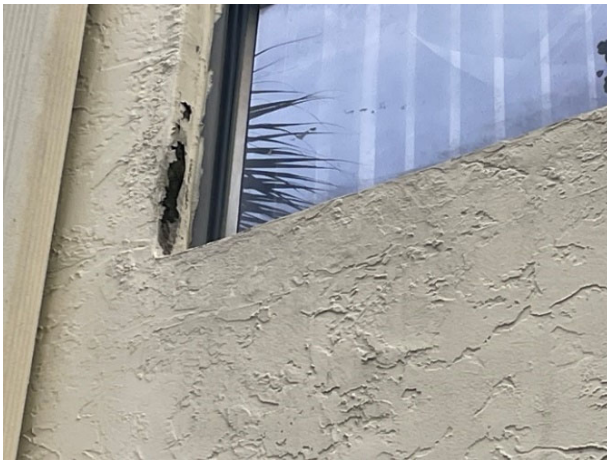
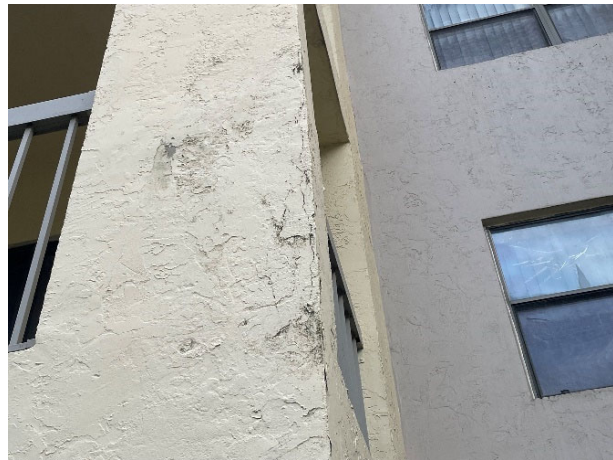
### Exterior Nonconcrete Walls

Nonbearing walls of exterior façade are in fair condition, showing signs of wear such as cracks and surface deterioration.

Minor wear such as small cracks were found at nonbearing walls. Maintenance is recommended over the next ten years, including localized repairs, repainting, sealing, and addressing any waterproofing issues to prevent further deterioration and maintain their functionality and appearance.

Maintenance is recommended over the next ten years, including localized crack repairs, repainting, resealing of joints and windows, and improvements to waterproofing where needed to prevent moisture intrusion.

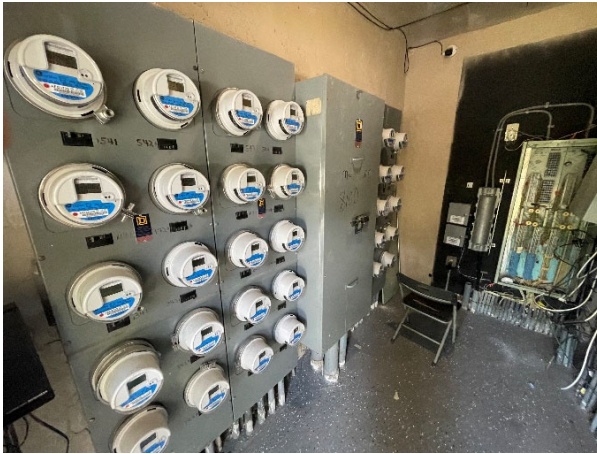
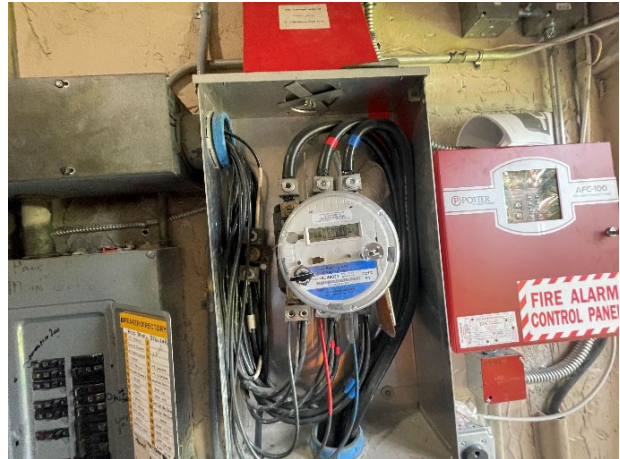
## A. Electrical Systems

The general conduits & raceways require repairs; There is rust and corrosion on some conduits. Moreover, there is loose BX conduit exiting concrete slab, the penetrations around these conduits must be patched, the wire and cables have rusted conduits and loose connections for BX exiting the concrete slab.

No defects were observed with swimming pool wiring or mechanical equipment or in wiring to mechanical equipment. There was no exposed wiring observed in open parking garage areas. Some breakers will need to be replaced during the ten-year period.

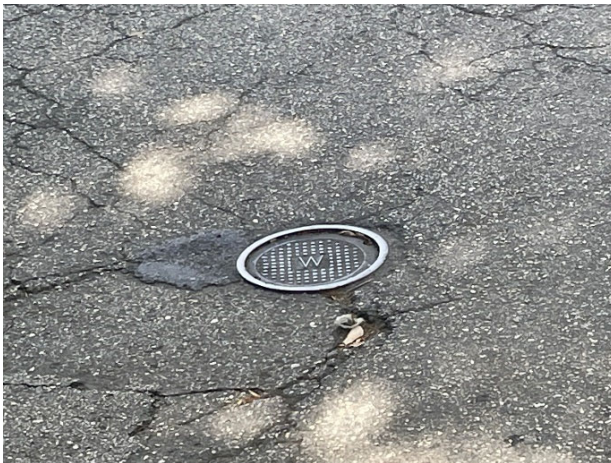
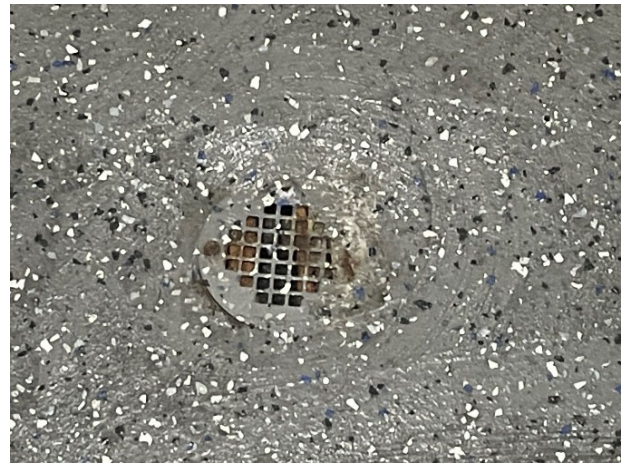
### Sanitary System:

They consist of sanitary risers (stacks) with full size ventilation through the roof. We project four incidents for this building in a ten years period.

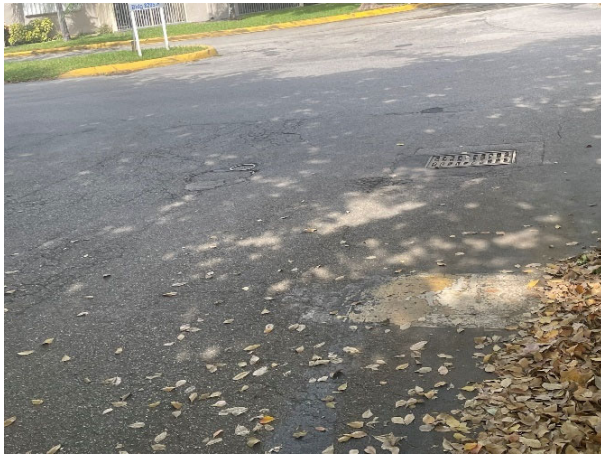
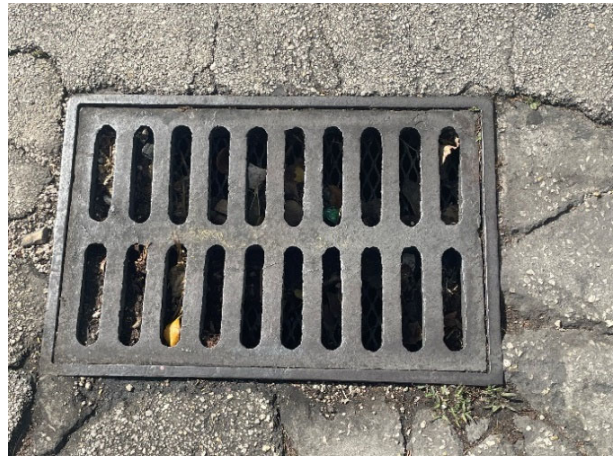
## Drainage System

A new drainage is needed to replace the existing ones, ensuring enhanced performance and durability. This section includes the replacement of the isolated catch basing and pipes.

The drainage system is included in this item, it is needed to replace the existing ones, ensuring enhanced performance and durability in the hurricane season. This includes the replacement of the isolated catch basing and pipes.

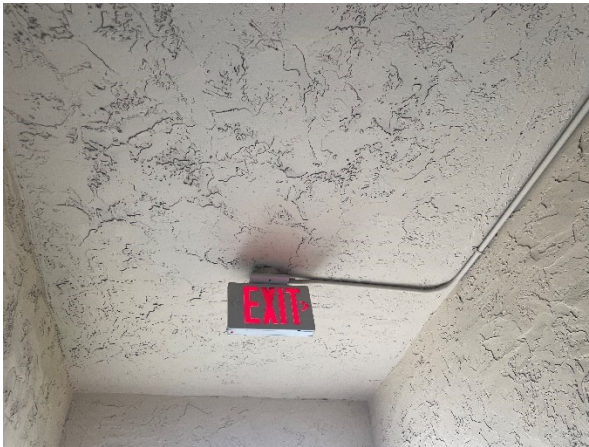
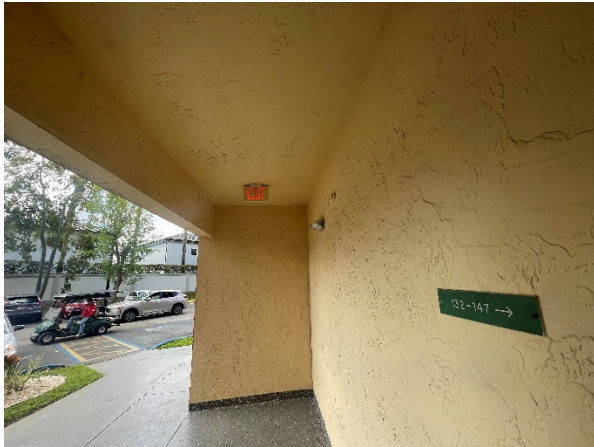
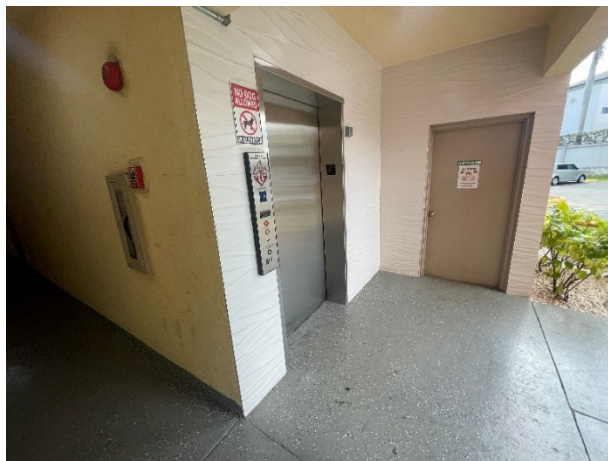
### C. Fireproofing and Fire Protection System

There is a fire alarm system in a dedicated fire command center; logbooks are up to date and provided in the electric panel room. The fire protection system utilizes a sprinklered system. There are fire alarm pull boxes, fire notification system and emergency lighting. Exit lights, emergency lights are building egress illumination is present and operable. Egress illumination is also present and operable in the parking garage. Some smoke detectors are covered due to ongoing masonry work causing dust to trigger alarms.

There is a fire alarm system in a dedicate fire command center; logbooks are up to date and provided in the electric panel room. The fire protection system utilizes a sprinklered system. There are fire alarm pull boxes, fire notification system and emergency lighting. Exit lights, emergency lights are building egress illumination is present and operable.

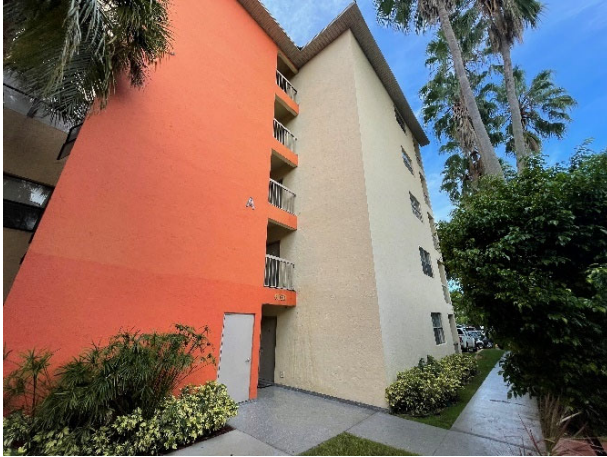
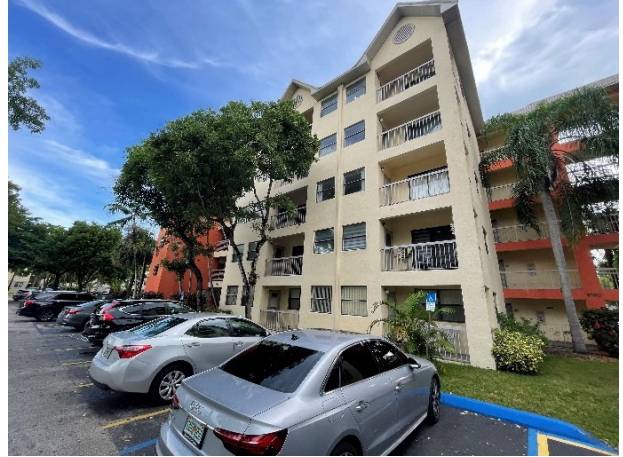
#### D. Painting

The paint is in overall fair condition; however, it is nearing the end of its service life and requires maintenance. Peeling paint was observed around windows on balconies, indicating the need for a new coating to preserve the building's exterior. Additionally, maintenance is required for some window caulking areas to prevent water infiltration. All services area of condominium are included.

The paint is in overall fair condition; however, it is nearing the end of its service life and requires maintenance. Peeling paint was observed around windows on balconies, indicating the need for a new coating to preserve the building's exterior. Additionally, maintenance is required for some window caulking areas to prevent water infiltration. Budgeting for repainting is necessary to maintain aesthetic and protective functions.

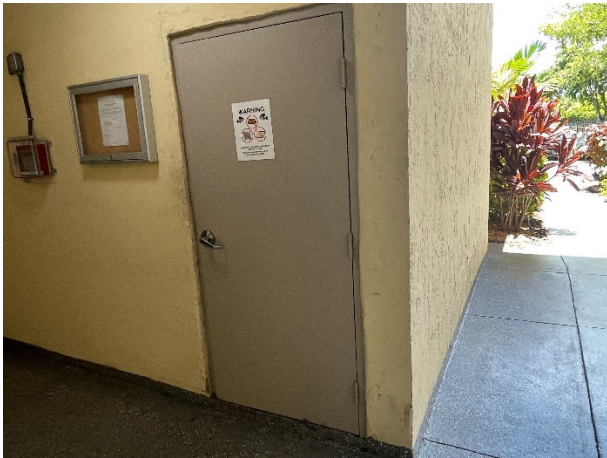
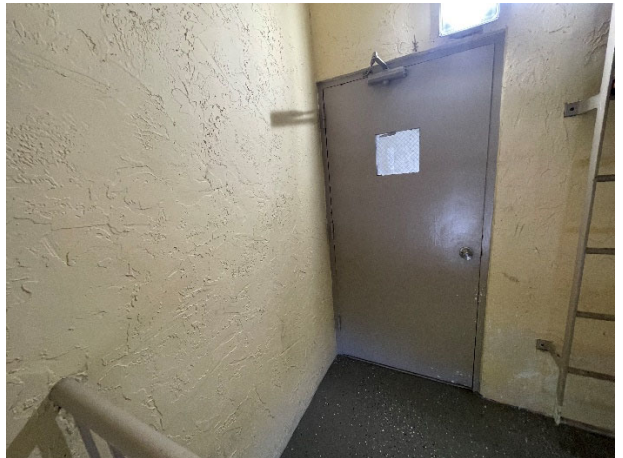
#### E. Exterior Doors

The installed doors are aluminum fixed and are in fair condition. Emergency metal doors are installed for stairs and mechanical rooms with metal frames. All doors are in fair condition.

All doors are in fair condition, only regular maintenance.
