**Executive Summary – September 2025**

JOB: Structural Integrity Reserve Study (**SIRS**)

ADDRESS: 8100 GENEVA, CITY OF DORAL

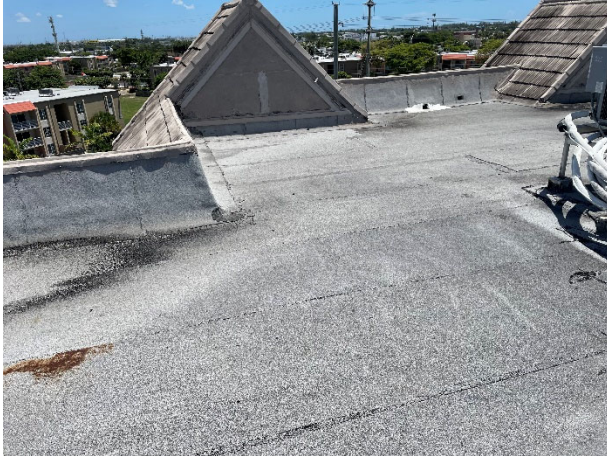
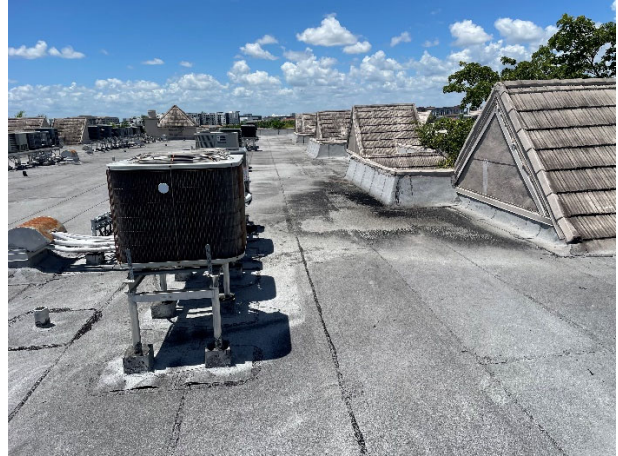
### Roof

Roof drains, scuppers on all balconies, gutters, and leaders discharge into trench drains. The drainage system is in fair condition; some corrosion was found but no repairs are currently needed. There are no roof framing members with obvious overloading, overstress, deterioration, or excessive deflection observed. Surface conditions are overall fair to poor conditions. Previous repairs were observed, and hairline cracks were noted on the roof.

The roof consists of reinforced concrete slabs in fair condition. The roof membrane is a built-up roof system with a granular surface modified bitumen cap sheet. The roofs are currently undergoing repair which are expected to be completed prior to December 21, 2025, reserve funds will be used to carry out the necessary maintenance and repair work during the ten-year period.

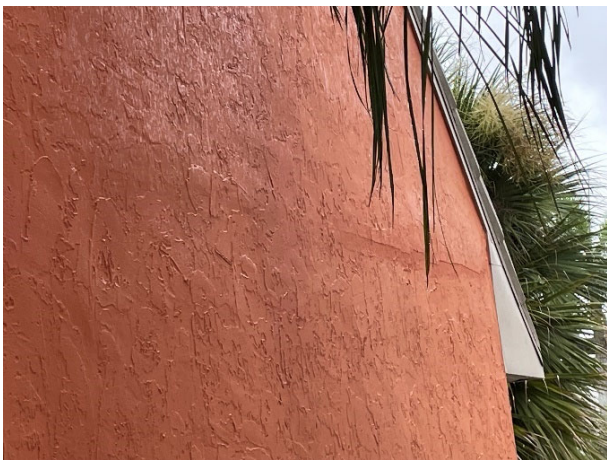
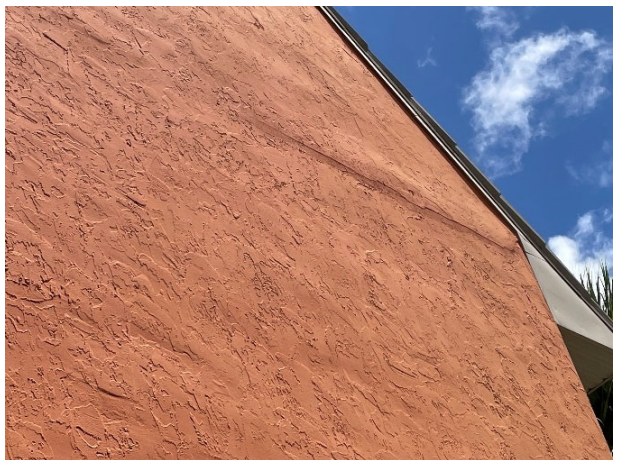
### Exterior Nonconcrete Walls

Nonbearing walls of exterior façade are in fair condition, showing signs of wear such as cracks and surface deterioration.

Minor wear such as small cracks were found at nonbearing walls. Maintenance is recommended over the next ten years, including localized repairs, repainting, sealing, and addressing any waterproofing issues to prevent further deterioration and maintain their functionality and appearance.

Maintenance is recommended over the next ten years, including localized crack repairs, repainting, resealing of joints and windows, and improvements to waterproofing where needed to prevent moisture intrusion.

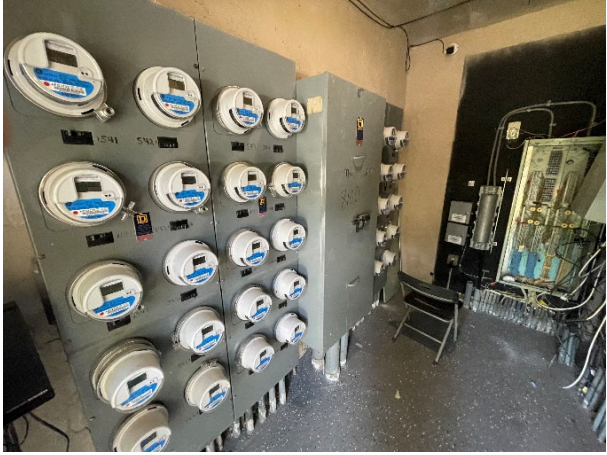
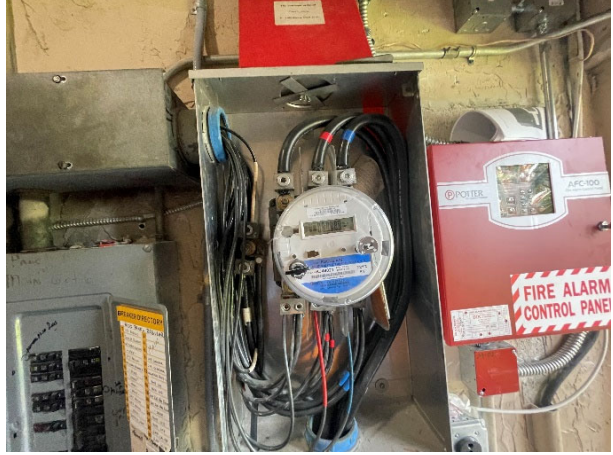
## A. Electrical Systems

The general conduits & raceways require repairs; There is rust and corrosion on some conduits. Moreover, there is loose BX conduit exiting concrete slab, the penetrations around these conduits must be patched, the wire and cables have rusted conduits and loose connections for BX exiting the concrete slab.

No defects were observed with swimming pool wiring or mechanical equipment or in wiring to mechanical equipment. There was no exposed wiring observed in open parking garage areas. Some breakers will need to be replaced during the ten-year period.

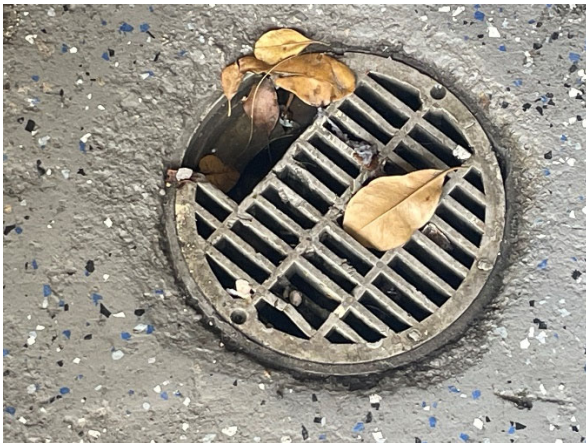
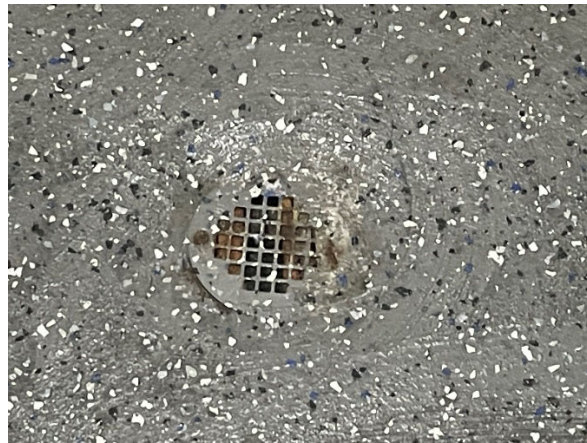
### Sanitary System:

They consist of sanitary risers (stacks) with full size ventilation through the roof. We project four incidents for this building in a ten years period.

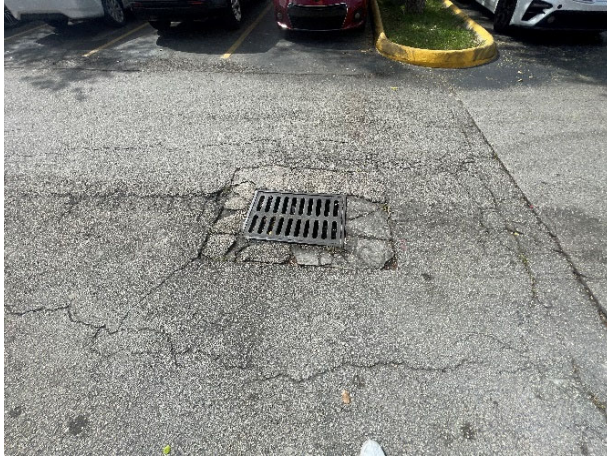
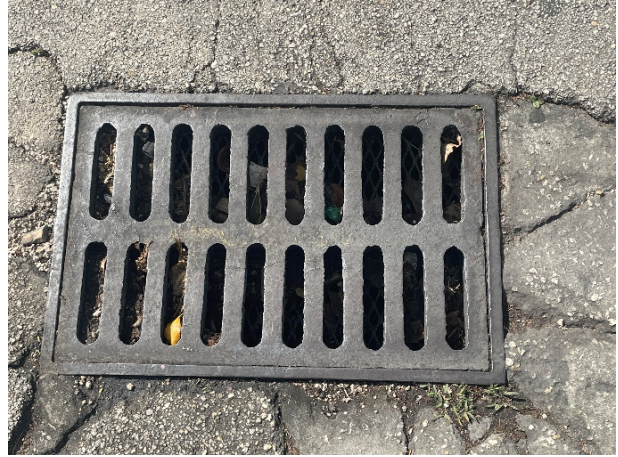
## Drainage System

A new drainage is needed to replace the existing ones, ensuring enhanced performance and durability. This section includes the replacement of the isolated catch basing and pipes.

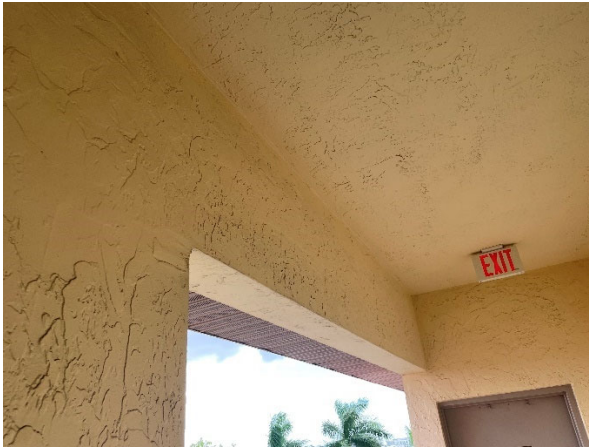
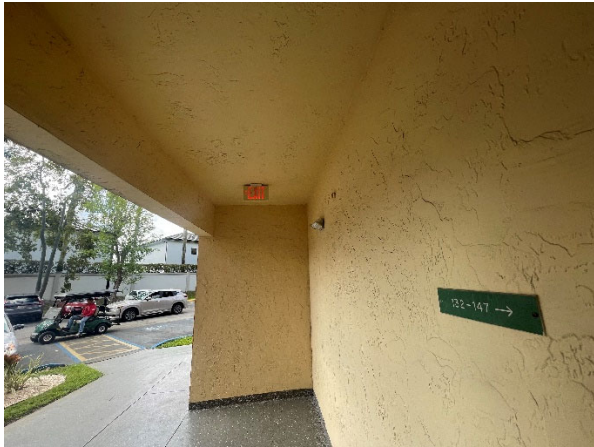
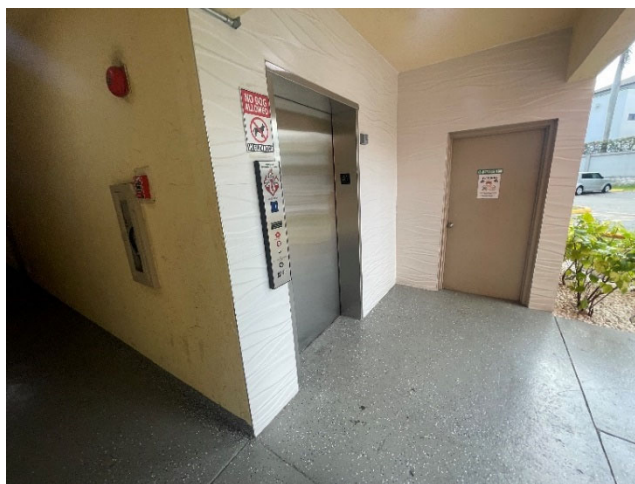
## C. Fireproofing and Fire Protection System

There is a fire alarm system in a dedicate fire command center; logbooks are up to date and provided in the electric panel room. The fire protection system utilizes a sprinklered system. There are fire alarm pull boxes, fire notification system and emergency lighting. Exit lights, emergency lights are building egress illumination is present and operable.

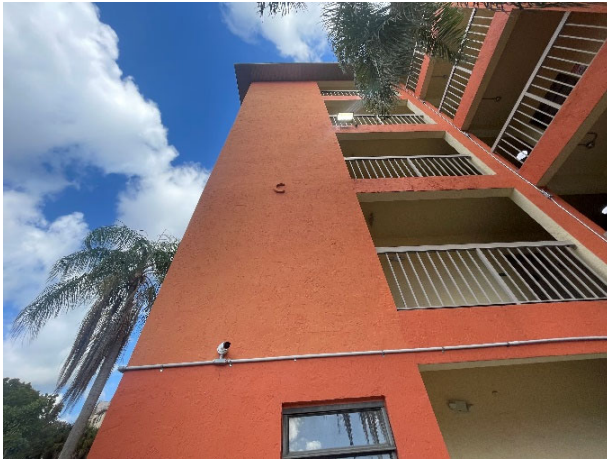
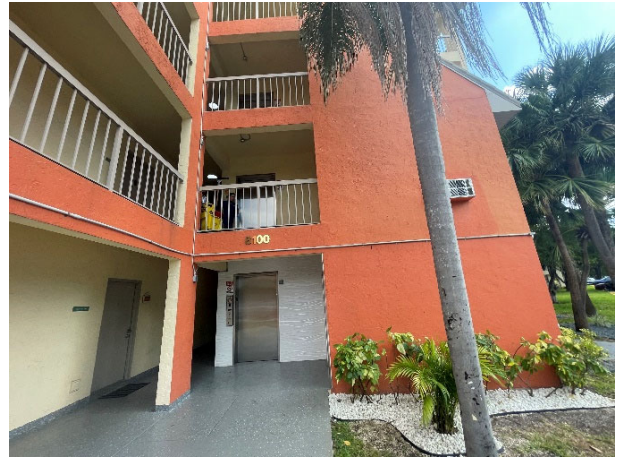
#### D. Painting

The paint is in overall fair condition; however, it is nearing the end of its service life and requires maintenance. Peeling paint was observed around windows on balconies, indicating the need for a new coating to preserve the building's exterior. Additionally, maintenance is required for some window caulking areas to prevent water infiltration. All services area of condominium are included.

The paint is in overall fair condition; however, it is nearing the end of its service life and requires maintenance. Peeling paint was observed around windows on balconies, indicating the need for a new coating to preserve the building's exterior. Additionally, maintenance is required for some window caulking areas to prevent water infiltration. Budgeting for repainting is necessary to maintain aesthetic and protective functions.

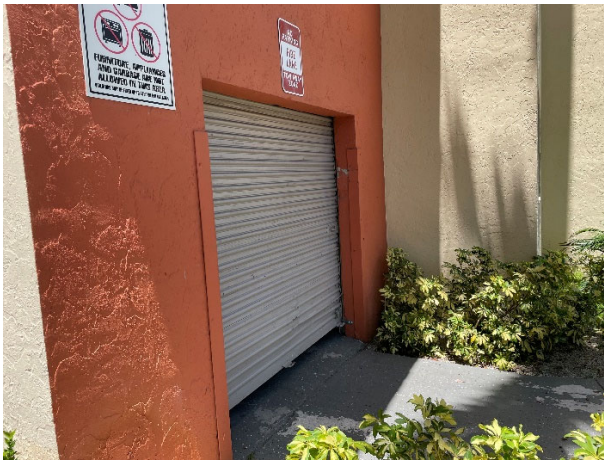
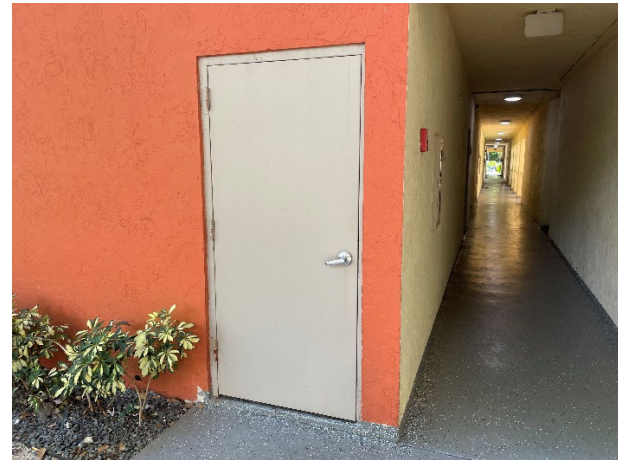
#### E. Exterior Doors

All doors are in fair condition, only regular maintenance.
