**Executive Summary – September 2025**

JOB: Structural Integrity Reserve Study (**SIRS**)

ADDRESS: 8120 GENEVA, CITY OF DORAL

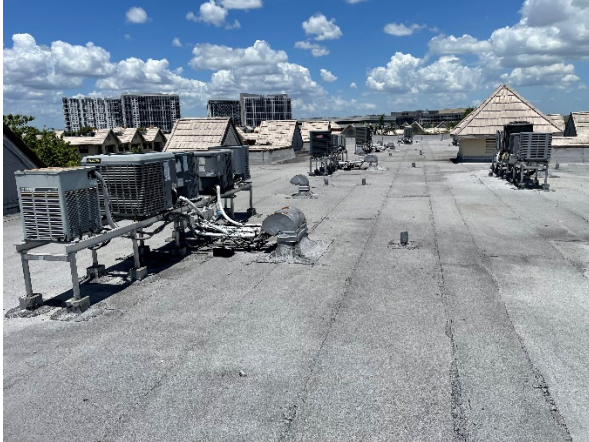
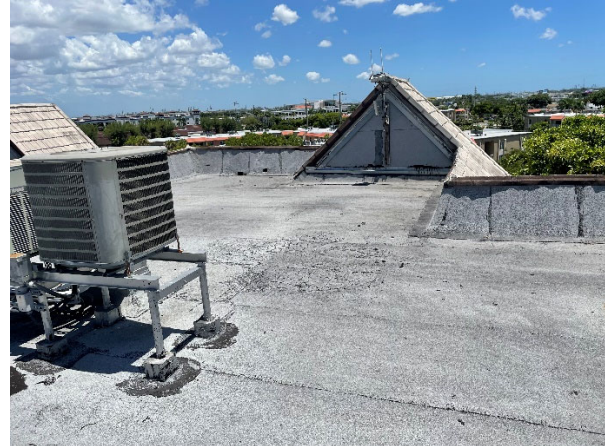
### Roof

The roof consists of reinforced concrete slabs in fair condition. The roof membrane is a built-up roof system with a granular surface modified bitumen cap sheet. The roofs are currently undergoing repair which are expected to be completed prior to December 21, 2025, reserve funds will be used to carry out the necessary maintenance and repair work during the ten-year period.

Roof drains, scuppers on all balconies, gutters, and leaders discharge into trench drains. The drainage system is in fair condition; some corrosion was found but no repairs are currently needed. There are no roof framing members with obvious overloading, overstress, deterioration, or excessive deflection observed. Surface conditions are overall fair to poor conditions. Previous repairs were observed, and hairline cracks were noted on the roof.

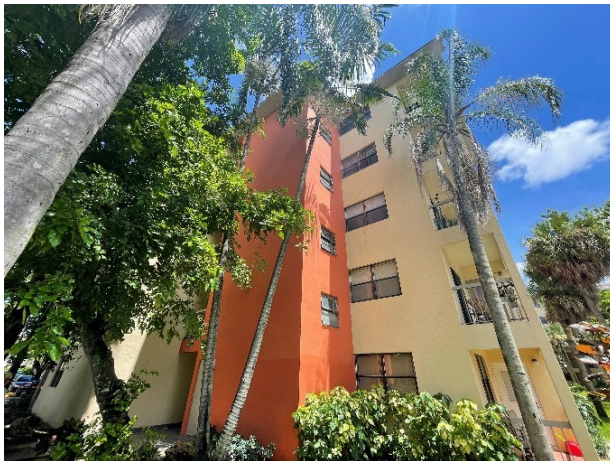
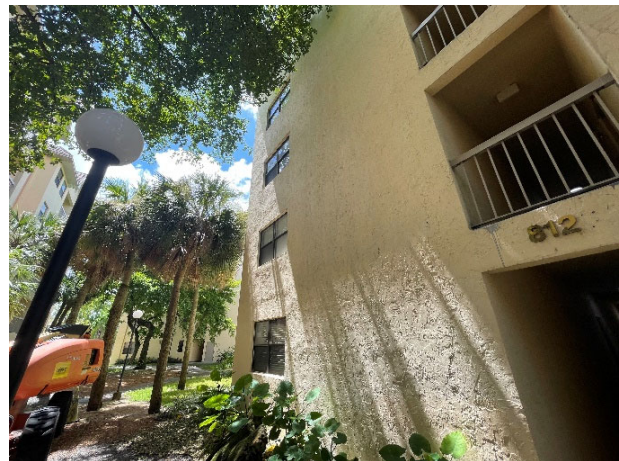
### Exterior Nonconcrete Walls

Nonbearing walls of exterior façade are in fair condition, showing signs of wear such as cracks and surface deterioration.

Minor wear such as small cracks were found at nonbearing walls. Maintenance is recommended over the next ten years, including localized repairs, repainting, sealing, and addressing any waterproofing issues to prevent further deterioration and maintain their functionality and appearance.

Maintenance is recommended over the next ten years, including localized crack repairs, repainting, resealing of joints and windows, and improvements to waterproofing where needed to prevent moisture intrusion.

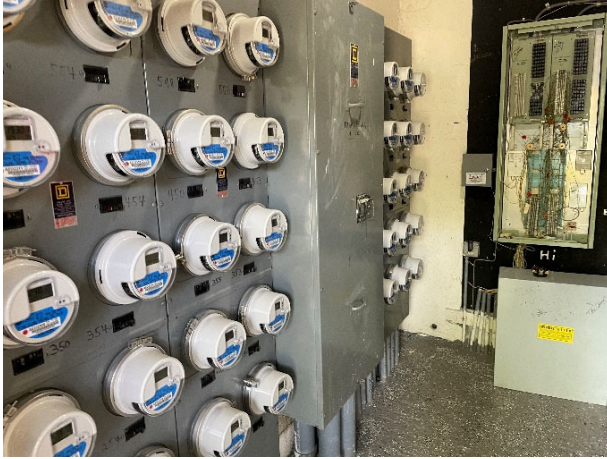
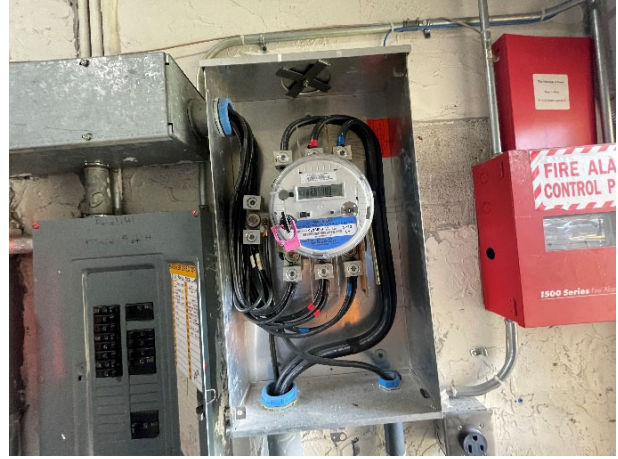
## A. Electrical Systems

The general conduits & raceways require repairs; There is rust and corrosion on some conduits. Moreover, there is loose BX conduit exiting concrete slab, the penetrations around these conduits must be patched, the wire and cables have rusted conduits and loose connections for BX exiting the concrete slab.

No defects were observed with swimming pool wiring or mechanical equipment or in wiring to mechanical equipment. There was no exposed wiring observed in open parking garage areas. Some breakers will need to be replaced during the ten-year period.

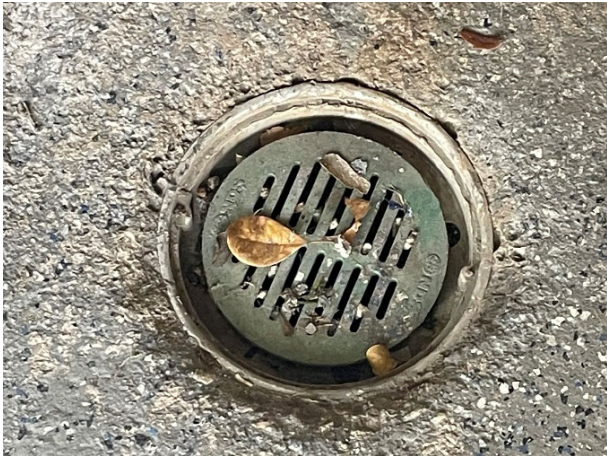
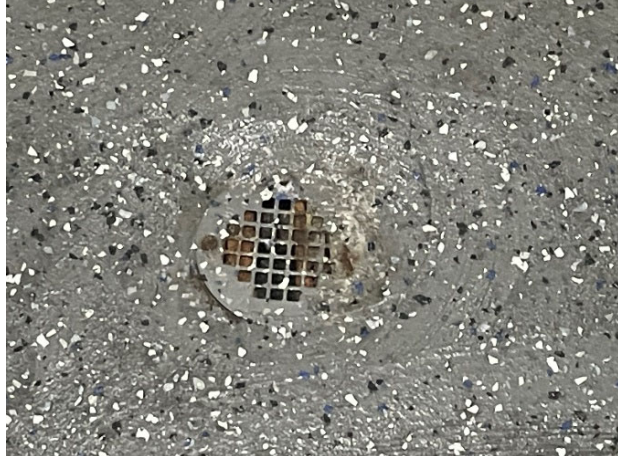
### Sanitary System:

They consist of sanitary risers (stacks) with full size ventilation through the roof. We project three incidents for this building in a ten years period.

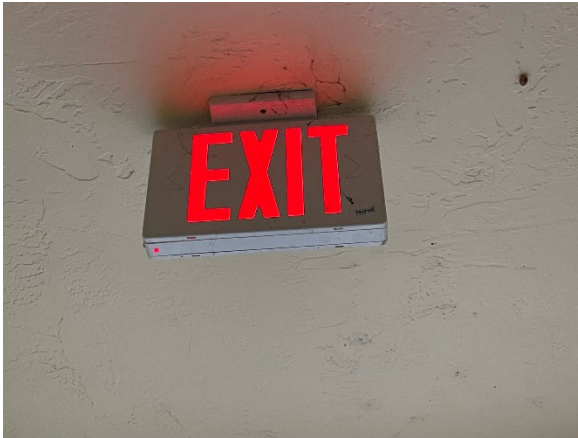
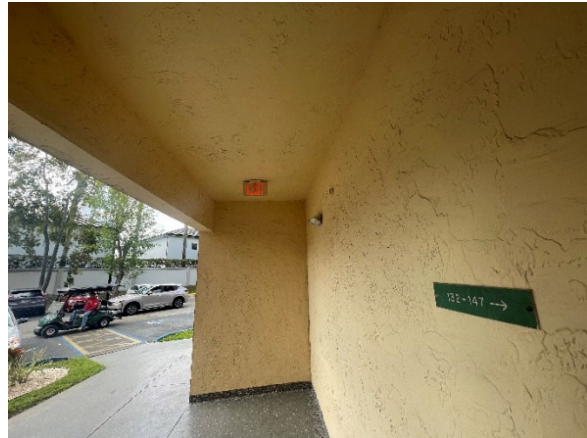
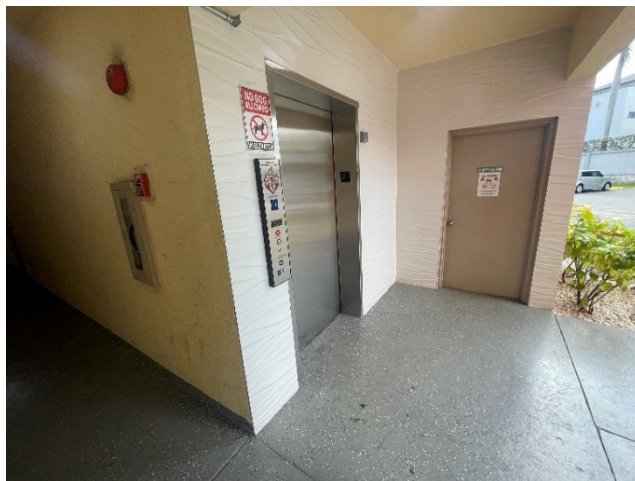
## C. Fireproofing and Fire Protection System

There is a fire alarm system in a dedicate fire command center; logbooks are up to date and provided in the electric panel room. The fire protection system utilizes a sprinklered system. There are fire alarm pull boxes, fire notification system and emergency lighting. Exit lights, emergency lights are all working. egress illumination is present and operable.

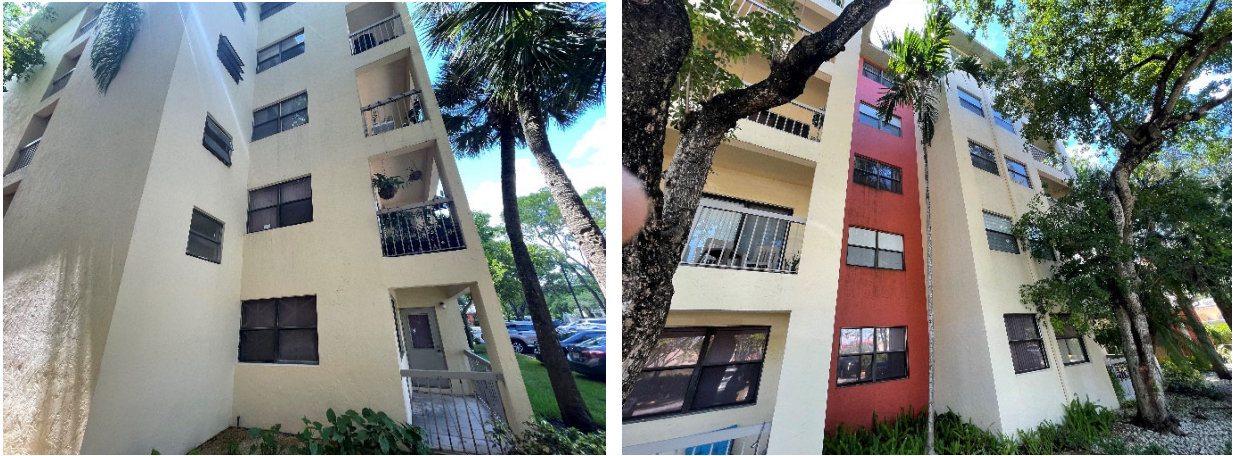
#### D. Painting

The paint is in overall fair condition; however, it is nearing the end of its service life and requires maintenance. Peeling paint was observed around windows on balconies, indicating the need for a new coating to preserve the building's exterior. Additionally, maintenance is required for some window caulking areas to prevent water infiltration. All services area of condominium are included.

The paint is in overall fair condition; however, it is nearing the end of its service life and requires maintenance. Peeling paint was observed around windows on balconies, indicating the need for a new coating to preserve the building's exterior. Additionally, maintenance is required for some window caulking areas to prevent water infiltration. Budgeting for repainting is necessary to maintain aesthetic and protective functions.

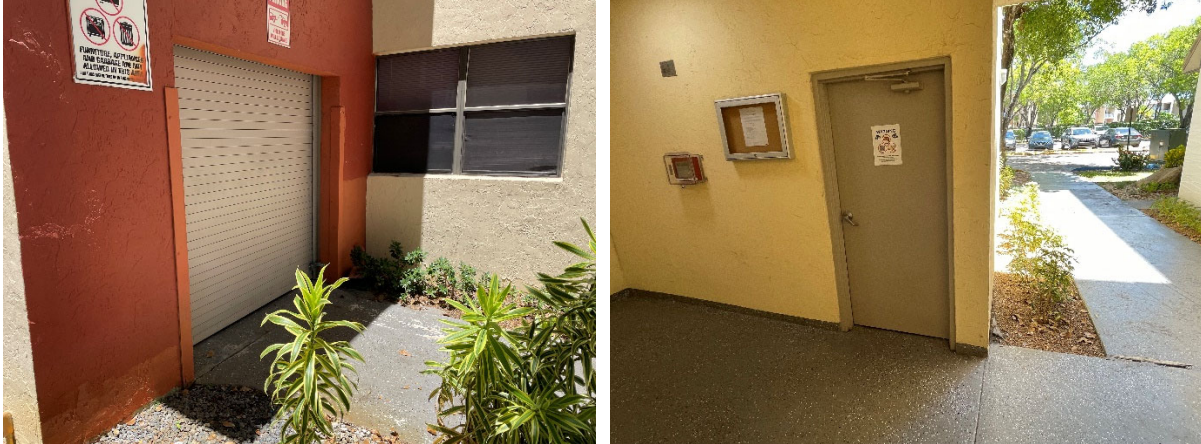
#### E. Exterior Doors

All doors are in fair condition, only regular maintenance.
