**Executive Summary – September 2025**

JOB: Structural Integrity Reserve Study (**SIRS**)  
ADDRESS: 8235 LAKE DRIVE, CITY OF DORAL

This Structural Integrity Reserve Study is being prepared in compliance with F.S. § 718.112 (2) (g)

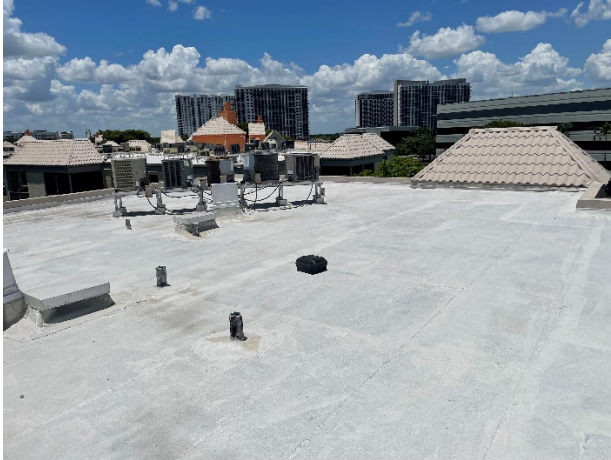
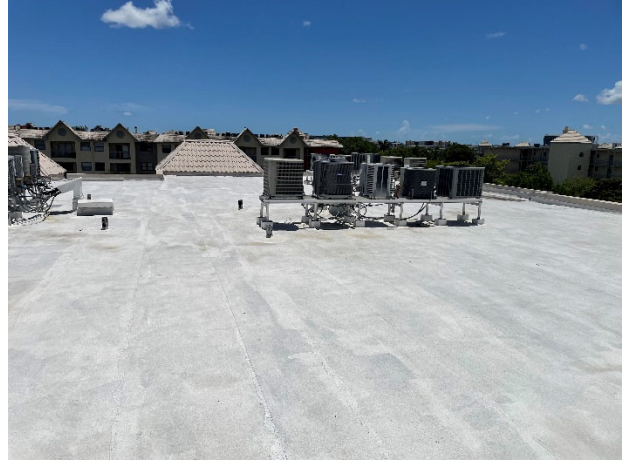
### Roof

Roof drains, scuppers on all balconies, gutters, and leaders discharge into trench drains. The drainage system is in fair condition; some corrosion was found but no repairs are currently needed. There are no roof framing members with obvious overloading, overstress, deterioration, or excessive deflection observed. Surface conditions are overall fair to poor conditions. Previous repairs were observed, and hairline cracks were noted on the roof.

The roof consists of reinforced concrete slabs in fair condition. The roof membrane is a built-up roof system with a granular surface modified bitumen cap sheet. The roofs are currently undergoing repair which are expected to be completed prior to December 21, 2025, reserve funds will be used to carry out the necessary maintenance and repair work during the ten-year period.

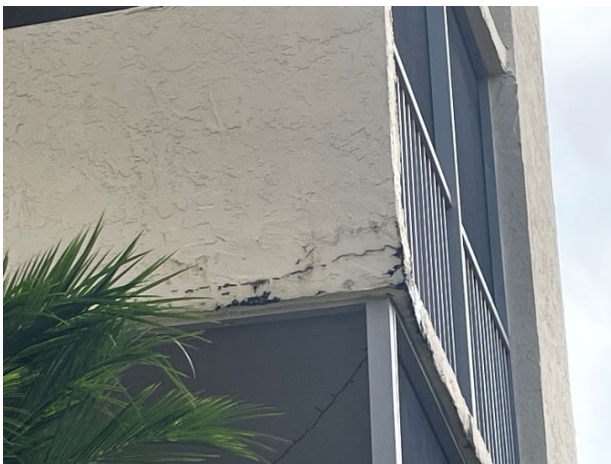
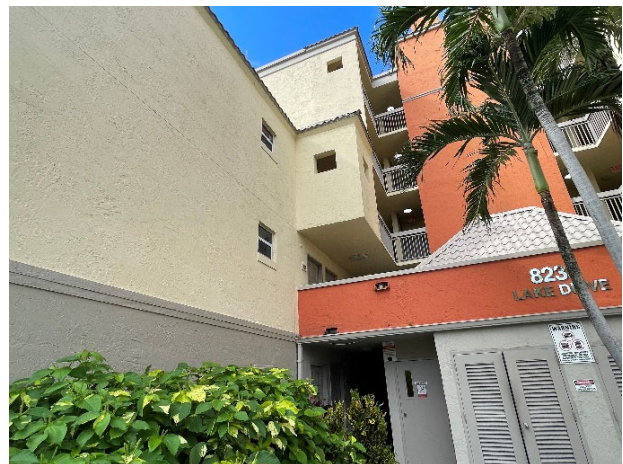
### Exterior Nonconcrete Walls

Nonbearing walls of exterior façade are in fair condition, showing signs of wear such as cracks and surface deterioration.

Minor wear such as small cracks were found at nonbearing walls. Maintenance is recommended over the next ten years, including localized repairs, repainting, sealing, and addressing any waterproofing issues to prevent further deterioration and maintain their functionality and appearance.

Maintenance is recommended over the next ten years, including localized crack repairs, repainting, resealing of joints and windows, and improvements to waterproofing where needed to prevent moisture intrusion.

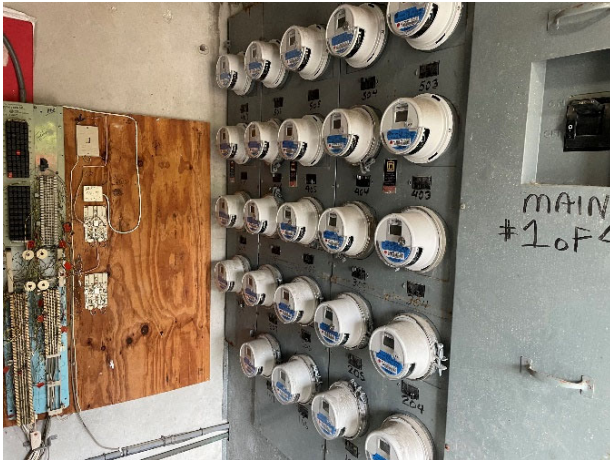
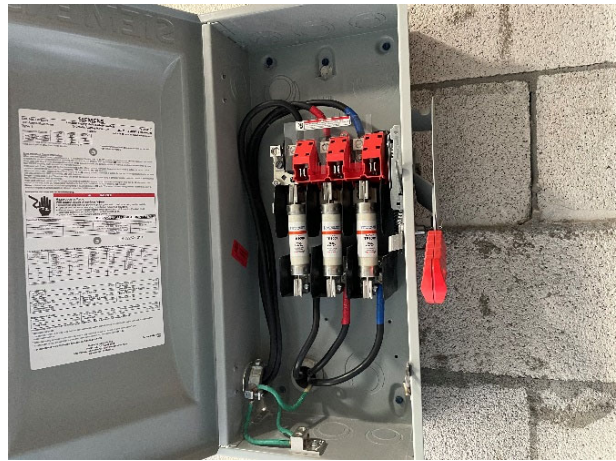
## A. Electrical Systems

The general conduits & raceways require repairs; There is rust and corrosion on some conduits. Moreover, there is loose BX conduit exiting concrete slab, the penetrations around these conduits must be patched, the wire and cables have rusted conduits and loose connections for BX exiting the concrete slab.

No defects were observed with swimming pool wiring or mechanical equipment or in wiring to mechanical equipment. There was no exposed wiring observed in open parking garage areas. Some breakers will need to be replaced during the ten-year period.

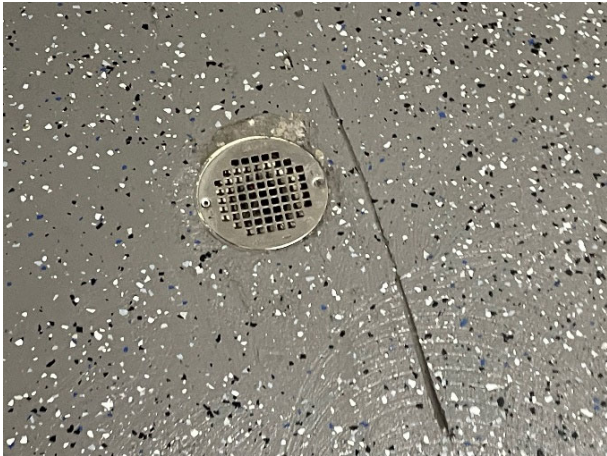
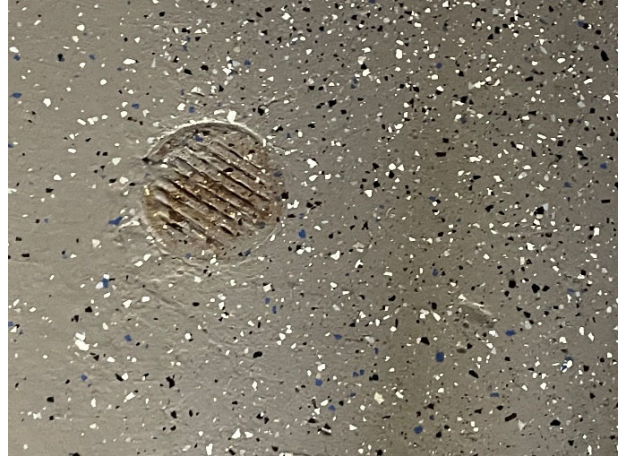
### Sanitary System:

They consist of sanitary risers (stacks) with full size ventilation through the roof. We project two incidents for this building in a ten years period.

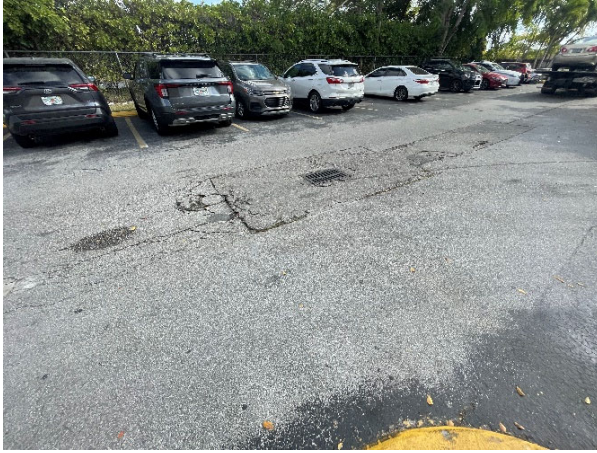
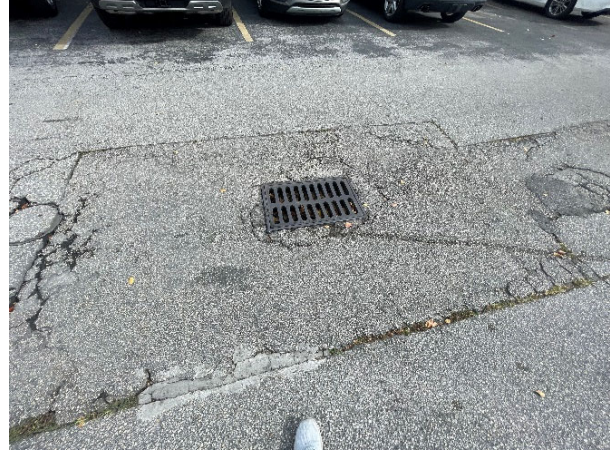
## Drainage System

A new drainage is needed to replace the existing ones, ensuring enhanced performance and durability. This section includes the replacement of the isolated catch basing and pipes.

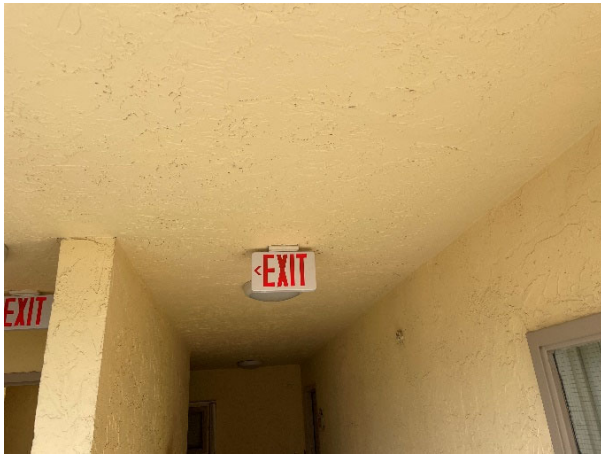
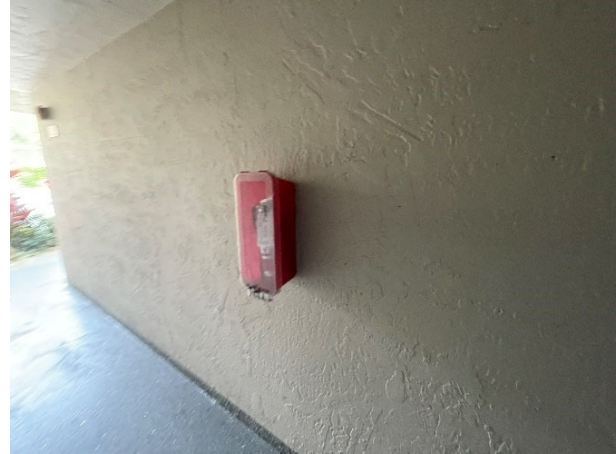
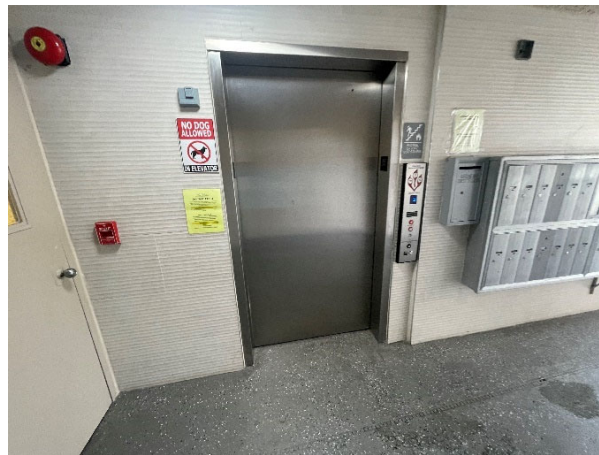
### C. Fireproofing and Fire Protection System

There is a fire alarm system in a dedicated fire command center; logbooks are up to date and provided in the electric panel room. The fire protection system utilizes a sprinklered system. There are fire alarm pull boxes, fire notification system and emergency lighting. Exit lights, emergency lights are building egress illumination is present and operable. Egress illumination is also present and operable in the parking garage. Some smoke detectors are covered due to ongoing masonry work causing dust to trigger alarms.

There is a fire alarm system in a dedicate fire command center; logbooks are up to date and provided in the electric panel room. The fire protection system utilizes a sprinklered system. There are fire alarm pull boxes, fire notification system and emergency lighting. Exit lights, emergency lights are building egress illumination is present and operable.

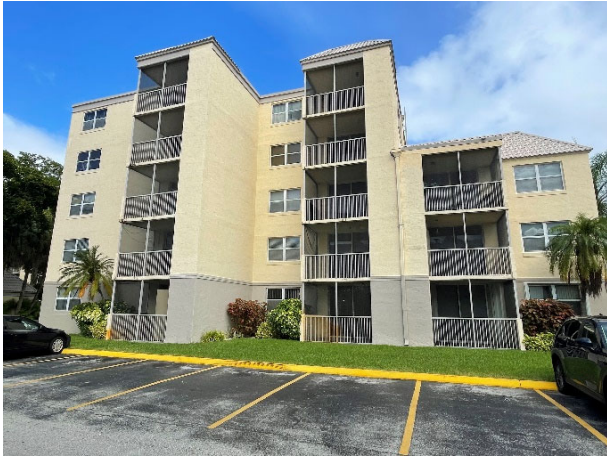
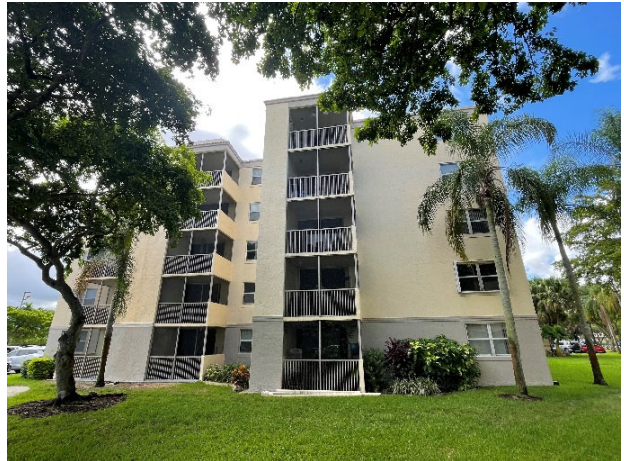
#### D. Painting

The paint is in overall fair condition; however, it is nearing the end of its service life and requires maintenance. Peeling paint was observed around windows on balconies, indicating the need for a new coating to preserve the building's exterior. Additionally, maintenance is required for some window caulking areas to prevent water infiltration. Budgeting for repainting is necessary to maintain aesthetic and protective functions.

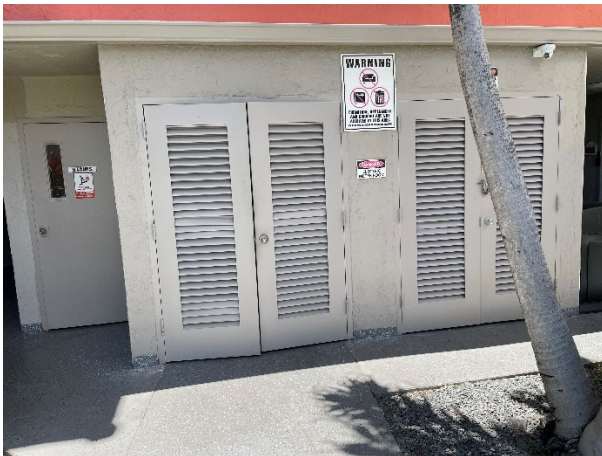
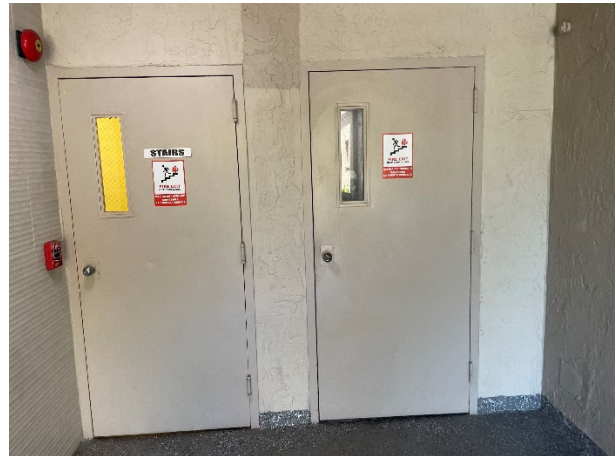
#### E. Exterior Doors

All doors are in fair condition, only regular maintenance.
