**Executive Summary – September 2025**

JOB: Structural Integrity Reserve Study (**SIRS**)  
ADDRESS: 8255 LAKE DRIVE, CITY OF DORAL

This Structural Integrity Reserve Study is being prepared in compliance with F.S. § 718.112 (2) (g)

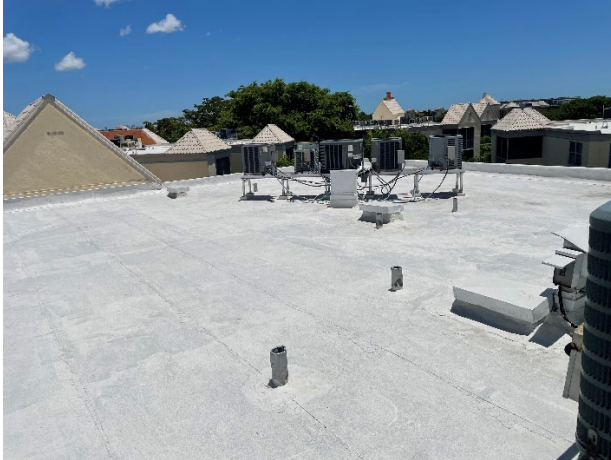
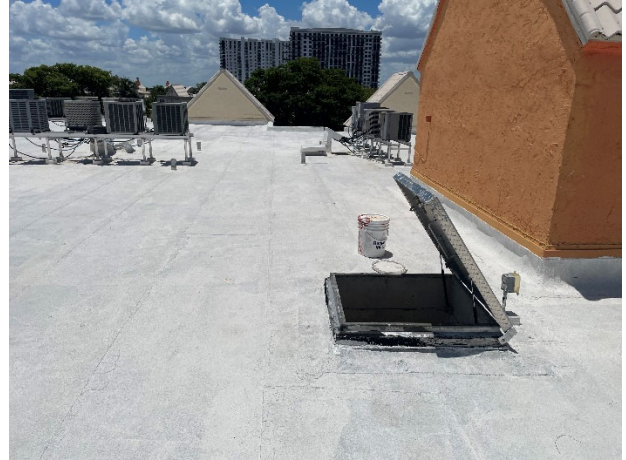
### Roof

Roof drains, scuppers on all balconies, gutters, and leaders discharge into trench drains. The drainage system is in fair condition; some corrosion was found but no repairs are currently needed. There are no roof framing members with obvious overloading, overstress, deterioration, or excessive deflection observed. Surface conditions are overall fair to poor conditions. Previous repairs were observed, and hairline cracks were noted on the roof.

The roof consists of reinforced concrete slabs in fair condition. The roof membrane is a built-up roof system with a granular surface modified bitumen cap sheet. The roofs are currently undergoing repair which are expected to be completed prior to December 21, 2025, reserve funds will be used to carry out the necessary maintenance and repair work during the ten-year period.

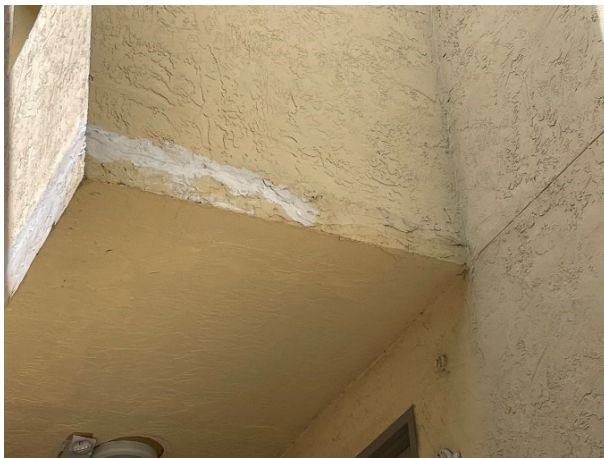
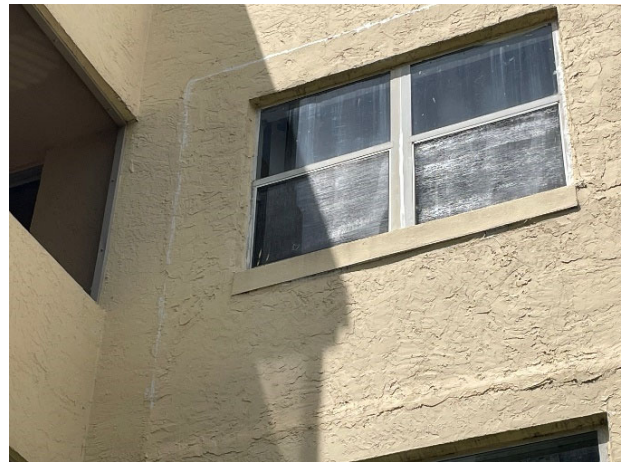
### Exterior Nonconcrete Walls

Nonbearing walls of exterior façade are in fair condition, showing signs of wear such as cracks and surface deterioration.

Minor wear such as small cracks were found at nonbearing walls. Maintenance is recommended over the next ten years, including localized repairs, repainting, sealing, and addressing any waterproofing issues to prevent further deterioration and maintain their functionality and appearance.

Maintenance is recommended over the next ten years, including localized crack repairs, repainting, resealing of joints and windows, and improvements to waterproofing where needed to prevent moisture intrusion.

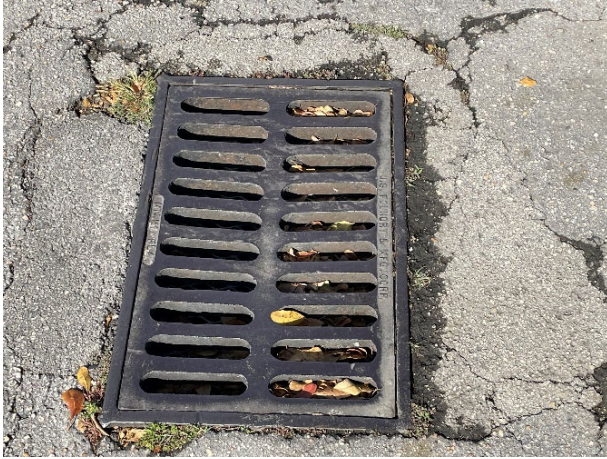
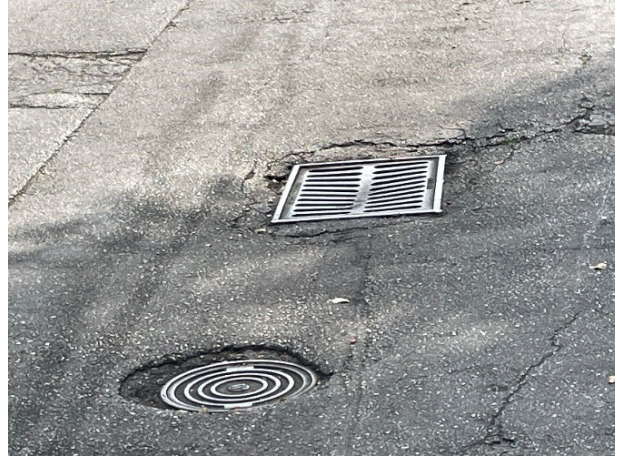
## Drainage System

A new drainage is needed to replace the existing ones, ensuring enhanced performance and durability. This section includes the replacement of the isolated catch basing and pipes.

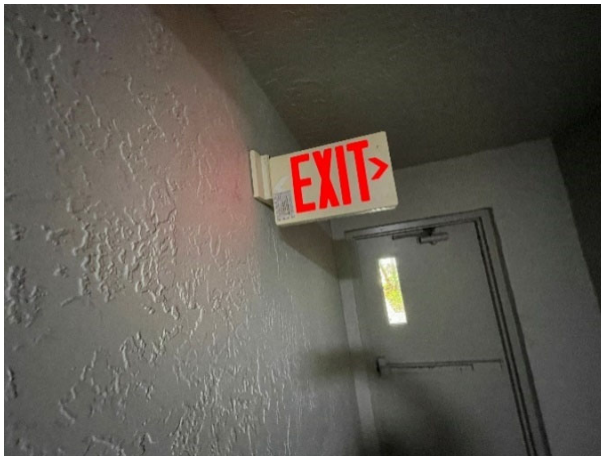
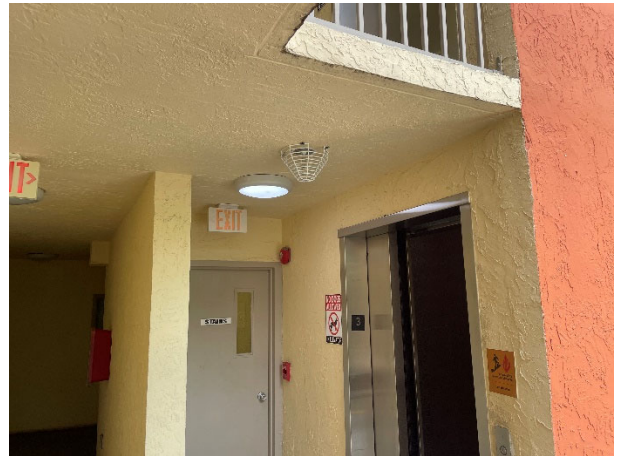
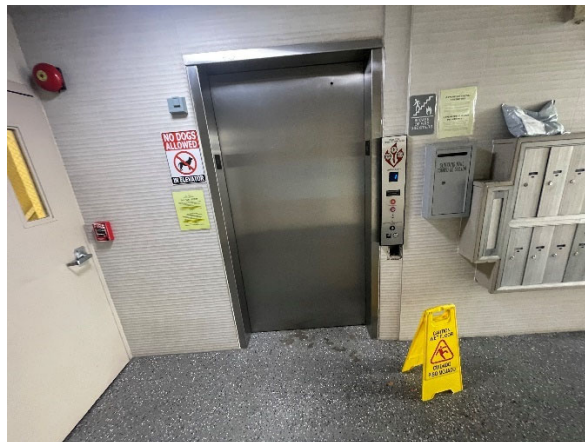
### C. Fireproofing and Fire Protection System

There is a fire alarm system in a dedicate fire command center; logbooks are up to date and provided in the electric panel room. The fire protection system utilizes a sprinklered system. There are fire alarm pull boxes, fire notification system and emergency lighting. Exit lights, emergency lights are building egress illumination is present and operable.

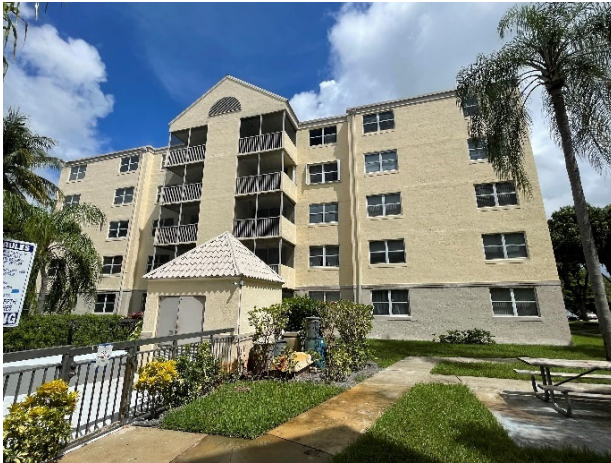
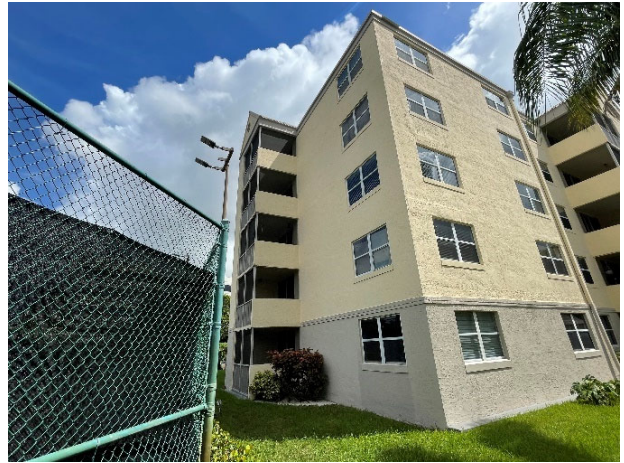
#### D. Painting

The paint is in overall fair condition; however, it is nearing the end of its service life and requires maintenance. Peeling paint was observed around windows on balconies, indicating the need for a new coating to preserve the building's exterior. Additionally, maintenance is required for some window caulking areas to prevent water infiltration. Budgeting for repainting is necessary to maintain aesthetic and protective functions.

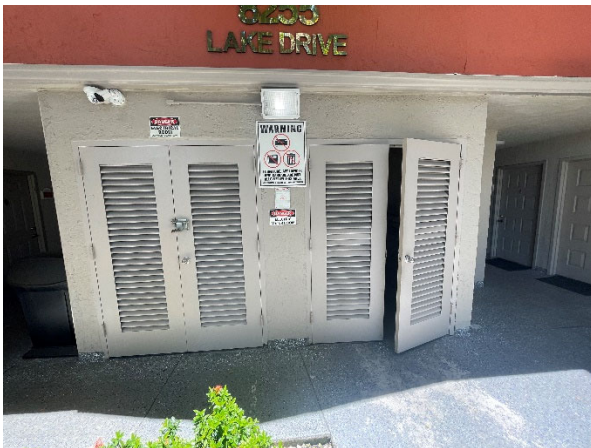
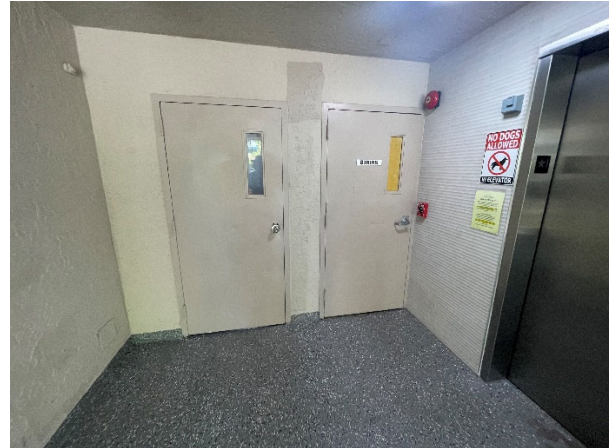
#### E. Exterior Doors

All doors are in fair condition, only regular maintenance.
