**Executive Summary – September 2025**

JOB: Structural Integrity Reserve Study (SIRS)  
ADDRESS: 8323 LAKE DRIVE, CITY OF DORAL

This Structural Integrity Reserve Study is being prepared in compliance with F.S. § 718.112 (2) (g)

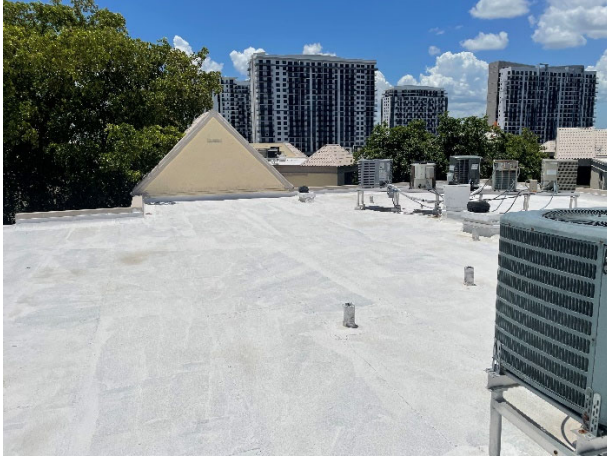
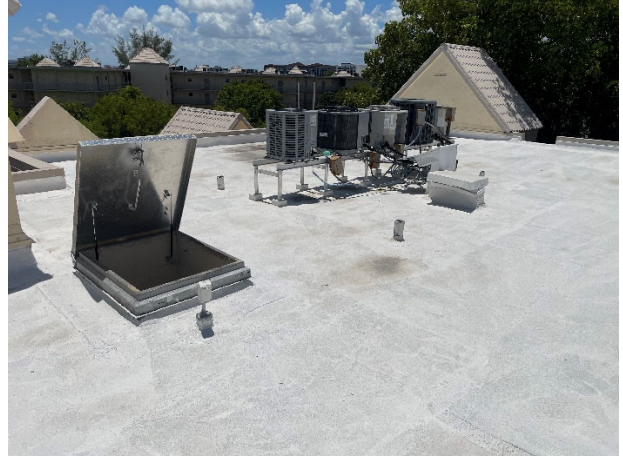
### Roof

The roof consists of reinforced concrete slabs in fair condition. The roof membrane is a built-up roof system with a granular surface modified bitumen cap sheet. The roofs are currently undergoing repair which are expected to be completed prior to December 21, 2025, reserve funds will be used to carry out the necessary maintenance and repair work during the ten-year period.

Roof drains, scuppers on all balconies, gutters, and leaders discharge into trench drains. The drainage system is in fair condition; some corrosion was found but no repairs are currently needed. There are no roof framing members with obvious overloading, overstress, deterioration, or excessive deflection observed. Surface conditions are overall fair to poor conditions. Previous repairs were observed, and hairline cracks were noted on the roof.

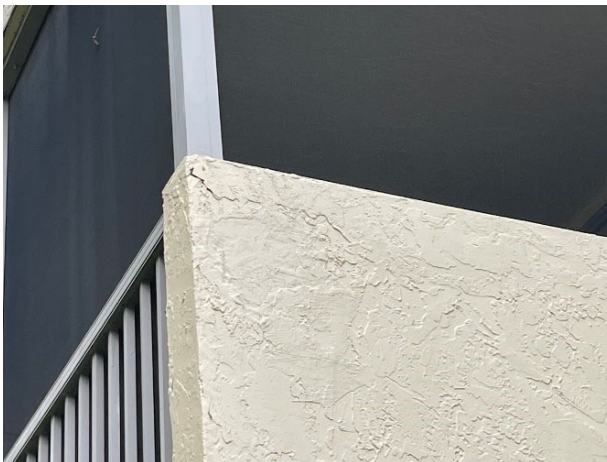
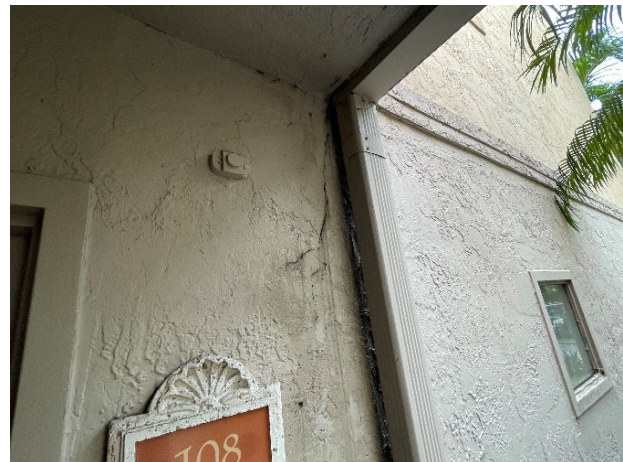
### Exterior Nonconcrete Walls

Nonbearing walls of exterior façade are in fair condition, showing signs of wear such as cracks and surface deterioration.

Minor wear such as small cracks were found at nonbearing walls. Maintenance is recommended over the next ten years, including localized repairs, repainting, sealing, and addressing any waterproofing issues to prevent further deterioration and maintain their functionality and appearance.

Maintenance is recommended over the next ten years, including localized crack repairs, repainting, resealing of joints and windows, and improvements to waterproofing where needed to prevent moisture intrusion.

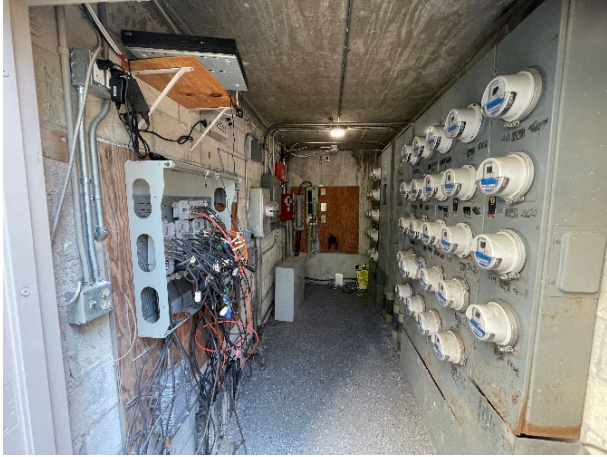
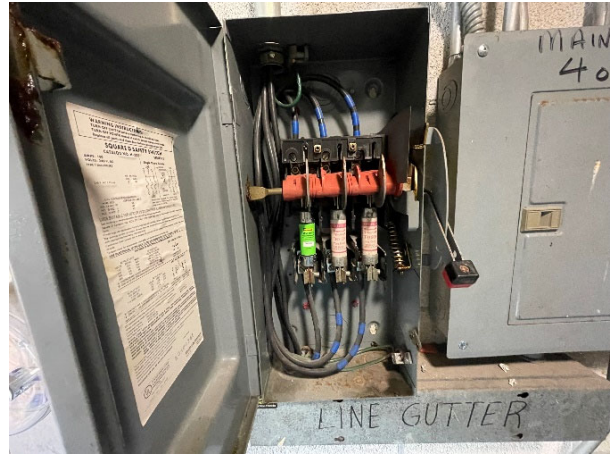
## A. Electrical Systems

The general conduits & raceways require repairs; There is rust and corrosion on some conduits. Moreover, there is loose BX conduit exiting concrete slab, the penetrations around these conduits must be patched, the wire and cables have rusted conduits and loose connections for BX exiting the concrete slab.

No defects were observed with swimming pool wiring or mechanical equipment or in wiring to mechanical equipment. There was no exposed wiring observed in open parking garage areas. Some breakers will need to be replaced during the ten-year period.

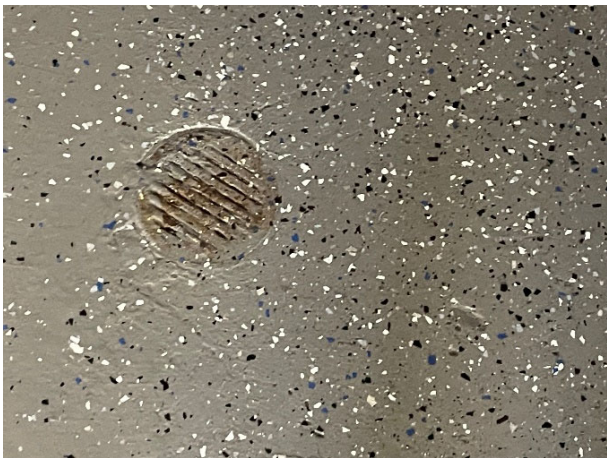
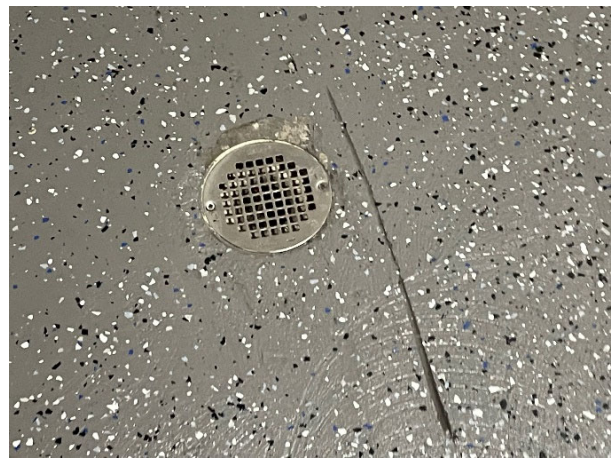
### Sanitary System:

They consist of sanitary risers (stacks) with full size ventilation through the roof. We project two incidents for this building in a ten years period.

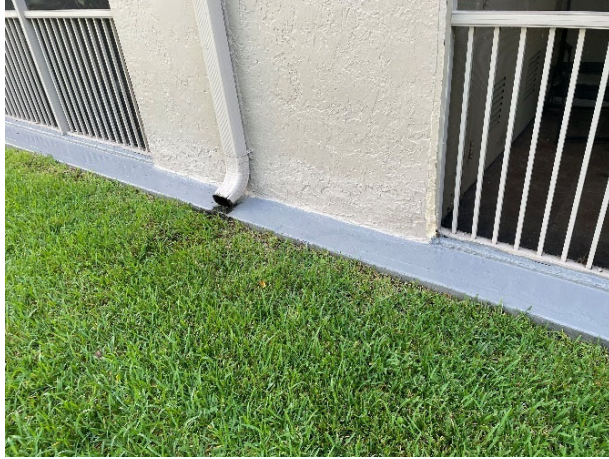
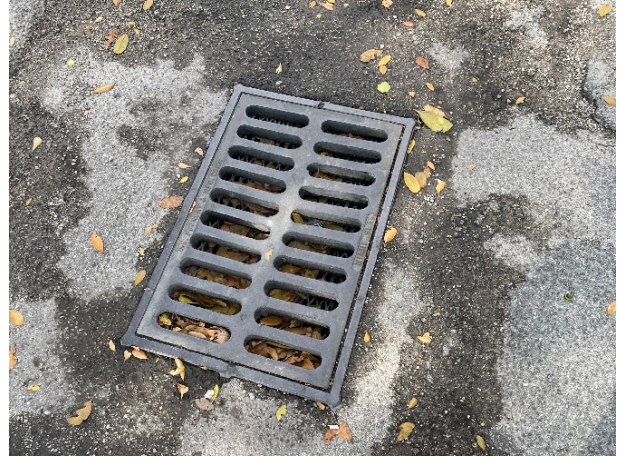
## Drainage System

A new drainage is needed to replace the existing ones, ensuring enhanced performance and durability. This section includes the replacement of the isolated catch basing and pipes.

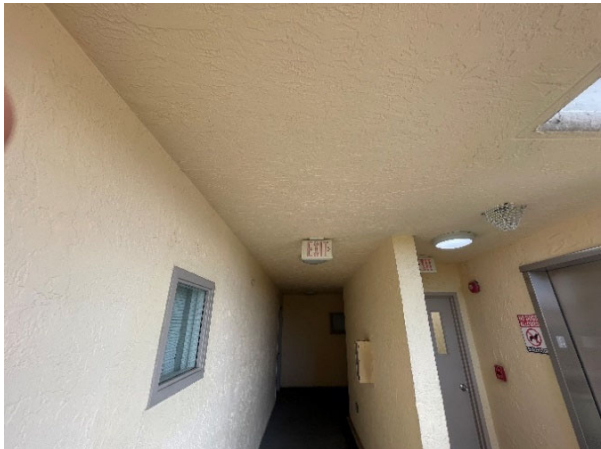
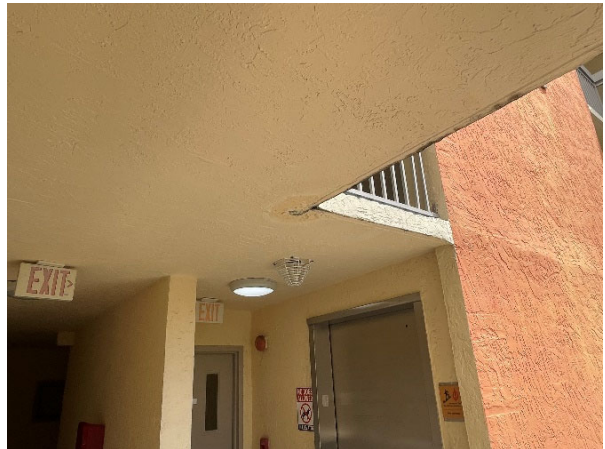
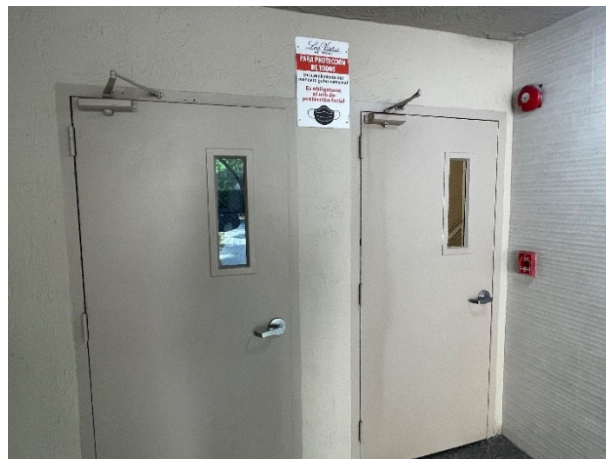
### C. Fireproofing and Fire Protection System

There is a fire alarm system in a dedicated fire command center; logbooks are up to date and provided in the electric panel room. The fire protection system utilizes a sprinklered system. There are fire alarm pull boxes, fire notification system and emergency lighting. Exit lights, emergency lights are building egress illumination is present and operable. Egress illumination is also present and operable in the parking garage. Some smoke detectors are covered due to ongoing masonry work causing dust to trigger alarms.

There is a fire alarm system in a dedicate fire command center; logbooks are up to date and provided in the electric panel room. The fire protection system utilizes a sprinklered system. There are fire alarm pull boxes, fire notification system and emergency lighting. Exit lights, emergency lights are building egress illumination is present and operable.

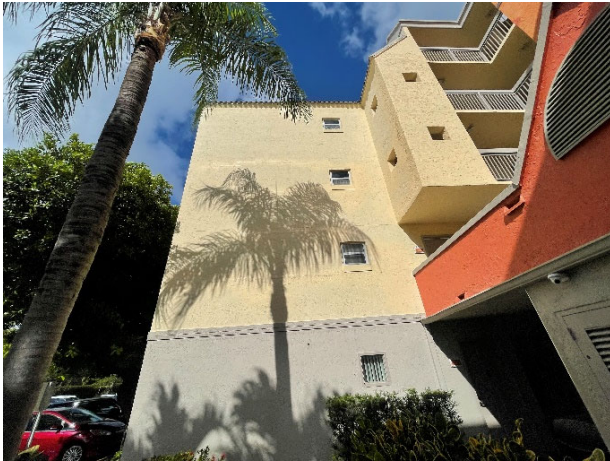
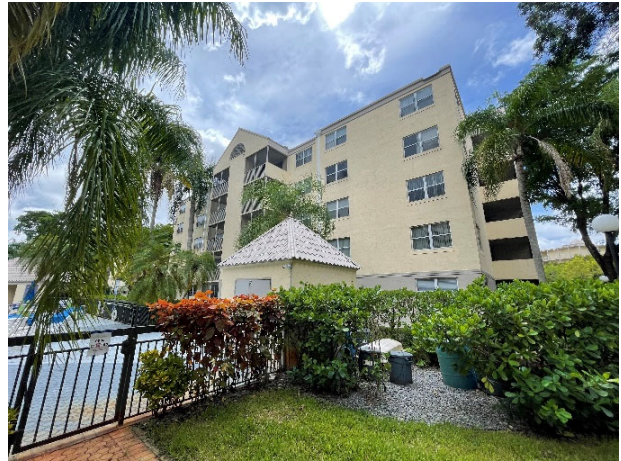
#### D. Painting

The paint is in overall fair condition; however, it is nearing the end of its service life and requires maintenance. Peeling paint was observed around windows on balconies, indicating the need for a new coating to preserve the building's exterior. Additionally, maintenance is required for some window caulking areas to prevent water infiltration. All services area of condominium are included.

The paint is in overall fair condition; however, it is nearing the end of its service life and requires maintenance. Peeling paint was observed around windows on balconies, indicating the need for a new coating to preserve the building's exterior. Additionally, maintenance is required for some window caulking areas to prevent water infiltration. Budgeting for repainting is necessary to maintain aesthetic and protective functions.

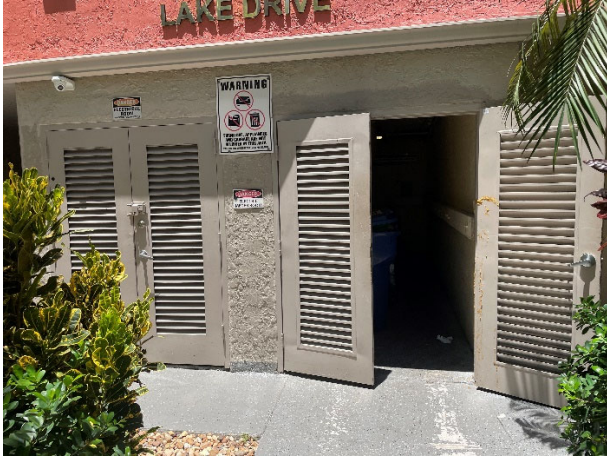
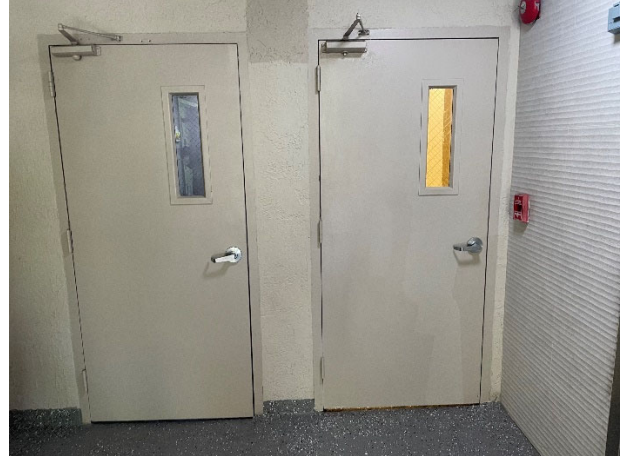
#### E. Exterior Doors

The installed doors are aluminum fixed and are in fair condition. Emergency metal doors are installed for stairs and mechanical rooms with metal frames. All doors are in fair condition.

All doors are in fair condition, only regular maintenance.
