**Executive Summary – September 2025**

JOB: Structural Integrity Reserve Study (**SIRS**)  
ADDRESS: 8373 LAKE DRIVE, CITY OF DORAL

This Structural Integrity Reserve Study is being prepared in compliance with F.S. § 718.112 (2) (g)

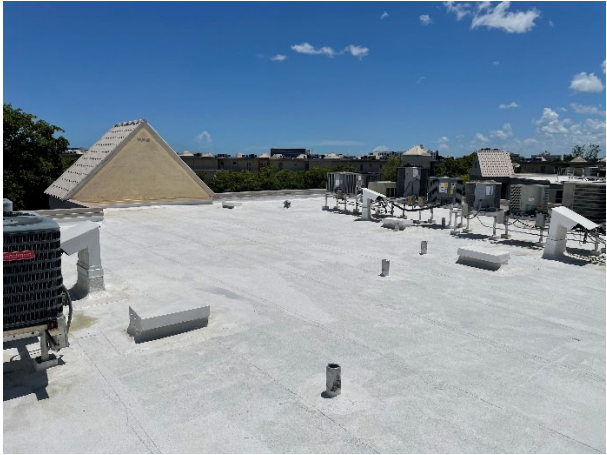
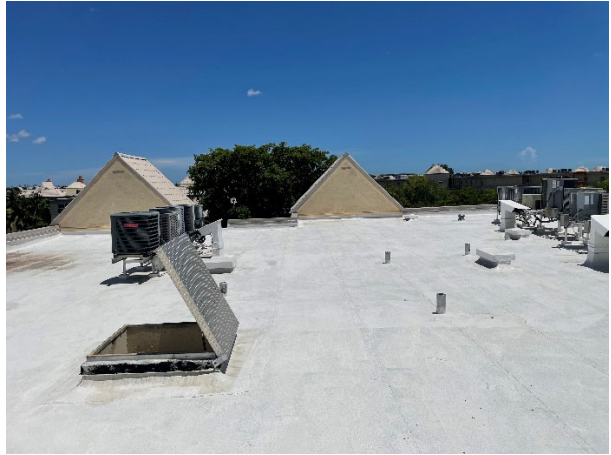
### Roof

Roof drains, scuppers on all balconies, gutters, and leaders discharge into trench drains. The drainage system is in fair condition; some corrosion was found but no repairs are currently needed. There are no roof framing members with obvious overloading, overstress, deterioration, or excessive deflection observed. Surface conditions are overall fair to poor conditions. Previous repairs were observed, and hairline cracks were noted on the roof.

The roof consists of reinforced concrete slabs in fair condition. The roof membrane is a built-up roof system with a granular surface modified bitumen cap sheet. The roofs are currently undergoing repair which are expected to be completed prior to December 21, 2025, reserve funds will be used to carry out the necessary maintenance and repair work during the ten-year period.

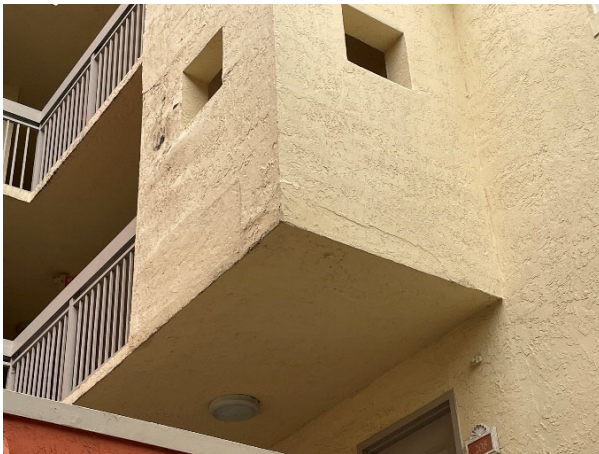
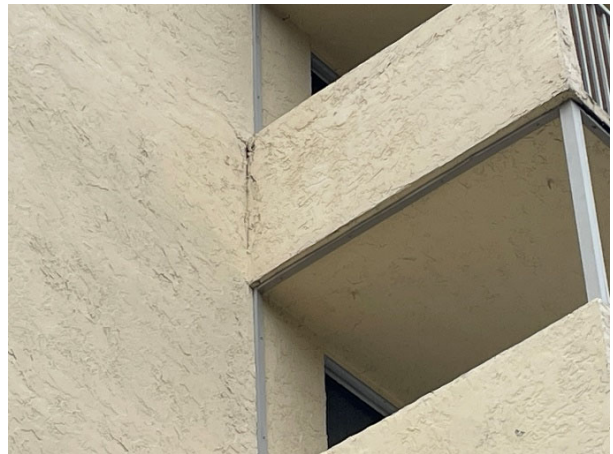
### Exterior Nonconcrete Walls

Nonbearing walls of exterior façade are in fair condition, showing signs of wear such as cracks and surface deterioration.

Minor wear such as small cracks were found at nonbearing walls. Maintenance is recommended over the next ten years, including localized repairs, repainting, sealing, and addressing any waterproofing issues to prevent further deterioration and maintain their functionality and appearance.

Maintenance is recommended over the next ten years, including localized crack repairs, repainting, resealing of joints and windows, and improvements to waterproofing where needed to prevent moisture intrusion.

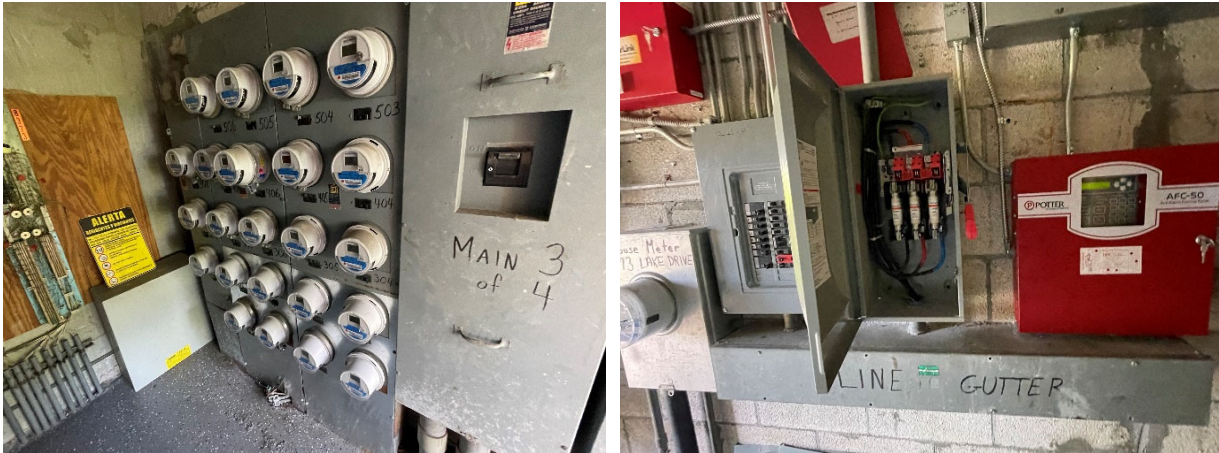
## A. Electrical Systems

The general conduits & raceways require repairs; There is rust and corrosion on some conduits. Moreover, there is loose BX conduit exiting concrete slab, the penetrations around these conduits must be patched, the wire and cables have rusted conduits and loose connections for BX exiting the concrete slab.

No defects were observed with swimming pool wiring or mechanical equipment or in wiring to mechanical equipment. There was no exposed wiring observed in open parking garage areas. Some breakers will need to be replaced during the ten-year period.

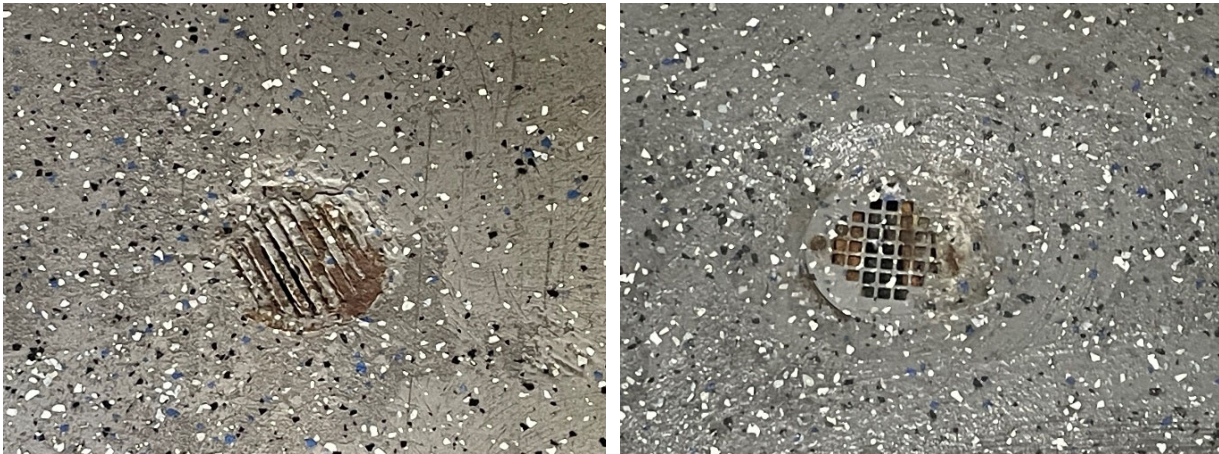
### Sanitary System:

They consist of sanitary risers (stacks) with full size ventilation through the roof. We project two incidents for this building in a ten years period.

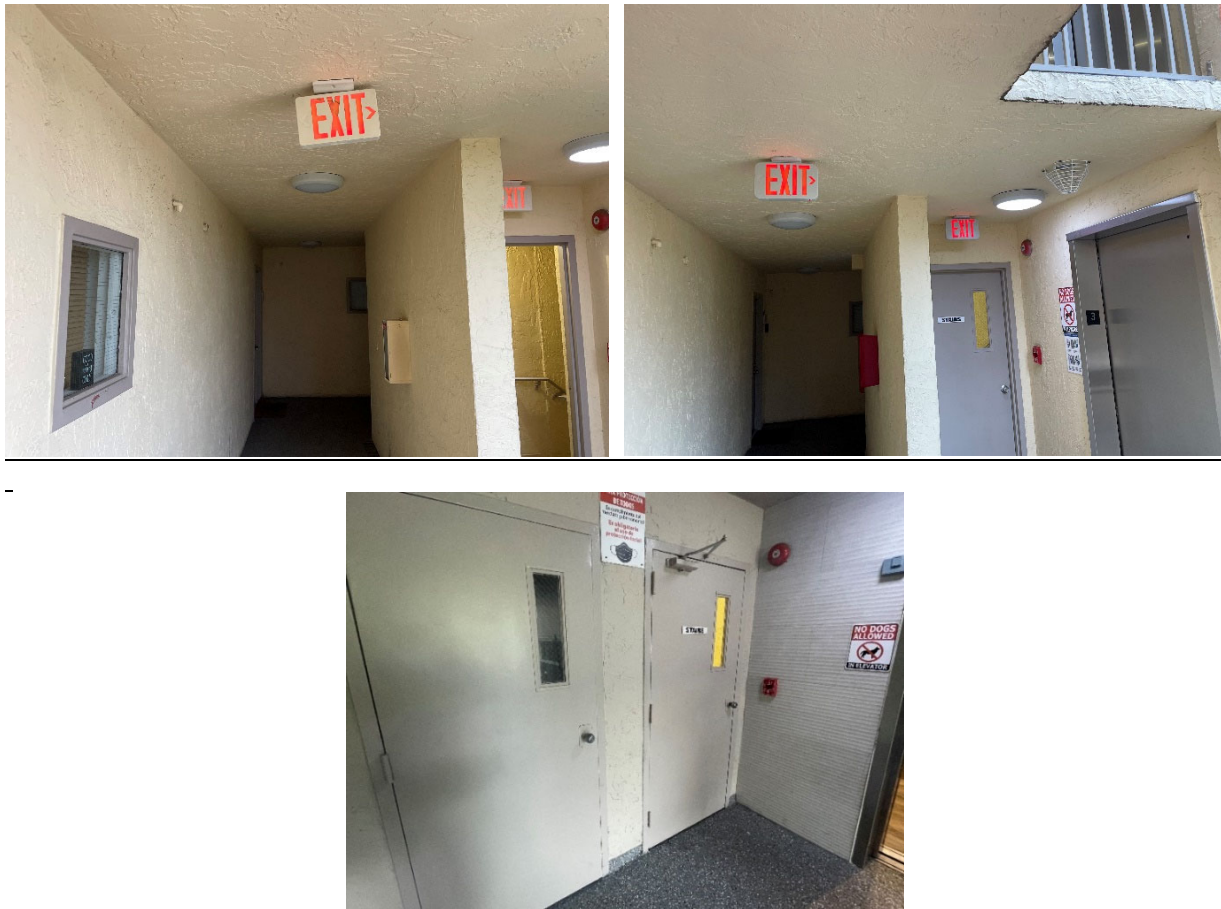
### C. Fireproofing and Fire Protection System

There is a fire alarm system in a dedicate fire command center; logbooks are up to date and provided in the electric panel room. The fire protection system utilizes a sprinklered system. There are fire alarm pull boxes, fire notification system and emergency lighting. Exit lights, emergency lights are building egress illumination is present and operable.

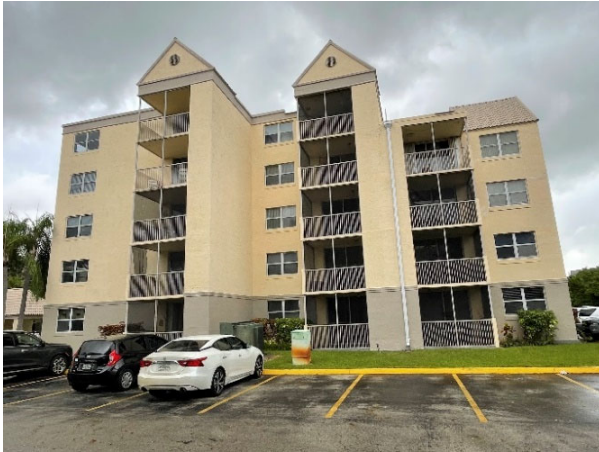
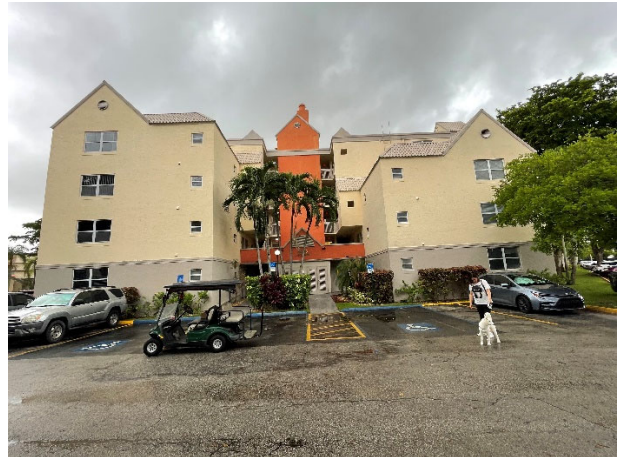
#### D. Painting

The paint is in overall fair condition; however, it is nearing the end of its service life and requires maintenance. Peeling paint was observed around windows on balconies, indicating the need for a new coating to preserve the building's exterior. Additionally, maintenance is required for some window caulking areas to prevent water infiltration. All services area of condominium are included.

The paint is in overall fair condition; however, it is nearing the end of its service life and requires maintenance. Peeling paint was observed around windows on balconies, indicating the need for a new coating to preserve the building's exterior. Additionally, maintenance is required for some window caulking areas to prevent water infiltration. Budgeting for repainting is necessary to maintain aesthetic and protective functions.

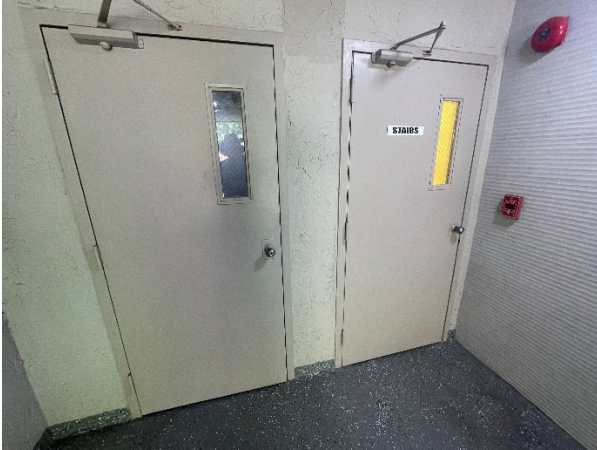
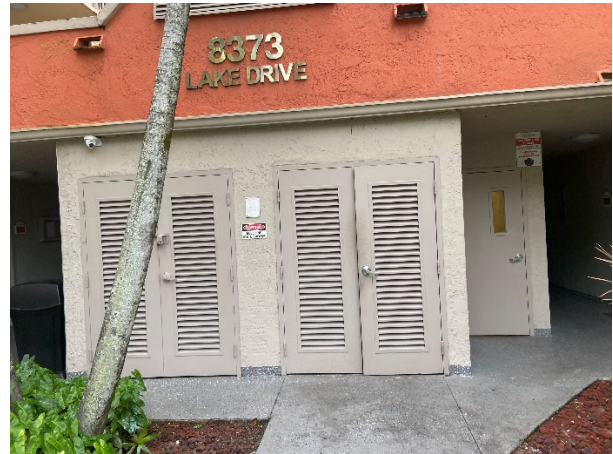
#### E. Exterior Doors

All doors are in fair condition, only regular maintenance.
