**Executive Summary – September 2025**

JOB: Structural Integrity Reserve Study (SIRS)  
ADDRESS: 8215 LAKE DRIVE, CITY OF DORAL

FOLIO: 35-3022-028-0001

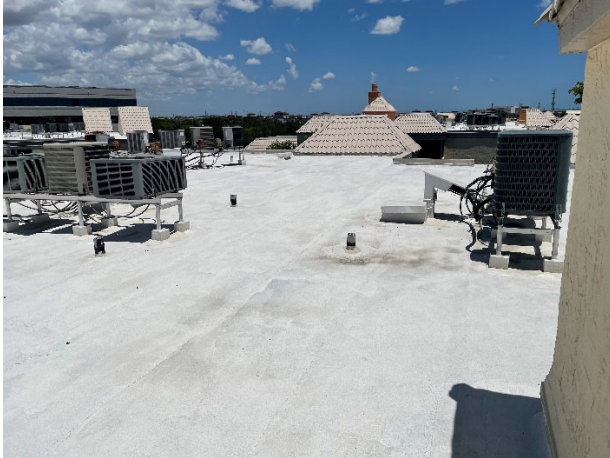
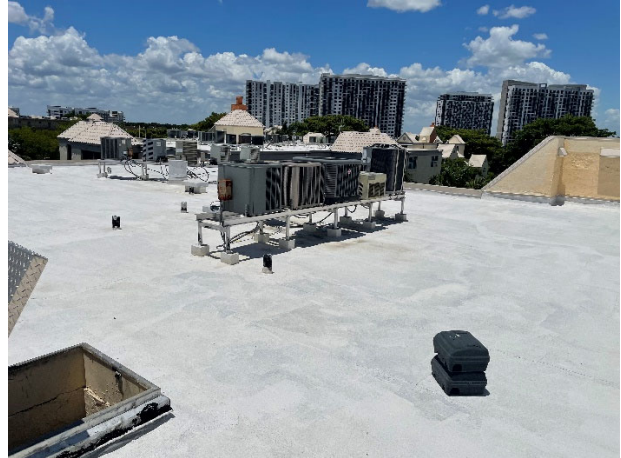
### Roof

Roof drains, scuppers on all balconies, gutters, and leaders discharge into trench drains. The drainage system is in fair condition; some corrosion was found but no repairs are currently needed. There are no roof framing members with obvious overloading, overstress, deterioration, or excessive deflection observed. Surface conditions are overall fair to poor conditions. Previous repairs were observed, and hairline cracks were noted on the roof.

The roof consists of reinforced concrete slabs in fair condition. The roof membrane is a built-up roof system with a granular surface modified bitumen cap sheet. The roofs are currently undergoing repair which are expected to be completed prior to December 21, 2025, reserve funds will be used to carry out the necessary maintenance and repair work during the ten-year period.

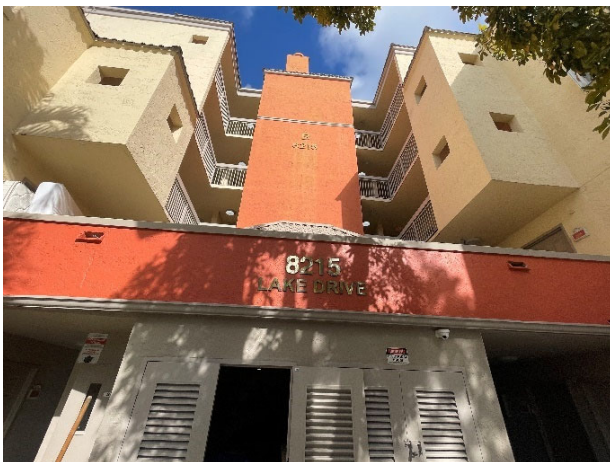
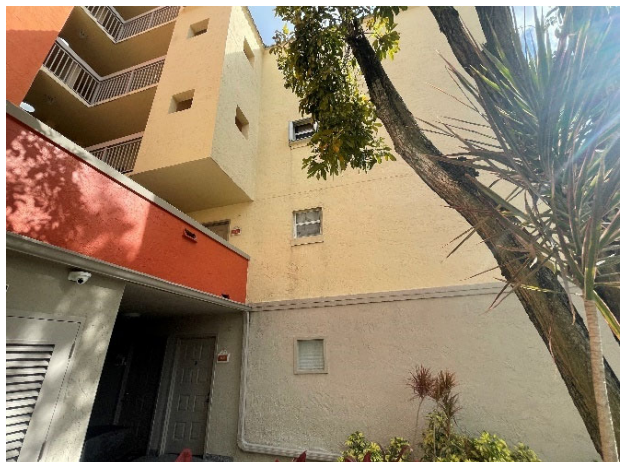
### Exterior Nonconcrete Walls

Nonbearing walls of exterior façade are in fair condition, showing signs of wear such as cracks and surface deterioration.

Minor wear such as small cracks were found at nonbearing walls. Maintenance is recommended over the next ten years, including localized repairs, repainting, sealing, and addressing any waterproofing issues to prevent further deterioration and maintain their functionality and appearance.

Maintenance is recommended over the next ten years, including localized crack repairs, repainting, resealing of joints and windows, and improvements to waterproofing where needed to prevent moisture intrusion.

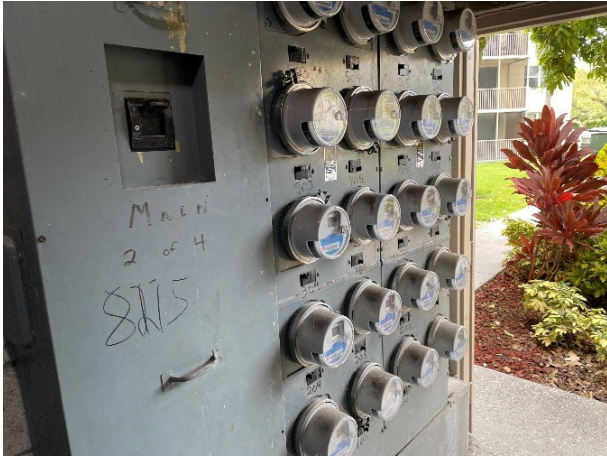
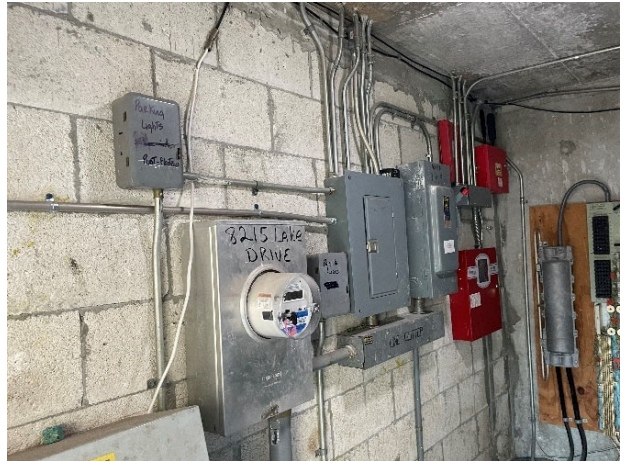
## A. Electrical Systems

The general conduits & raceways require repairs; There is rust and corrosion on some conduits. Moreover, there is loose BX conduit exiting concrete slab, the penetrations around these conduits must be patched, the wire and cables have rusted conduits and loose connections for BX exiting the concrete slab.

No defects were observed with swimming pool wiring or mechanical equipment or in wiring to mechanical equipment. There was no exposed wiring observed in open parking garage areas. Some breakers will need to be replaced during the ten-year period.

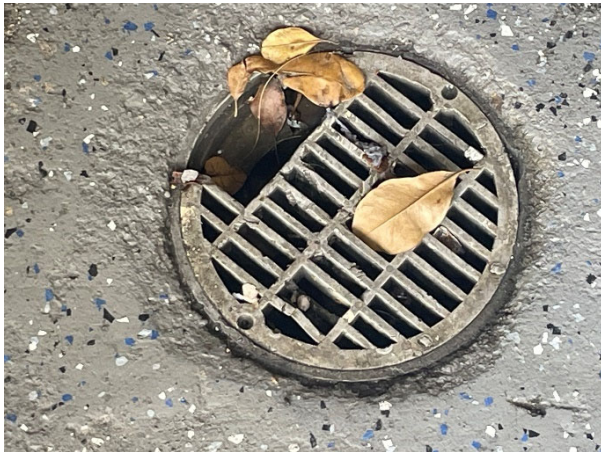
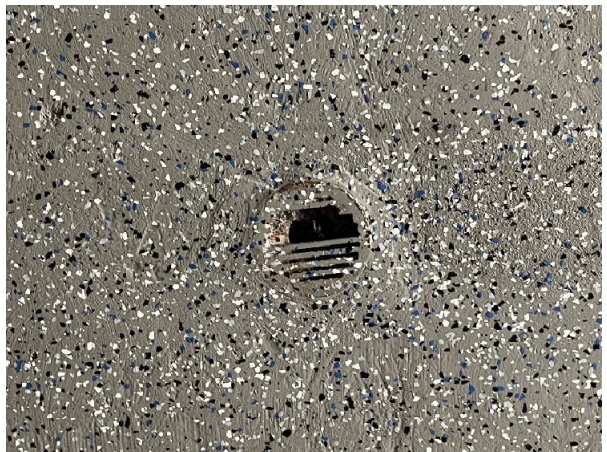
### Sanitary System:

They consist of sanitary risers (stacks) with full size ventilation through the roof. We project two incidents for this building in a ten years period.

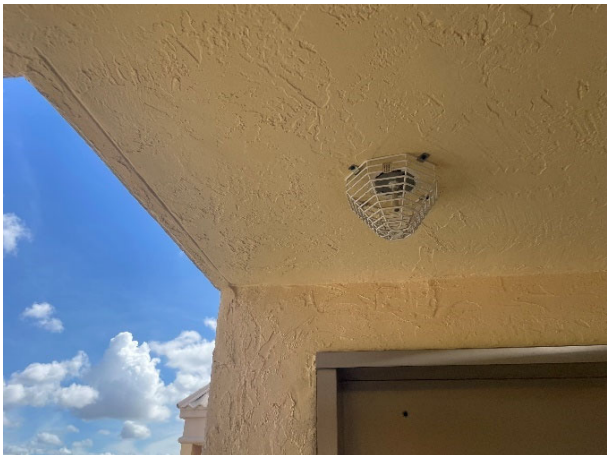
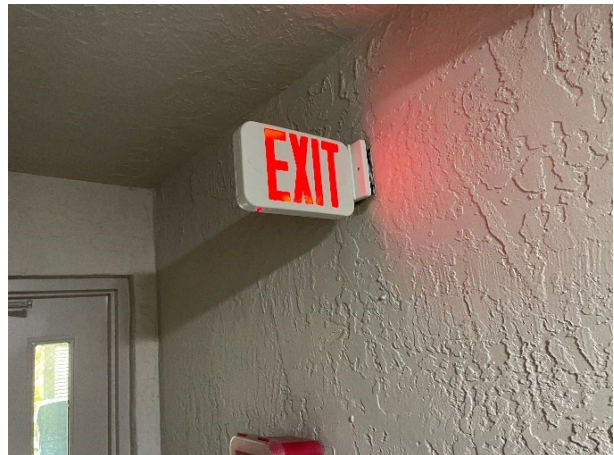
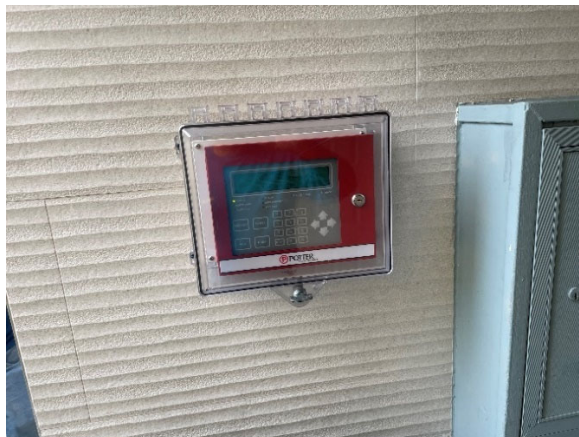
### C. Fireproofing and Fire Protection System

There is a fire alarm system in a dedicated fire command center; logbooks are up to date and provided in the electric panel room. The fire protection system utilizes a sprinklered system. There are fire alarm pull boxes, fire notification system and emergency lighting. Exit lights, emergency lights are building egress illumination is present and operable. Egress illumination is also present and operable in the parking garage. Some smoke detectors are covered due to ongoing masonry work causing dust to trigger alarms.

There is a fire alarm system in a dedicate fire command center; logbooks are up to date and provided in the electric panel room. The fire protection system utilizes a sprinklered system. There are fire alarm pull boxes, fire notification system and emergency lighting. Exit lights, emergency lights are building egress illumination is present and operable.

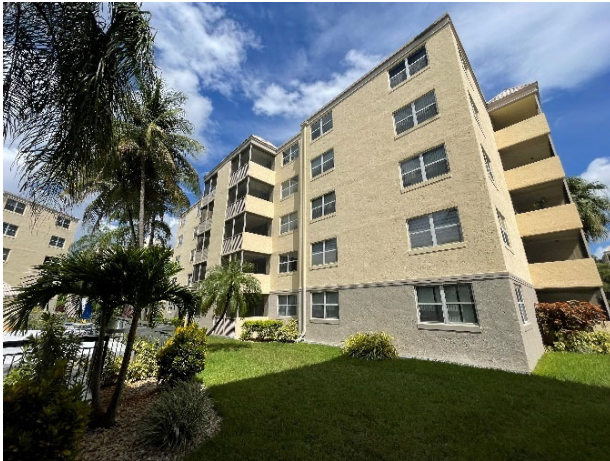
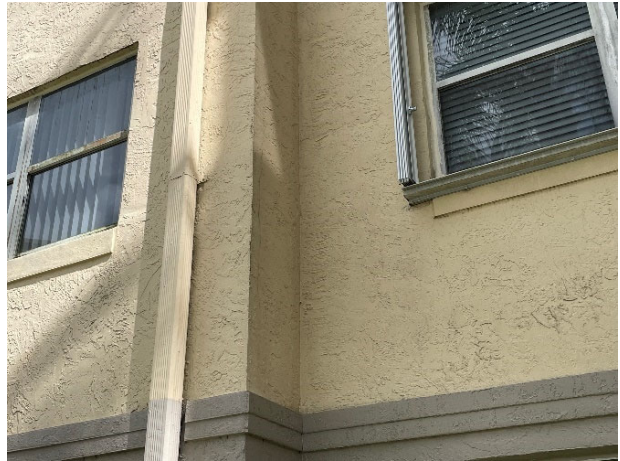
#### D. Painting

The paint is in overall fair condition; however, it is nearing the end of its service life and requires maintenance. Peeling paint was observed around windows on balconies, indicating the need for a new coating to preserve the building's exterior. Additionally, maintenance is required for some window caulking areas to prevent water infiltration. All services area of condominium are included.

The paint is in overall fair condition; however, it is nearing the end of its service life and requires maintenance. Peeling paint was observed around windows on balconies, indicating the need for a new coating to preserve the building's exterior. Additionally, maintenance is required for some window caulking areas to prevent water infiltration. Budgeting for repainting is necessary to maintain aesthetic and protective functions.

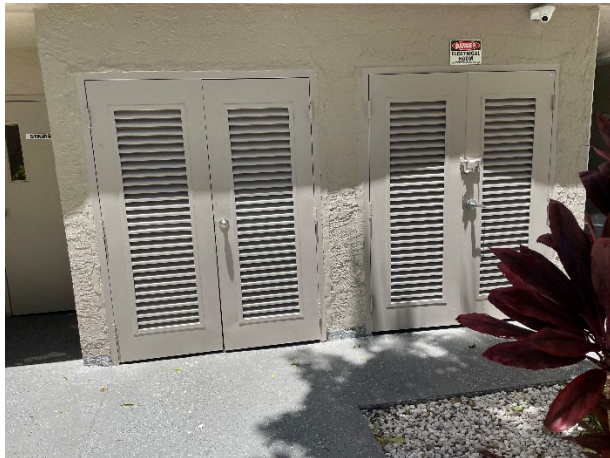
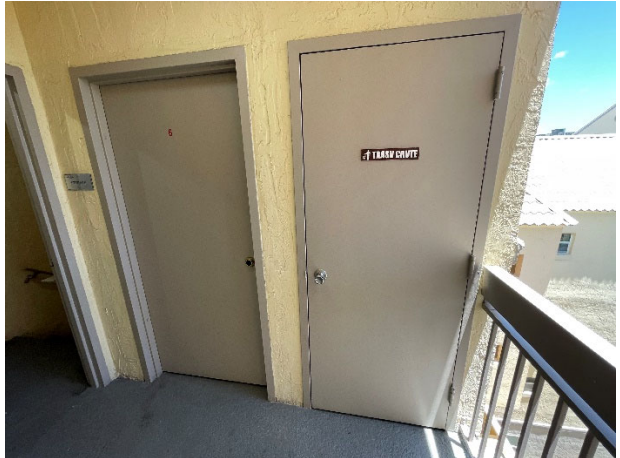
#### E. Exterior Doors

All doors are in fair condition, only regular maintenance.
