**Executive Summary – September 2025**

JOB: Structural Integrity Reserve Study (**SIRS**)  
ADDRESS: 8333 LAKE DRIVE, CITY OF DORAL

This Structural Integrity Reserve Study is being prepared in compliance with F.S. § 718.112 (2) (g)

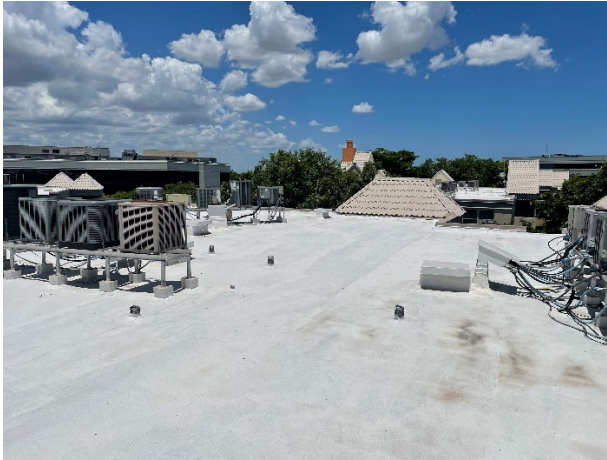
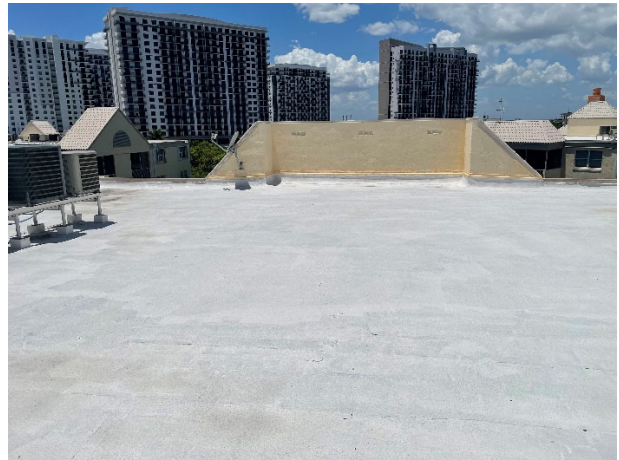
### Roof

The roof consists of reinforced concrete slabs in fair condition. The roof membrane is a built-up roof system with a granular surface modified bitumen cap sheet. The roofs are currently undergoing repair which are expected to be completed prior to December 21, 2025, reserve funds will be used to carry out the necessary maintenance and repair work during the ten-year period.

Roof drains, scuppers on all balconies, gutters, and leaders discharge into trench drains. The drainage system is in fair condition; some corrosion was found but no repairs are currently needed. There are no roof framing members with obvious overloading, overstress, deterioration, or excessive deflection observed. Surface conditions are overall fair to poor conditions. Previous repairs were observed, and hairline cracks were noted on the roof.

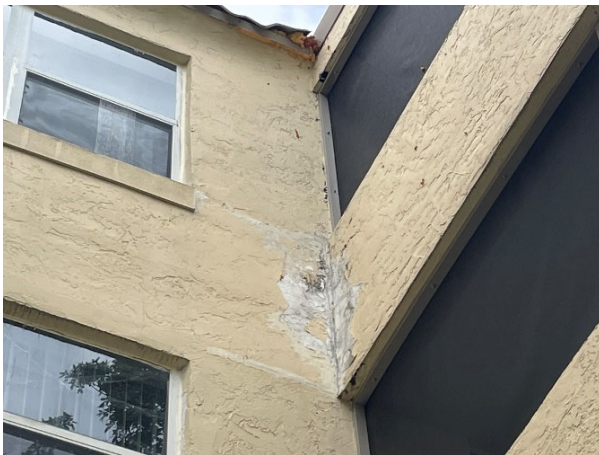
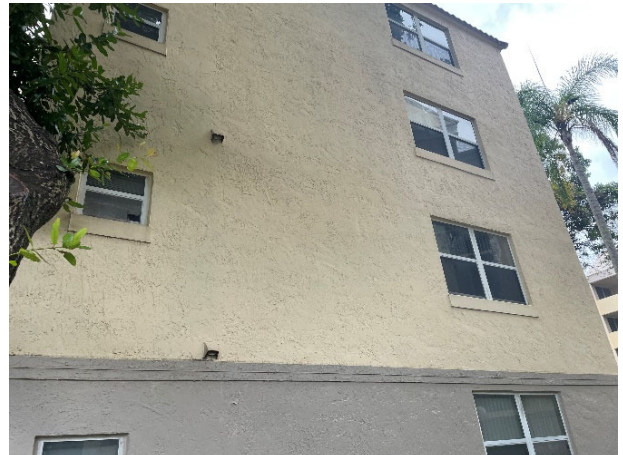
### Exterior Nonconcrete Walls

Nonbearing walls of exterior façade are in fair condition, showing signs of wear such as cracks and surface deterioration.

Minor wear such as small cracks were found at nonbearing walls. Maintenance is recommended over the next ten years, including localized repairs, repainting, sealing, and addressing any waterproofing issues to prevent further deterioration and maintain their functionality and appearance.

Maintenance is recommended over the next ten years, including localized crack repairs, repainting, resealing of joints and windows, and improvements to waterproofing where needed to prevent moisture intrusion.

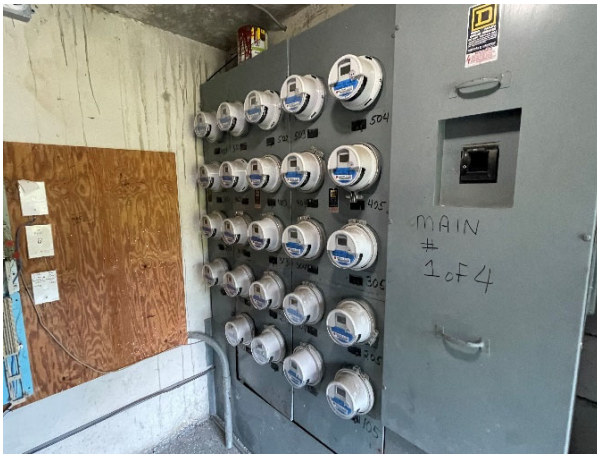
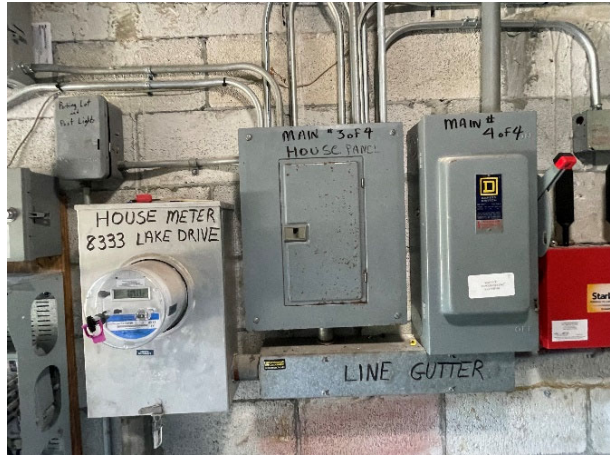
## A. Electrical Systems

The general conduits & raceways require repairs; There is rust and corrosion on some conduits. Moreover, there is loose BX conduit exiting concrete slab, the penetrations around these conduits must be patched, the wire and cables have rusted conduits and loose connections for BX exiting the concrete slab.

No defects were observed with swimming pool wiring or mechanical equipment or in wiring to mechanical equipment. There was no exposed wiring observed in open parking garage areas. Some breakers will need to be replaced during the ten-year period.

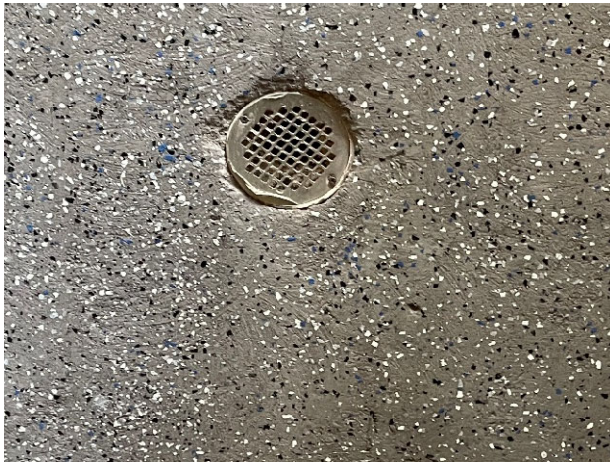
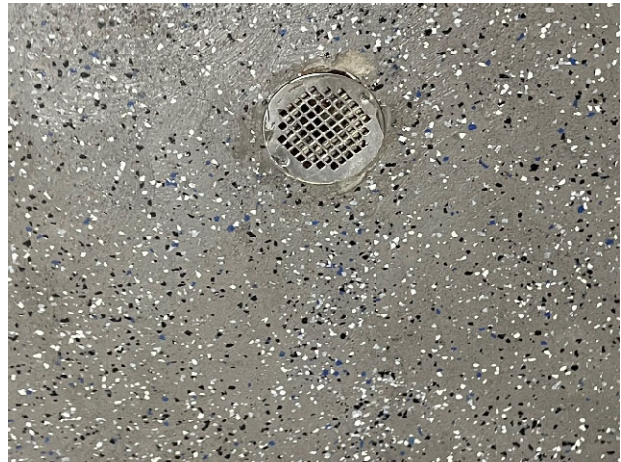
### Sanitary System:

They consist of sanitary risers (stacks) with full size ventilation through the roof. We project two incidents for this building in a ten years period.

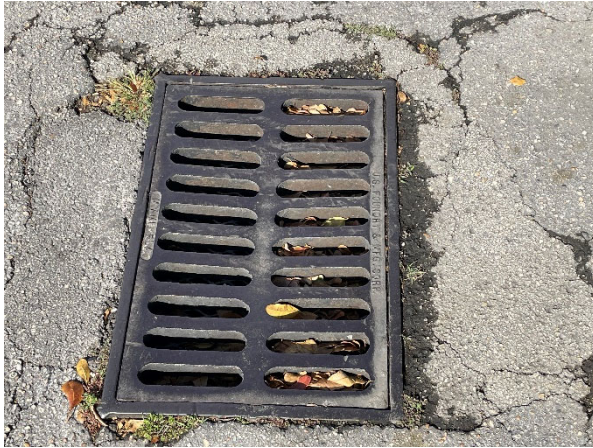
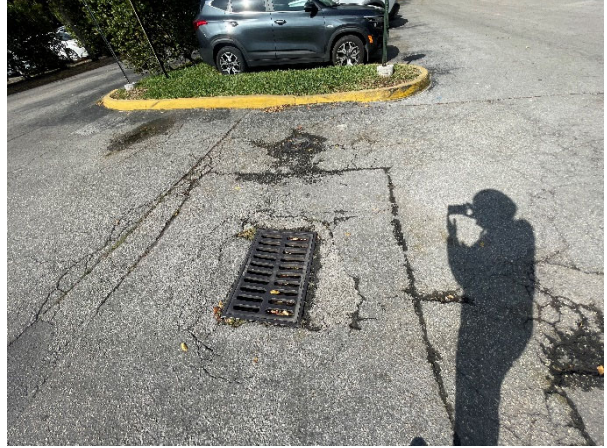
## Drainage System

A new drainage is needed to replace the existing ones, ensuring enhanced performance and durability. This section includes the replacement of the isolated catch basing and pipes.

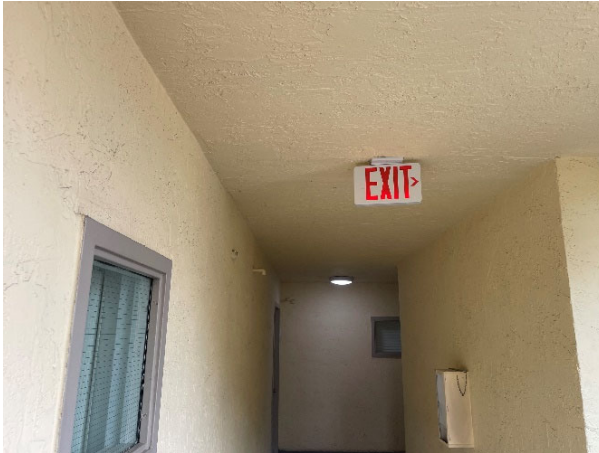
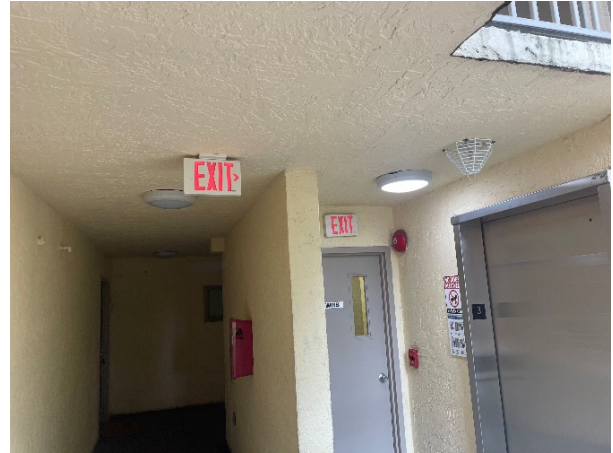
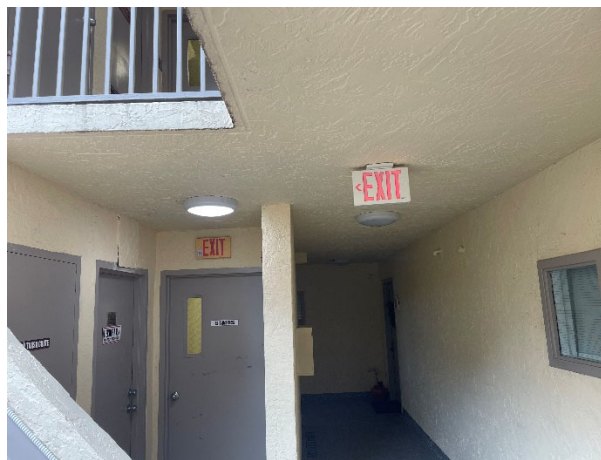
### C. Fireproofing and Fire Protection System

There is a fire alarm system in a dedicated fire command center; logbooks are up to date and provided in the electric panel room. The fire protection system utilizes a sprinklered system. There are fire alarm pull boxes, fire notification system and emergency lighting. Exit lights, emergency lights are providing egress illumination is present and operable.

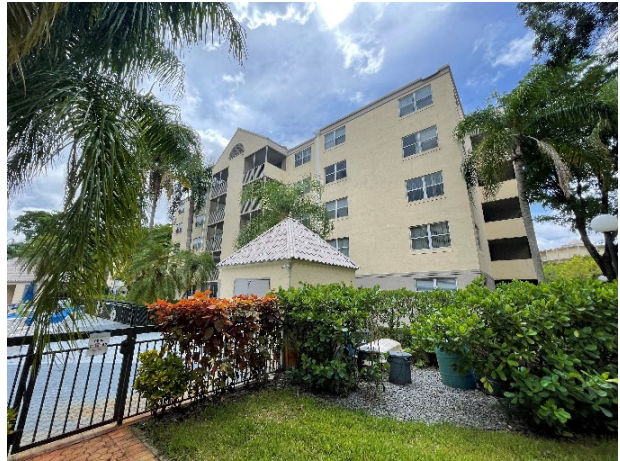
#### D. Painting

The paint is in overall fair condition; however, it is nearing the end of its service life and requires maintenance. Peeling paint was observed around windows on balconies, indicating the need for a new coating to preserve the building's exterior. Additionally, maintenance is required for some window caulking areas to prevent water infiltration. Budgeting for repainting is necessary to maintain aesthetic and protective functions.

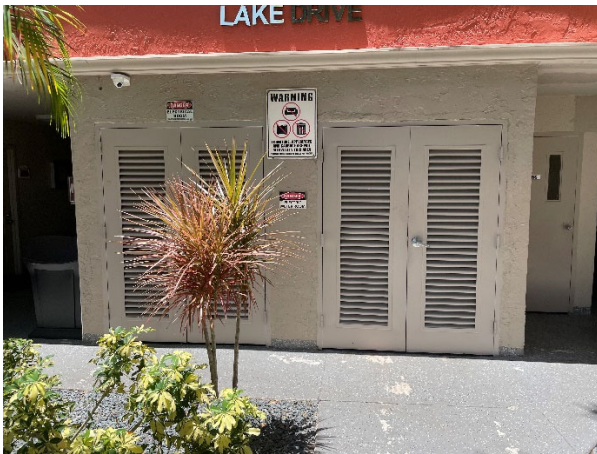
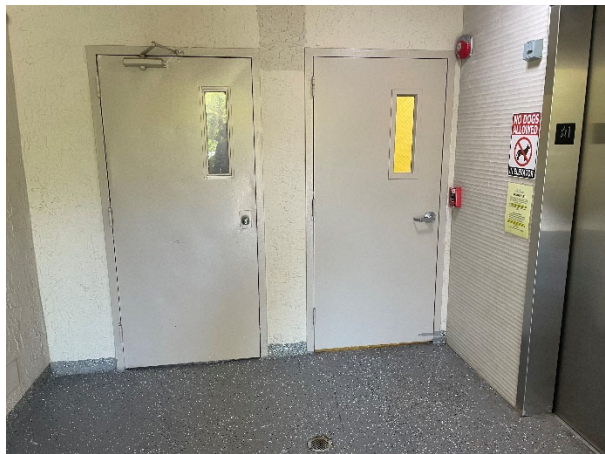
#### E. Exterior Doors

All doors are in fair condition, only regular maintenance.
